SIB 51 26 17

## CREAKING NOISES WHEN DRIVING ON ROUGH ROAD

Engineering Designation	Model Description
F48	(X1 Sports Activity Vehicle)

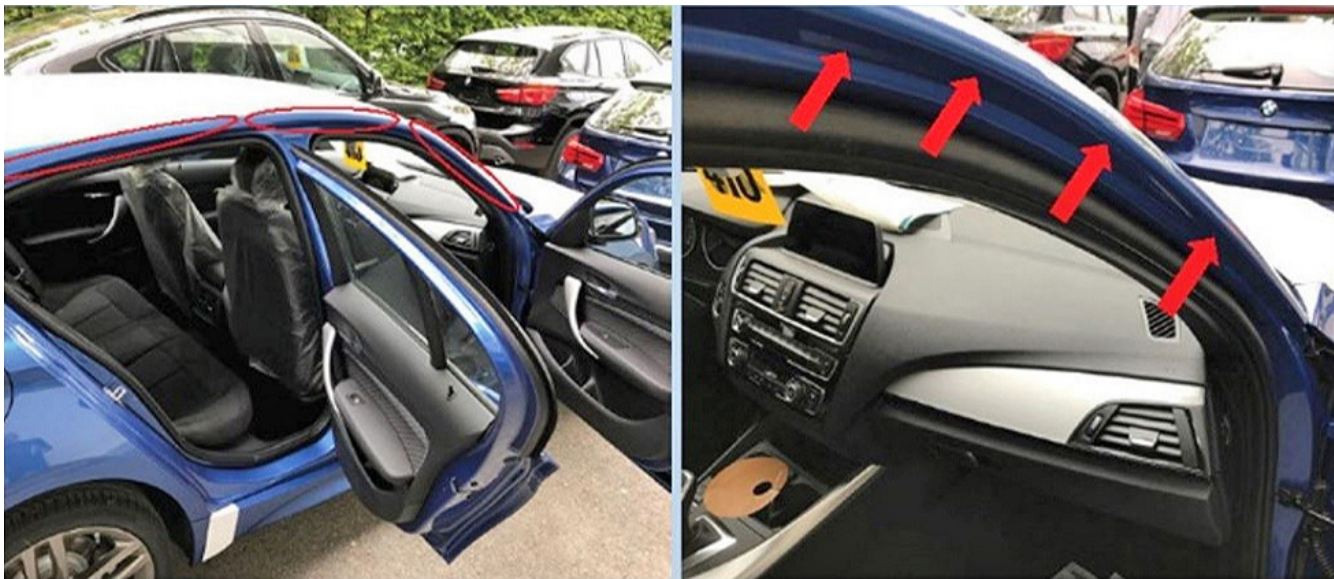
Creaking (groaning) noises are heard from above the door.

Excessive friction between the door seals and the body's door opening. The situation is worsened by:

1. Clean the outer window seal (upper door edge to body, mounted to the door; circled), and painted body contact surface (arrows) with anti-static cleaner (PN 51 91 2 347 903).

2. Bond transparent sliding tape (PN 83 19 9 407 798) to the respective painted contact surface of the door seal that was cleaned in step 1. Press firmly over entire surface for maximum adhesion.

3. Apply Gummi-Pflege rubber care fluid (PN 83 19 2 449 390) to the window seal that was cleaned in step 1.
