SIB 52 06 19

SECOND ROW MECHANICAL 60/40 REAR SEAT NOISE DIAGNOSIS

E-Series	Model Description
G05	(X5 Sports Activity Vehicle)
G06	(X6 Sports Activity Vehicle)

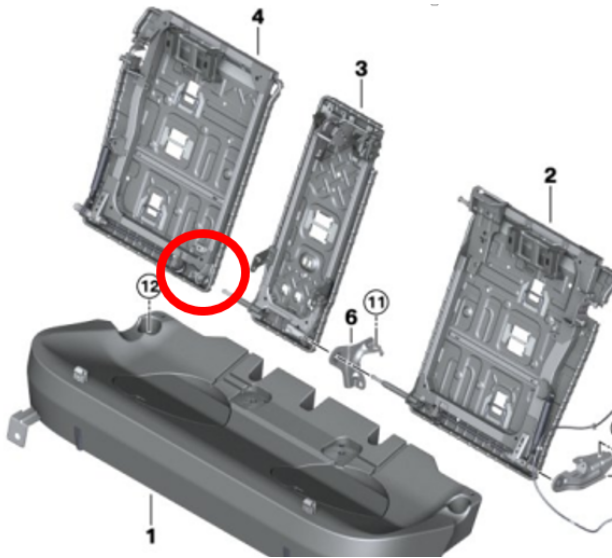
1. Missing, damage plastic bushing (white) at 40% backrest. Collision with the 60% backrest.
2. Backrest unlocking Bowden cable disengaged / damaged. Indicator for the lock visible (red).
3. Unfavorable tolerances in the lock (top, bottom) cause interference noises.
4. Trim wire has become detached from the foam structure.
5. Missing anti-groaning noise web structure at the entry sill accentuates the groaning noise.
6. Unlocking in the luggage compartment, grouting in the clutch not OK and routing of the Bowden cable is not correct.

1. Interference noise (clattering, rattling) from the 2nd row of seats, between the 40% and 60% rear seat backrest on rough road surfaces:

1. Confirm noise is coming from area indicated.

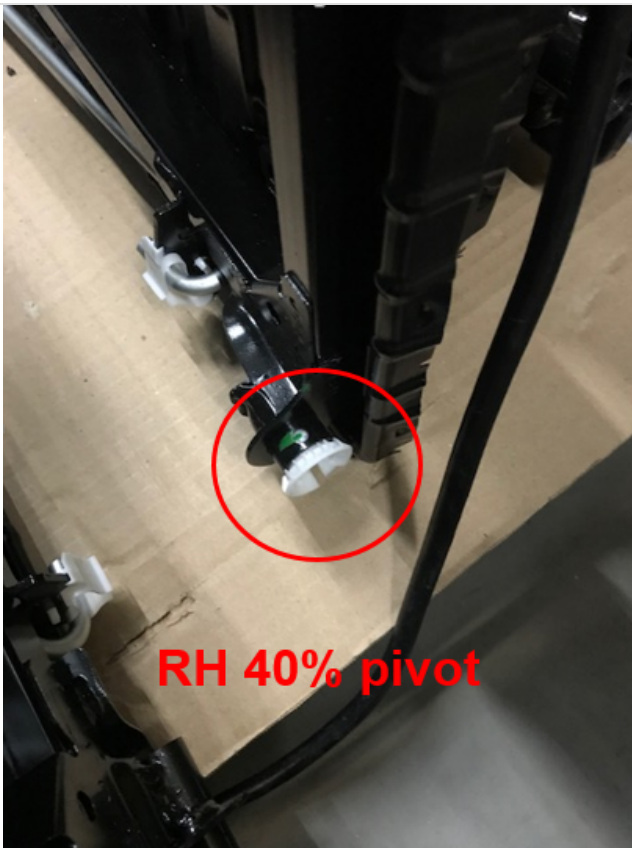
Disassemble 40% passenger seat to access the pivot bushing.

2. Renew the plastic bushing between the 40% and 60% backrest.

This repair part is contained within Service Kit Part Number 52 20 6 994 317.

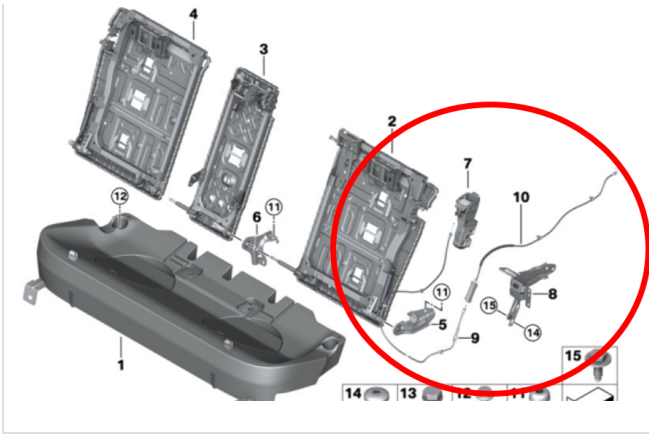
2. Backrest unlocking function does not work and causes noises:

1. Replace the damaged Bowden cable (9) and make sure that the routing of the Bowden cable is correct.

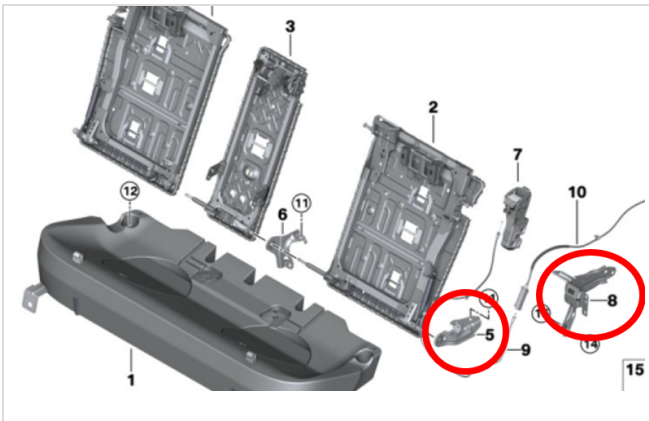
3. Backrest locking (top, bottom) rattles on rough road surfaces without load.

1. If the fault pattern corresponds to the attached video

Replace the top and bottom lock of the backrest (5, 8).

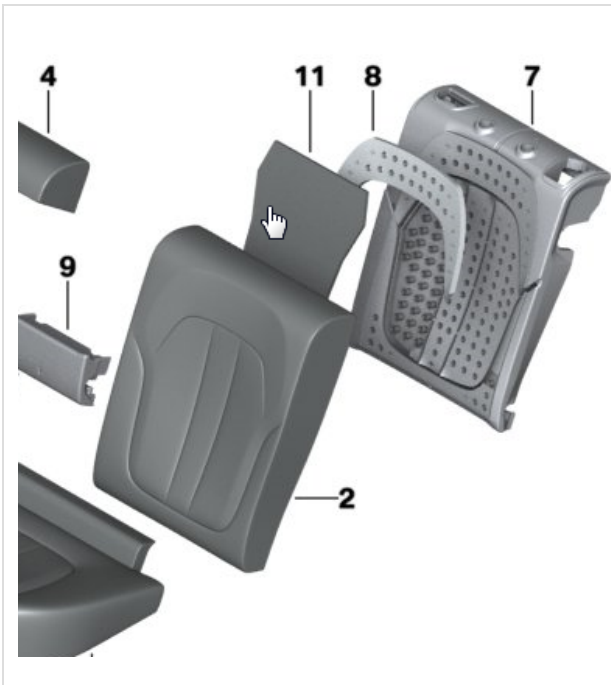
4. Squeaking noises from the rear seat bench (left and right) when loaded.

1. Remove the seat cover of the rear seat bench and replace the foam part(s) of the seat if the spring wire at the top of the seat foam is detached and visible (7, 8).

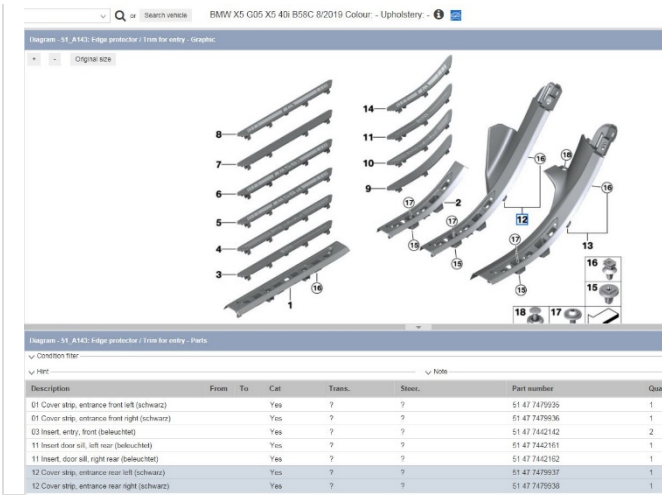
5. Groaning noise when entering and exiting.

1. If the fault pattern corresponds to the attached video-

Replace the door sill cover strip (12).

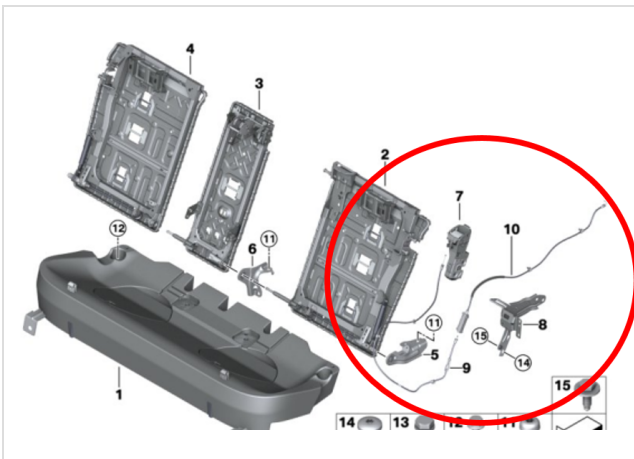
6. Unlocking in the luggage compartment, Bowden cable in the luggage compartment does not work and causes interference noises.

1. Renew the Bowden cable in the luggage compartment and ensure that it is routed correctly (10).
