SIB 52 19 19

SECOND ROW 60/40 PASSENGERS SIDE SEAT INTERMITTENTLY
WON'T LATCH

2019-08-05

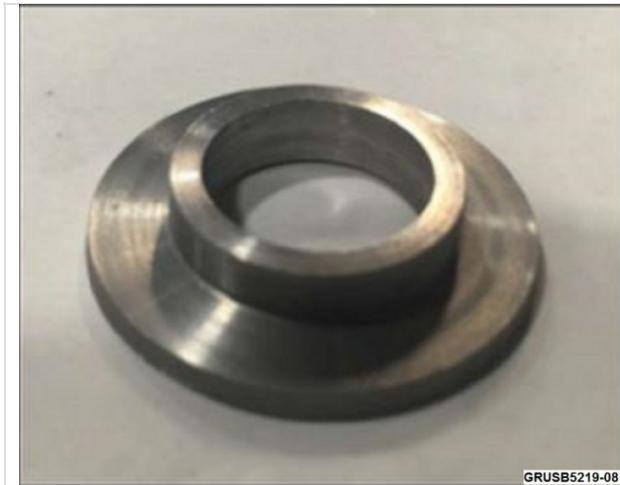
The passenger's side (right rear) of the 60/40 split 2nd row seat may intermittently not fully latch into position on one side (inner rail).

Manufacturing tolerances of the seat assembly produced between mid-July (Calendar week 26) and early October (CW40) of 2019.

As of CW40 production, one machined washer (shown) will be added to the bottom of the inner seat rail on the passenger's side (right rear) of the 60/40 split 2nd row seat.

For vehicles with this specific complaint that were produced from June 24, 2019 thru October 1, 2019, a comparable correction is to add a single 2mm thick flat washer in this location.

- 15mm inner diameter hole for the bolt fitment
- Outside diameter must be at least 30mm
