SIB 64 06 13

A/C COOLING: INTERMITTENT REDUCTION OF AIR FLOW

This Service Information Bulletin (Revision 9) supersedes SI B64 06 13 dated June 2017.

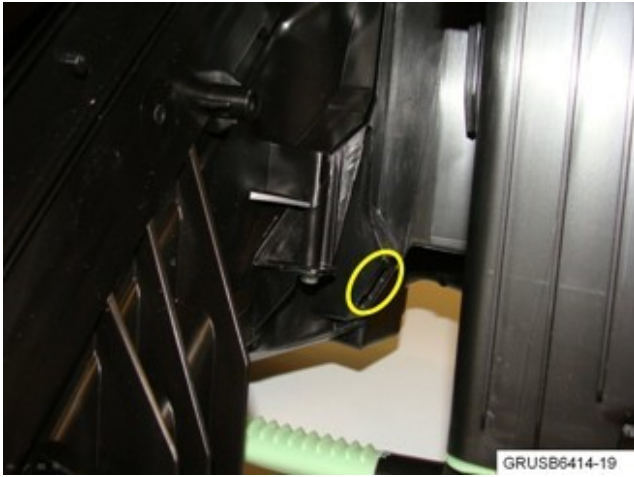
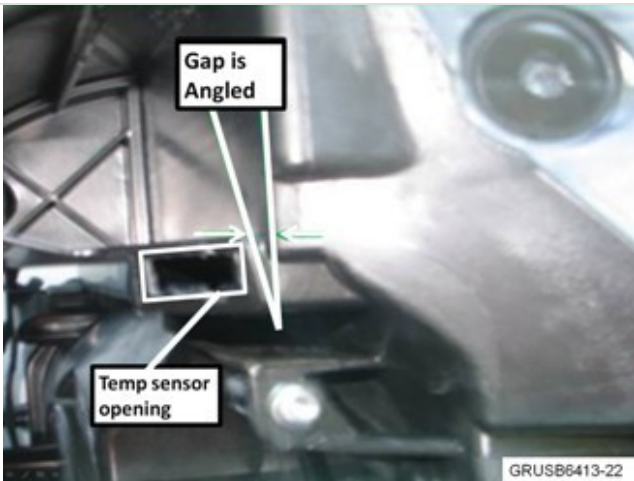
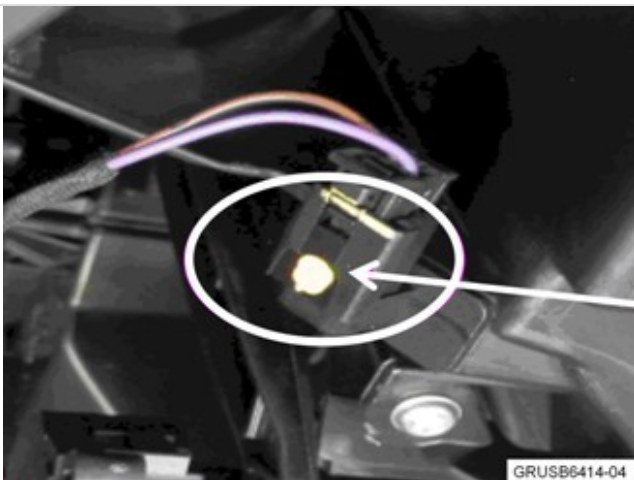
6. Locate the evaporator temperature sensor opening (sensor removed for clarity).

Check the gap between the sensor opening and the evaporator case.

If the sensor opening contact surface is slightly angled as shown, this housing is **NOT** affected by this repair procedure. In this case, proceed with normal A/C diagnostic procedures.

If no gap exists proceed to the next step.

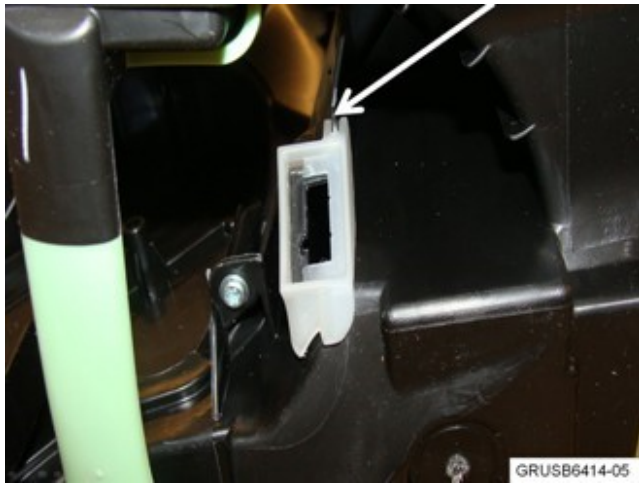
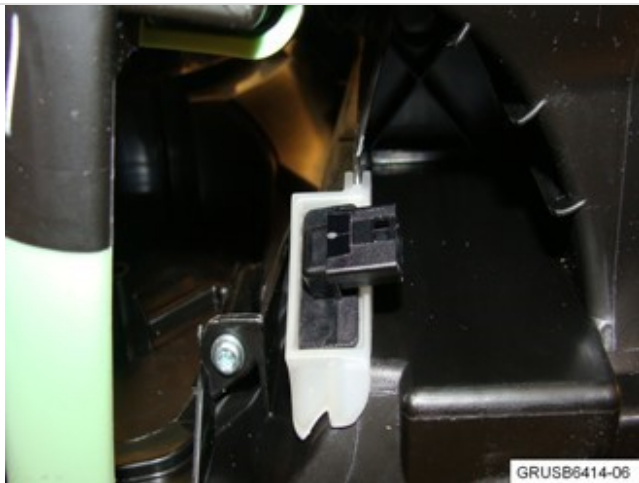
7. Check for a marking on the electrical connector.

If a mark is seen or **NO** gap exists, the IHKA housing must be modified.

Do not replace any parts. The repair procedure includes installing a new adapter to correct the gap.

8. Insert the new adapter firmly into the sensor opening, as shown.

Note: The arrow shows the slot in the adapter that is properly fitted into the raised rib of the housing.

9. Insert the temperature sensor through the opening in the adapter, and push in firmly.

Note: The temperature sensor is keyed and will only fit one way.
