## SIM 65 02 19 SECURITY IMPROVEMENTS FOR HEAD UNITS

2019-08-28

F54 (MINI Clubman)	F55 (MINI Hardtop 4 Door)	F56 (MINI Hardtop 2 Door)	F57 (MINI Convertible)
F60 (MINI Countryman)

Only Model Years 2014 to 2018 are affected.

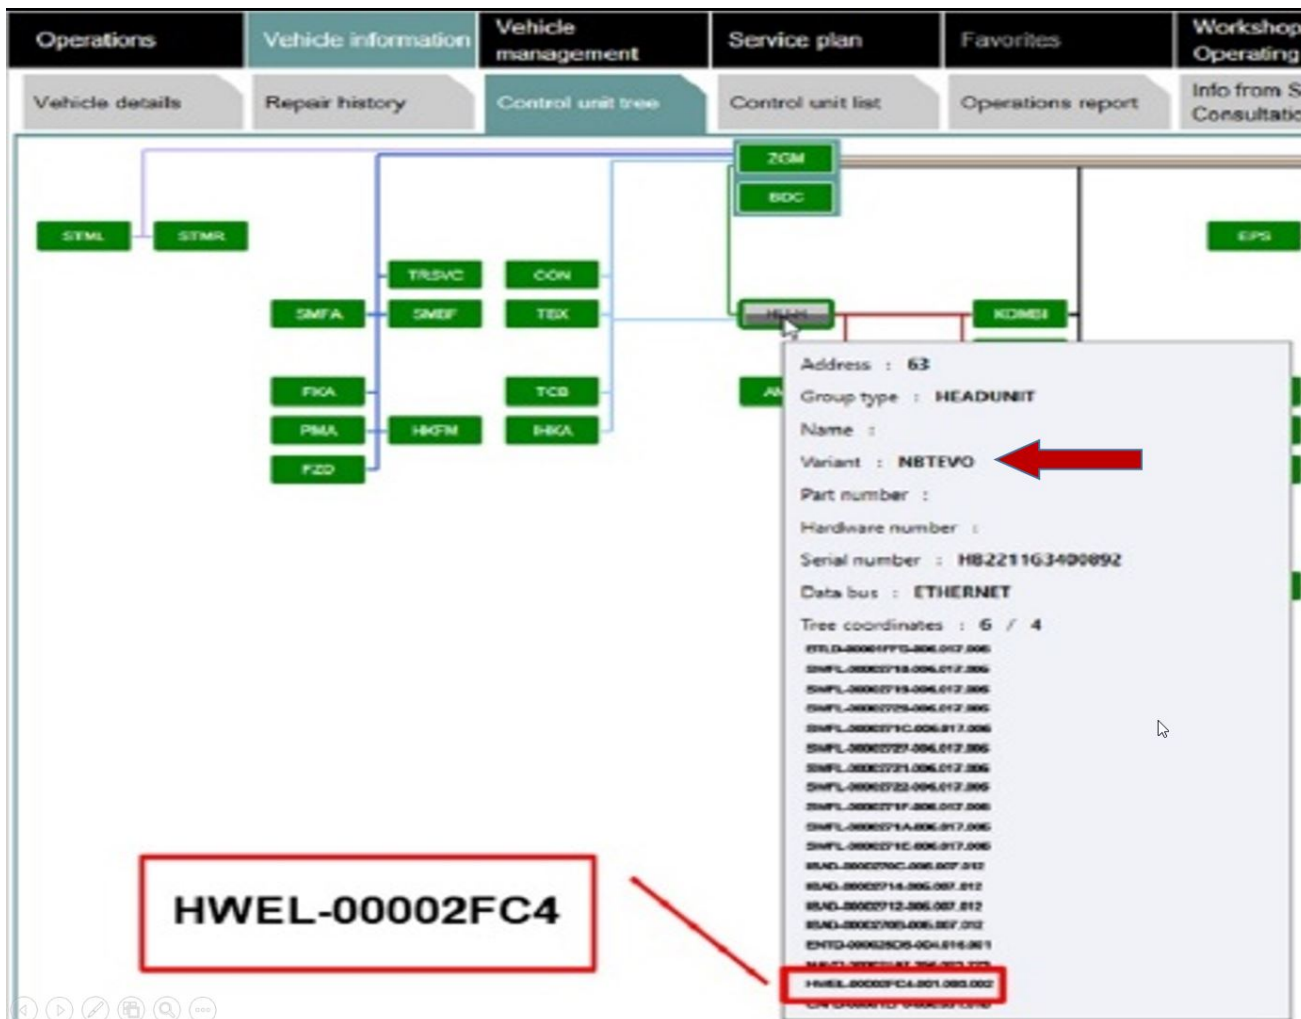
- a. The head unit variant installed in the vehicle (arrow)
- b. The HWEL (hardware electronics) number.
  - If the vehicle is equipped with an RSE (Rear Seat Entertainment), also check the last numbers starting with “RSE...” in the respective column below.
3. Is the HWEL version readout from the vehicle listed below for the corresponding head unit?
