SIB 01 21 18

N63 ENGINE: OIL CONSUMPTION CLASS ACTION SETTLEMENT DIAGNOSIS AND REPAIR PROCEDURES

This Service Information bulletin (Revision 11) supersedes SI B01 21 18 dated **June 2019**.

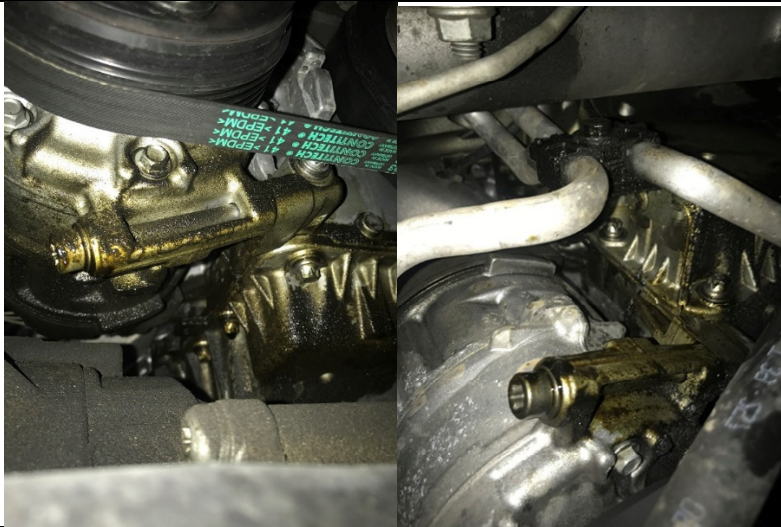
4. Inspect the front engine cover for engine oil leakage.

Front cover is **not** leaking. Go to step 5.

Front cover is leaking. Go to step 7.

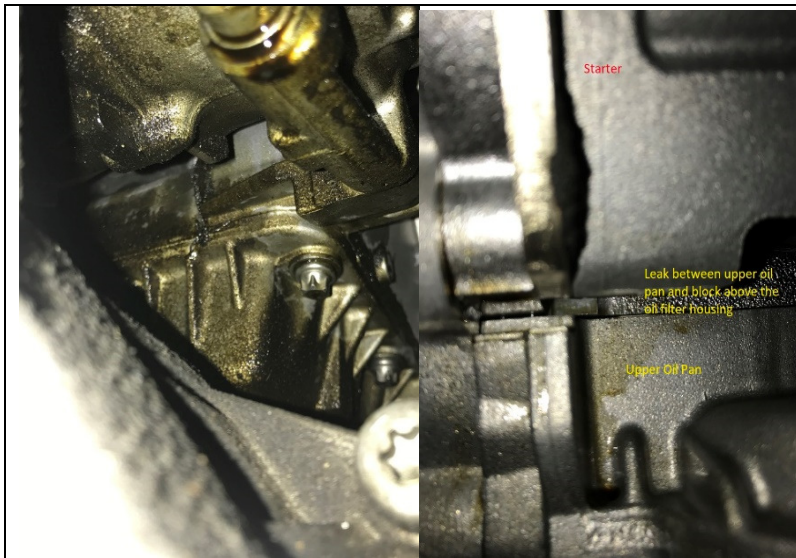
5. Inspect the upper engine oil pan for engine oil leakage.

The upper engine oil pan is **not** leaking.
Go to step 6.

The upper engine oil pan is leaking.
Go to step 7.

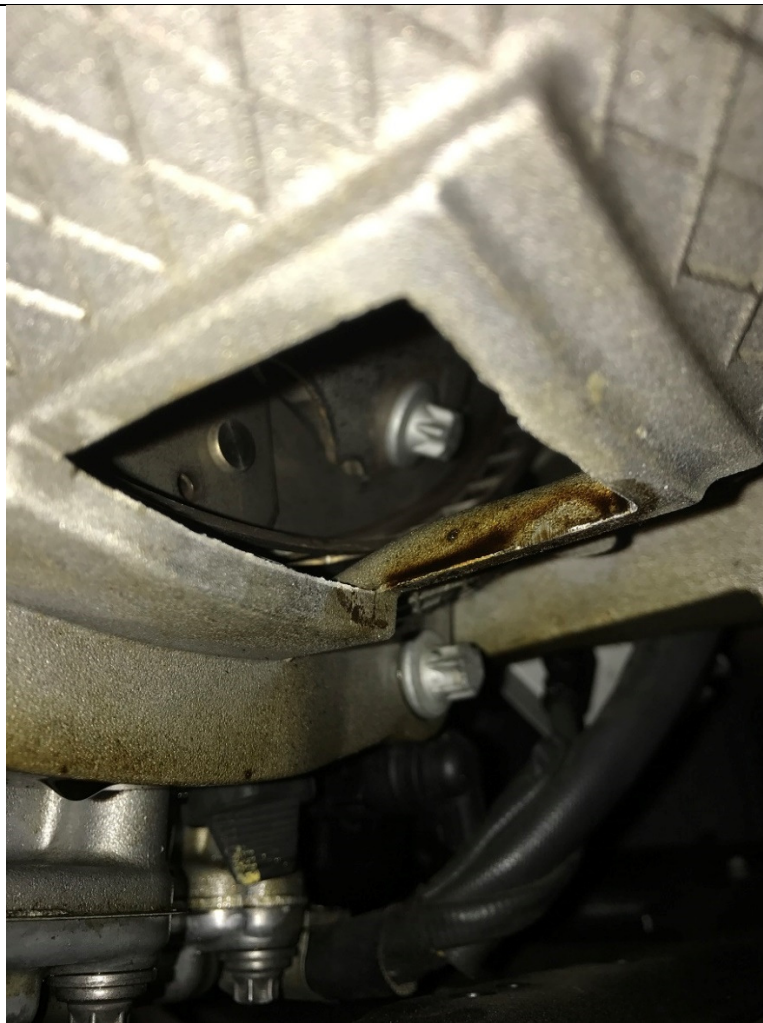
6. Inspect the lower bell housing for engine oil leakage

The lower bell housing is **not** leaking. Go
to step 8.

The lower bell housing is leaking. Go to
step 7.

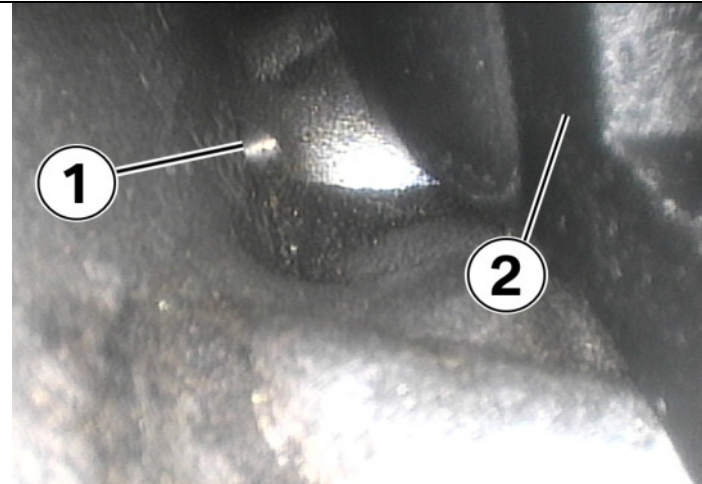
<p>Once the bore scope has gone under the plastic reservoir tab then the engine valley drain hole (1) and surrounding area can be clearly inspected.</p> <p>The dark material at the bottom of the photo is dust and dirt. This material appears to be reflective but it is dry.</p> <p>Engine valley drain hole (1)</p> <p>Plastic vacuum reservoir (2)</p>
--	--

If engine oil is found in the valley area, then the root cause of the engine oil leak resides in the components on top of the engine i.e. turbocharger oil lines cover, turbo charger, etc. Further basic diagnosis will be needed to find the root cause this engine oil leak. Do not remove the transmission from the vehicle. Go to Step 8.

If NO engine oil residue is found at the engine valley drain hole, but an original visual inspection indicated leak in the bell housing area, the root cause of the engine leak resides in the rear main seal and rear engine cover. Do not remove transmission from the vehicle. Go to step 8.

If NO engine oil residue is found at the engine valley drain hole, then the root cause of the engine oil leak will be related to the original visual inspection of front cover, or oil pan. Go to step 12.

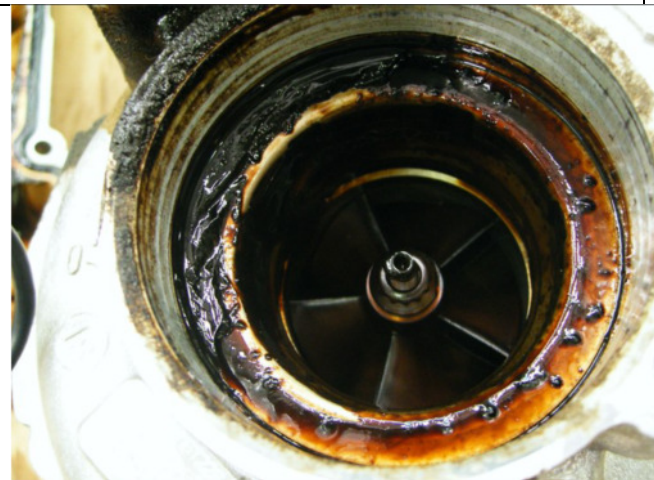
The turbocharger is not OK.

The turbocharger impeller seals are leaking engine oil.

If the turbocharger inspection is "NOT OK", then replace the turbochargers in conjunction with the recommendations in step 11. Go to step 11.

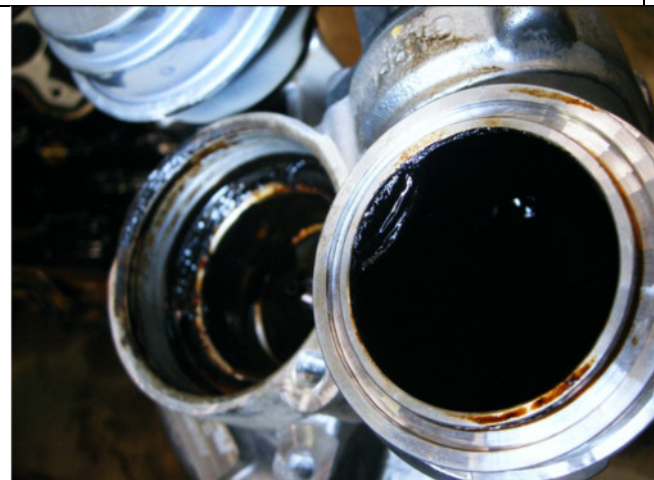
The turbocharger is not OK.

The turbocharger impeller seals are leaking engine oil.

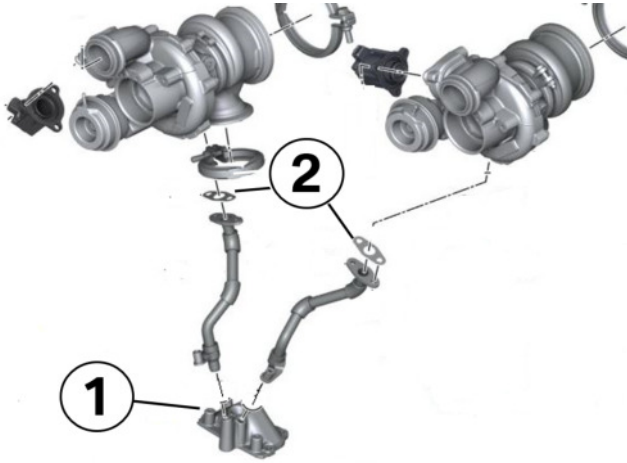
If engine oil is found under the turbos using a borescope then the oil return line cover (1) or the oil return line gaskets (2) are leaking engine oil.

(1) The oil return cover comes with all 3 O-rings. Use P/N 11 42 7 935 572.

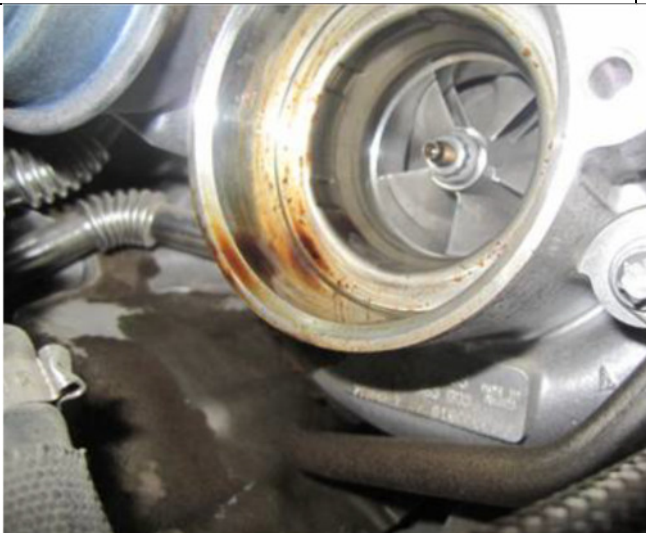
The turbocharger is OK.

No engine oil can be seen around the turbocharger impeller.

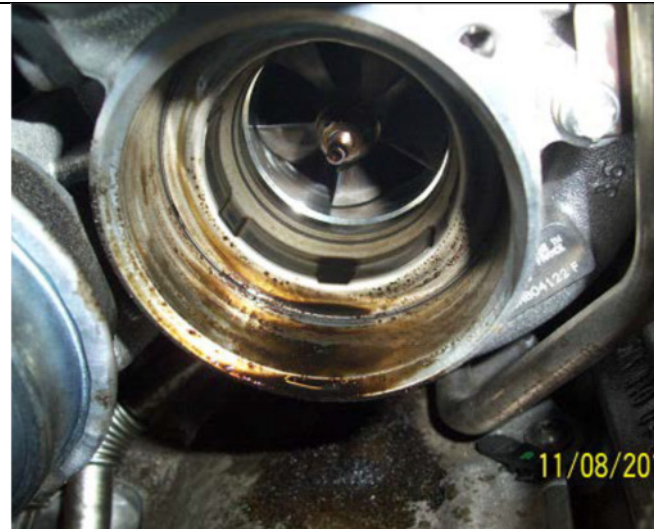
The turbocharger is OK.

No engine oil can be seen around the turbocharger impeller.

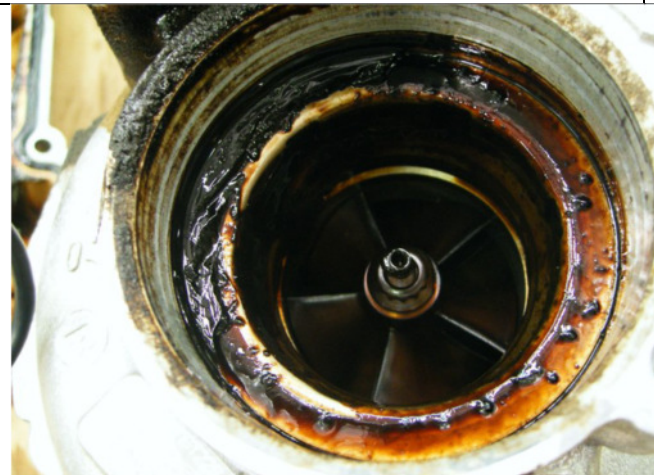
The turbocharger is not OK.

The turbocharger impeller seals are leaking engine oil.

If the turbocharger inspection is "NOT OK", then replace the turbochargers in conjunction with the recommendations in step 14. Go to step 14.

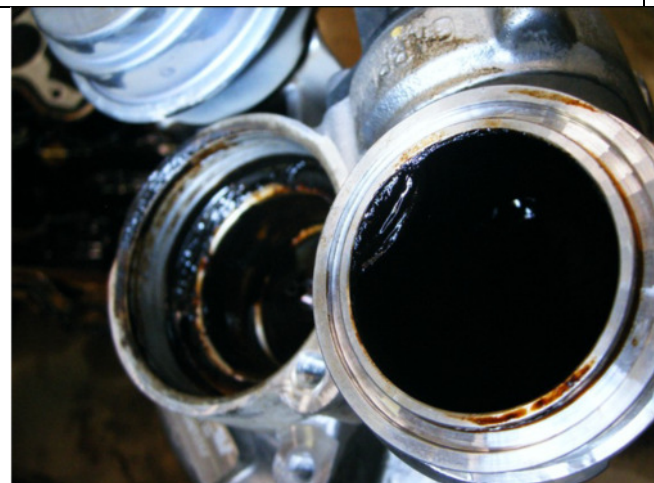
The turbocharger is not OK.

The turbocharger impeller seals are leaking engine oil.
