SIB 32 08 18

SERVICE ACTION: REWORK THE STEERING GEAR

This Service Action involves F22, F23, F30, F32 and F36 Series vehicles produced from October 19, 2011 to May 19, 2015.

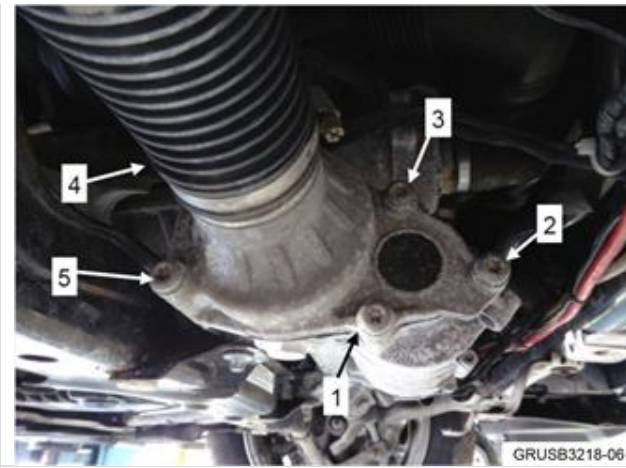
1. Disconnect the battery according the **REP 61 20 900**.
2. Remove the front underbody protection according to **REP 51 47 490**.
3. For vehicles with sports suspension settings, remove the underride protection for steering.
4. Visually inspect the (5) screws securing the power pack to the steering gear.

Are any of the screws, in the (5) indicated locations, missing or been obviously sheared off?
YES – Go to next step.
NO – Perform the attached Steering Gear Power Supply Attachment Rework procedure.

5. Reconnect the battery.
6. Connect the vehicle to ISTA/D and perform a vehicle test.
7. Following repair instructions **REP 32 13 572**, replace the steering gear.
8. Following repair instructions **REP 32 00 155**, perform a wheel alignment.
9. Work through the measures plan and program the vehicle using ISTA 4.12.30 or higher.

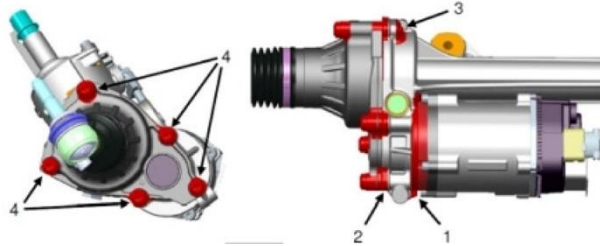
2. Clean the flange on the interface from the housing to the differential cover (areas indicated in red on illustration) so that wax can be applied and adhere to the flange surface.

Warning: Steering gear subject to corrosion if improperly cleaned!

Steel or brass brushes used to clean the steering gear may cause corrosion. Do not use steel or brass brushes!

- Carefully clean around the five screws (callout #4 in illustration).
- Using compressed air, blow off any loose dirt.

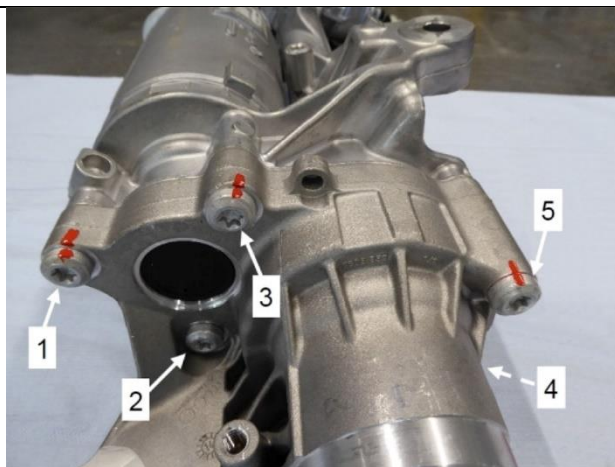
3. Mark screws with red paint pen.

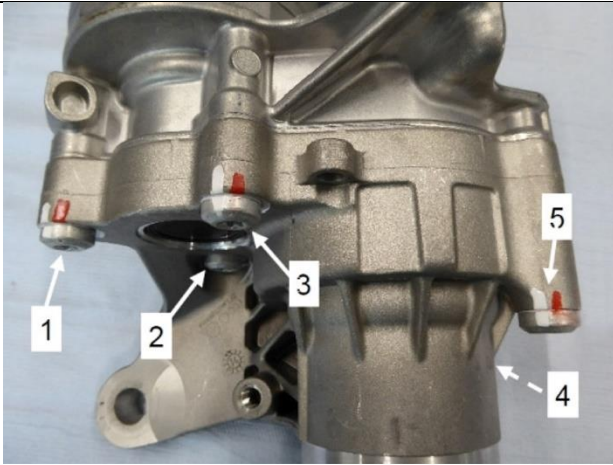
Warning: Do not loosen more than one screw at a time or damage to the steering system may occur!</p> <p>4. Replace the five indicated screws, one at a time, using the following procedure.</p> <p>

Note: If at any time during this procedure, a screw in the steering gear flange breaks, abort this procedure and replace the steering gear as detailed in the main bulletin B32 08 18.</p> <p>

Note: Tools used must be periodically tested for accuracy. Specified torque is applicable to a hand-operated torque wrench.</p> <ol style="list-style-type: none"> A. Remove screw 1. B. Discard the screw. C. Install a new screw using an electronic torque wrench. <p>Torque: 5 Nm (+/- 0.5 Nm) +90° angle of rotation (+0° / -20°).</p> <ol style="list-style-type: none"> D. Mark the installed screw with a white paint pen (similar to illustration). E. Repeat the procedure for remaining screws 2, 3, 4, and 5, verifying replacement status on the basis of the paint marks.

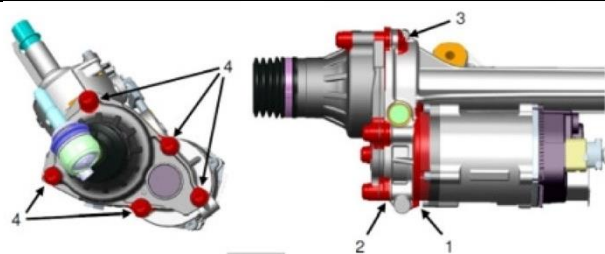
<p>5. The following areas must be coated with body cavity protection spray (wax), where indicated.</p> <ul style="list-style-type: none"> • Flange interface from housing to engine (1) • Flange interface from housing to differential cover (2) • Both through-holes (3) • All five screw heads (4) <ol style="list-style-type: none"> A.

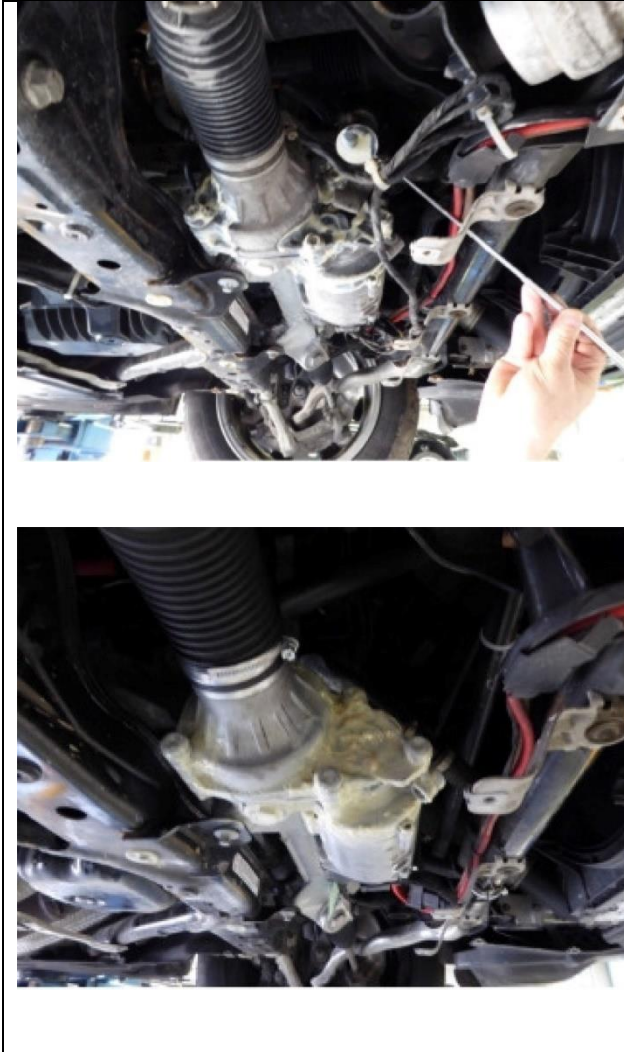
- steering gear flange (1 & 2) and screws with wax.
- B. Using a mirror where necessary, check for complete coverage. If required, spray any areas missed, again.
 - C. Wait three minutes for the wax to dry slightly.
 - D. **UPDATE!** Using the air-vent with spraying pipe, re-spray the entire area again.
 - E. Check for complete coverage and re-spray, as needed.
6. Reconnect the battery.
 7. Connect the vehicle to ISTA/D and perform a vehicle test. Check the repair list.
 8. Clear the fault memory.
 9. For vehicles with sports suspension settings, install the underride protection.
 10. Install the front underbody protection according to REP 51 47 490.
 11. Test the steering function.
