SIB 51 21 19

2019-08-16

ACTIVE AIR FLAP FAULT DIAGNOSIS AND REPAIR

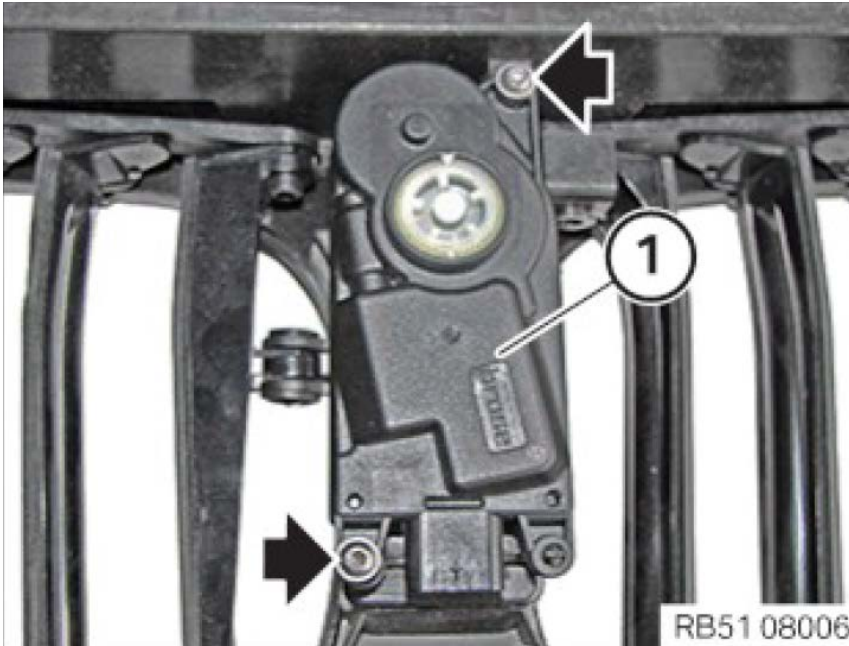
1. Remove the upper active air flap, following the repair instructions within ISTA for the specific vehicle by VIN.
2. Remove screws (see arrows) from upper active air flap actuator (1) as shown below:

3. With the active air flap actuator removed, manually open the flaps.
4. Install the replacement active air flap actuator.
5. Install screws, tightening to the following specifications:
G01/G02-3nm
G12, G30, G32- 2nm
6. Reinstall the upper air flap following ISTA repair instructions.
