SIB 51 22 19

2019-08-16

PASSENGER SIDE UPPER ACTIVE AIR FLAP STUCK OPEN/CLOSED

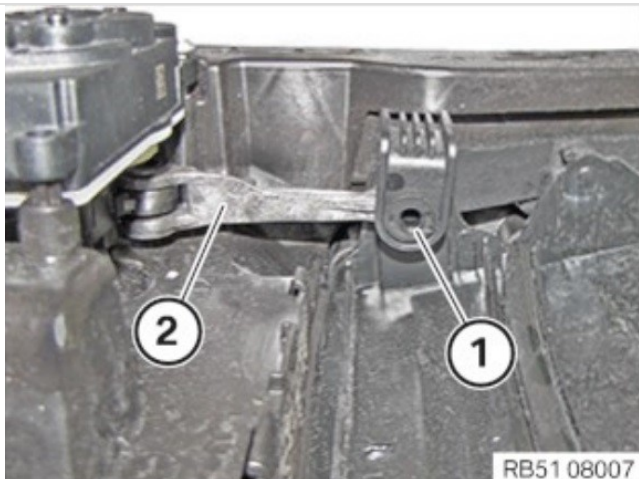
The pin used to attach the upper active air flap actuator has detached from the linkage.

2. Using the photo to the left, inspect the actuator linkage (1).

- Is the pin missing, and linkage detached?
