SIB 51 23 19

2019-08-09

## SERVICE ACTION: REWORKING THE LOCK ON THE REAR LEFT DOOR

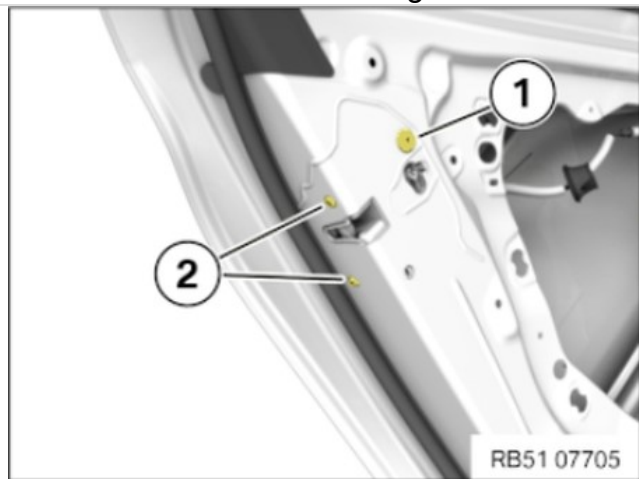
The screw connection for the left rear door lock may not have been torqued correctly.

During vehicle production, the screws were not torqued to specification.

2. First, tighten both screws (2) to 8.8Nm
3. Next, tighten screw (1) to 8.8Nm
4. Completely reassemble the vehicle following ISTA repair instructions **REP 51 42 000** "Remove and install left or right rear door trim panel".
