SIB 51 24 19 CRACKING NOISE FROM DASHBOARD TRIM

| E-Series | Model Description |
|---|---|
| F90 | M5 Sedan |
| G30 | 5 Series Sedan |
| G32 | 640i xDrive Gran Turismo |

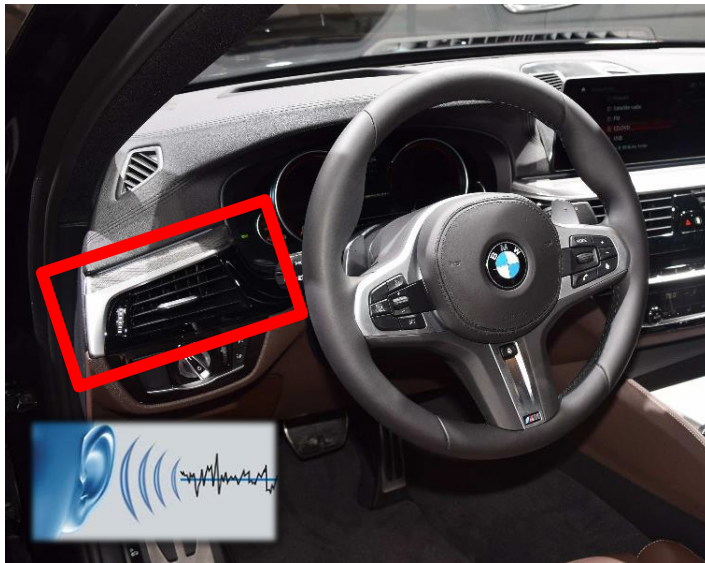
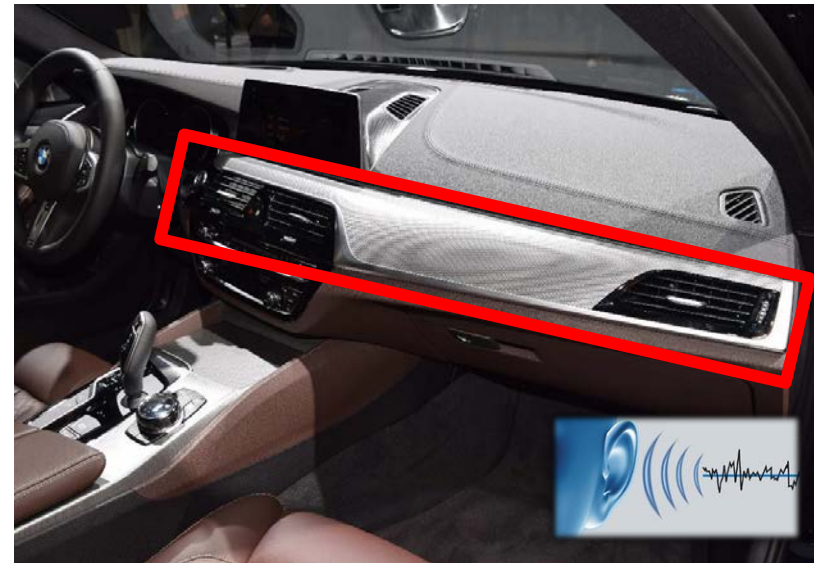
Creaking / cracking noise from the area of decor strip / CID during temperature increase or decrease of the interior.

The noise can be reproduced during the cooling phase / warm-up phase of the interior.

The customer complaint is reproducible. As the interior is cooled down or heated up to a normal level, a creaking, cracking noise at the middle of the instrument panel occurs.

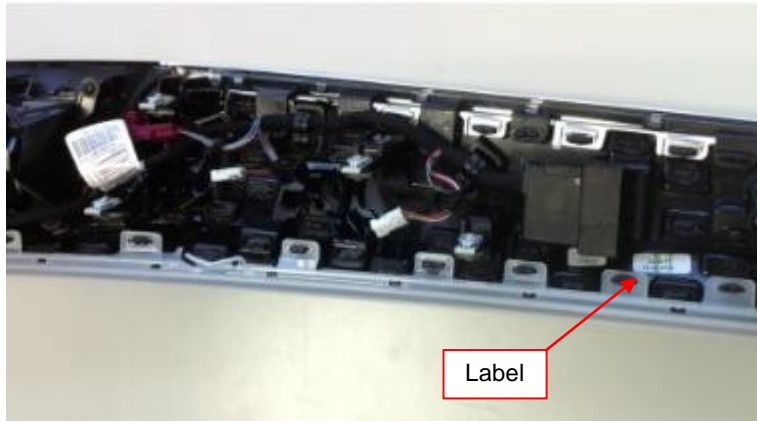
Check the production date of the decor strip, referencing the label shown below. The trim must be produced AFTER 3/26/2018. If the production date is before 3/26/2018, replace the trim and continue on. A label with the production date is placed on the back side of the decor strip, just to the side of the main 26 pin harness connector.
