SIB 51 25 19

GROANING NOISE WHEN OPENING/CLOSING FRONT WINDOWS

E-Series	Model Description
F30	3 Series Sedan
F80	M3 Sedan

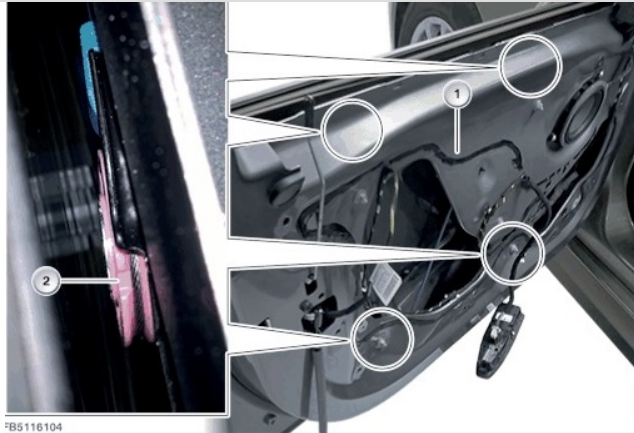
A groaning noise can be heard from the front door(s) when opening or closing the power windows.

Insufficient lubrication of the window regulator(s).

2. Lubricate the rollers (2) of the front window regulator as shown to the left using adhesive grease PN 81 22 9 407 629.
