## Technical Service Bulletin

| <b>Topic</b> | Rotating screen alignment |
| <b>Transaction No.</b> | 2051526/3 |

### New Continental GT

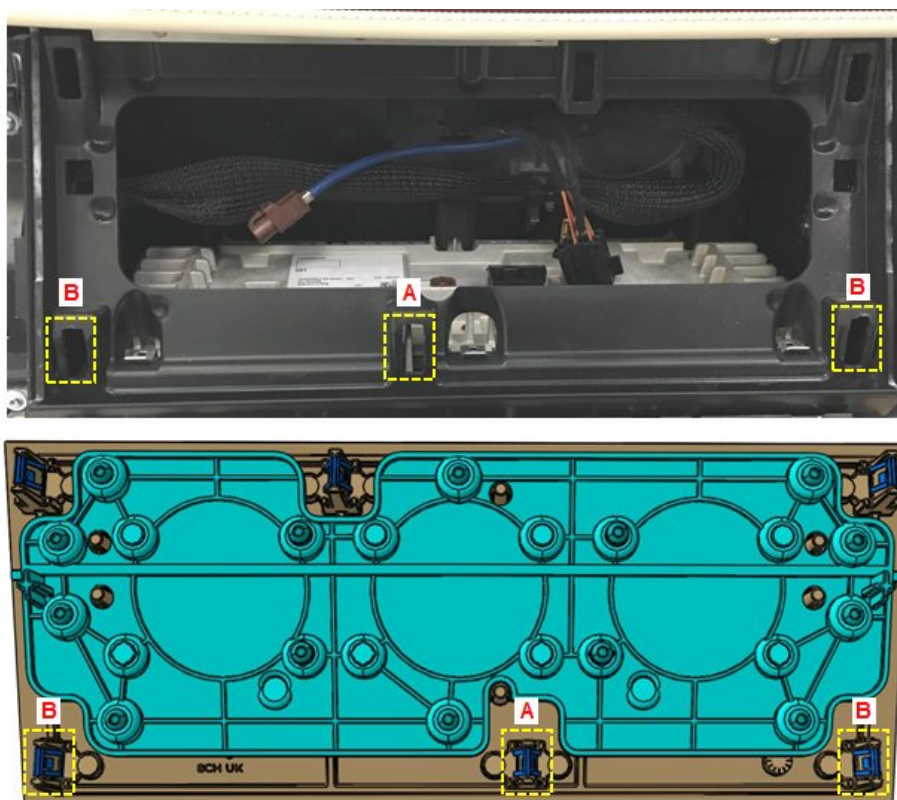
Figure 1

The veneer face fascia panel is fixed to the “BRD” by six locator pins and receiving holes. See Figure 1.

The following locator pins (A & B) control the position of the fascia panel as follows:

A = Side to side axis

B = Up and down axis

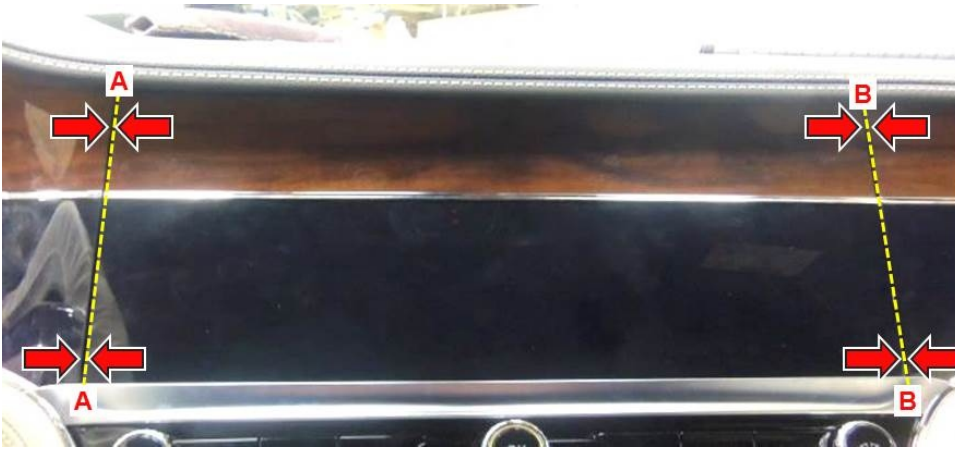
**Figure 2**

Measure the gaps (A & B) between the veneer face fascia panel and the passenger and drivers side fascia panels. See Figure 2.

The specified gapping is 1.5mm +/- 0.5mm tolerance. The gap between the "BRD" veneer face fascia panel and passenger and drivers side fascia panels **MUST** be parallel on both sides.

If the gaps are not within the specified values then adjust as follows.

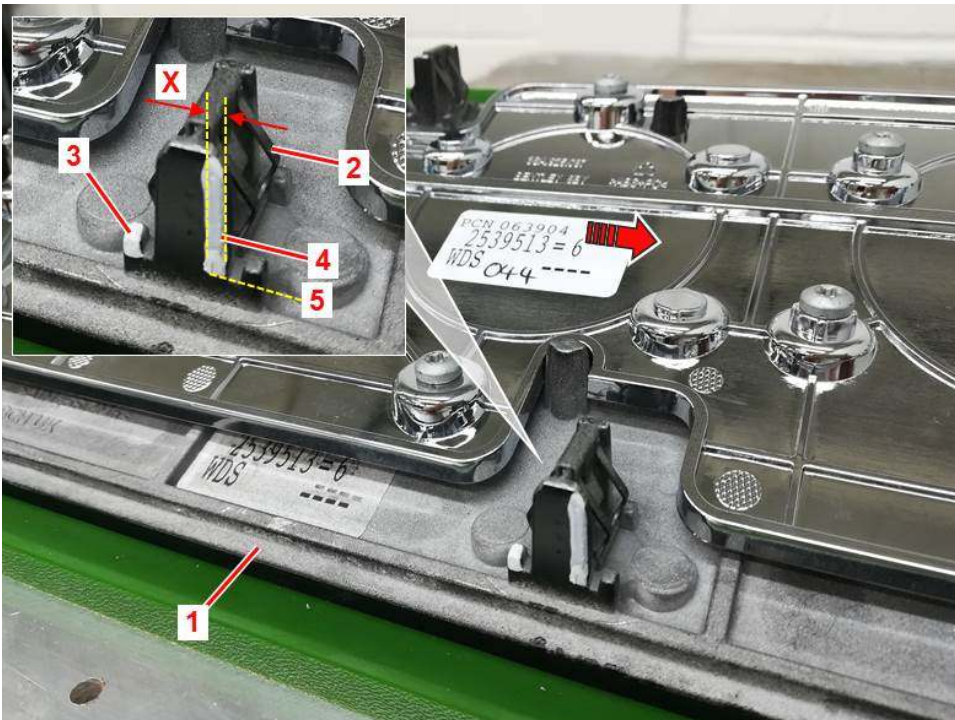
**Figure 3**

**i** Only the centre lowermost locator pin shown governs the side to side movement of the fascia panel. Only this locator pin will require modifying.

Place the veneer face fascia panel (1) face down on a soft, clean and protective work surface and mark accordingly the direction in which the panel needs to move (arrow). See Figure 3.

Remove the spring retaining clip (2) from the lowermost locator pin. If the fascia panel requires moving by 0.5mm then remove the same amount of material (X) from the appropriate side of the lower centre locator pin (4) as shown on the aluminium substrate casting. In addition, file the trailing RPS point (3) flat, level with the recess. See Figure 3.

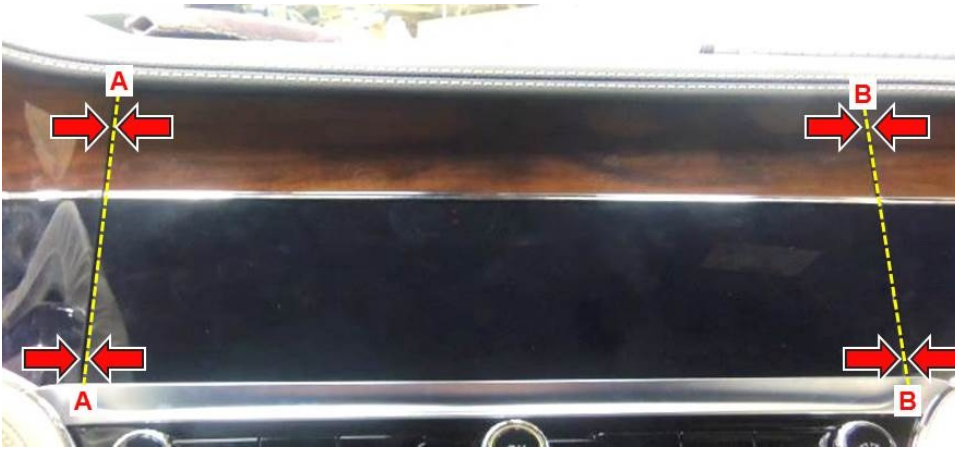
**Figure 6**

Again measure the gaps (A & B) between the veneer face fascia panel and the passenger and drivers side fascia panels. See Figure 6.

The correct gapping is 1.5mm +/- 0.5mm tolerance. The gap between the veneer face fascia panel and passenger and drivers side fascia panels **MUST** be parallel on both sides.

If the gaps are not within the specified values then add/remove anti-creak tape to adjust accordingly.

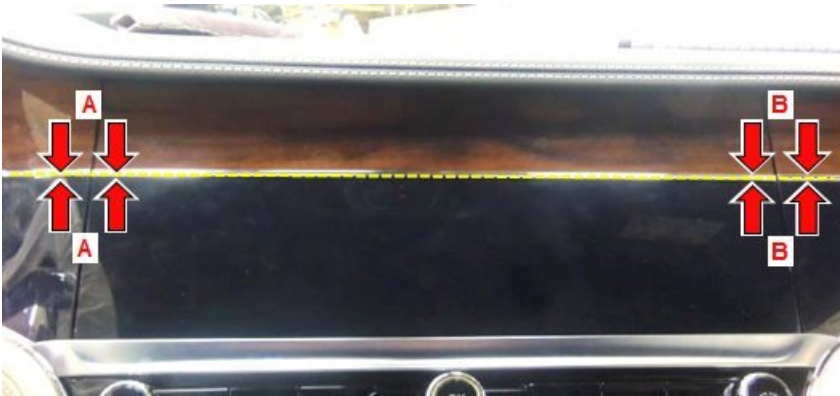
**Figure 7**

Visually check that the chrome brightware strip on the "veneer face" fascia panel is aligned with the chrome strips at points A & B on the passenger and drivers side fascia panels. See Figure 7.

The specified tolerance in the vertical plane (A & B) is 0.5mm.

If the chrome brightware strip on the "veneer face" fascia panel is out of line, carry out the following to adjust the panel.

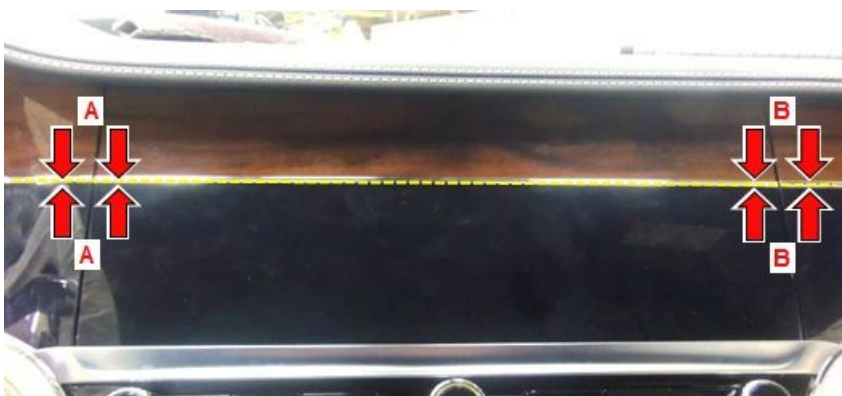
Figure 10

Visually check that the chrome brightware strip on the "veneer face" fascia panel is aligned with the chrome strips at points A & B on the passenger and drivers side fascia panels. See Figure 10.

The tolerance in the vertical plane (A & B) is 0.5mm.

If the chrome brightware strip on the "veneer face" fascia panel is still out of line, and is not within the specified tolerance then add/remove anti-creak tape to adjust accordingly.

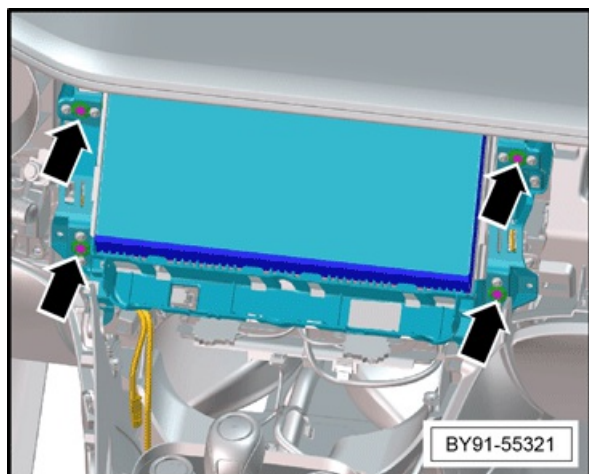
**Figure 11**

Under no circumstances should any attempt be made to adjust the "BRD" module inboard or outboard by adjusting any of the four setting screws (arrows) shown in Figure 11.

The setting screws (arrows) are factory sealed and any attempt to make adjustments via these four screws may result in failure of the rotating display and/or information display touch screen.

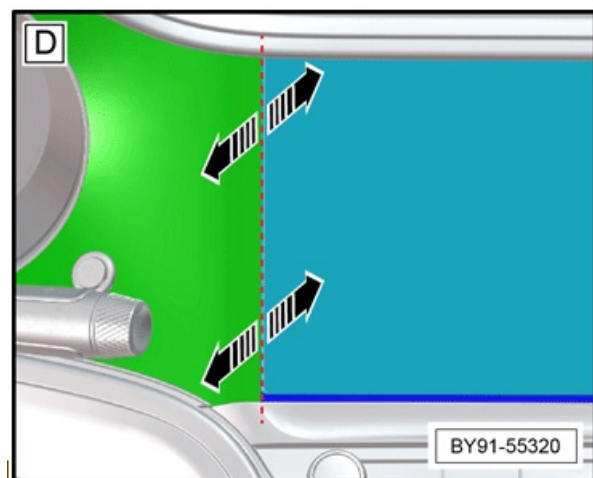
**Figure 12**

Measure the profile (D) between the "BRD" veneer face fascia panel and the passenger and drivers side fascia panels. See Figure 12

The specified setting dimension for the "BRD" fascia panel is -0.5mm (under flush) +/- 0.5mm tolerance and MUST be equal on both sides.

If either of the passenger and drivers side fascia panels are out of tolerance and require adjustment, make a note of which point requires adjustment and by how much on each panel.

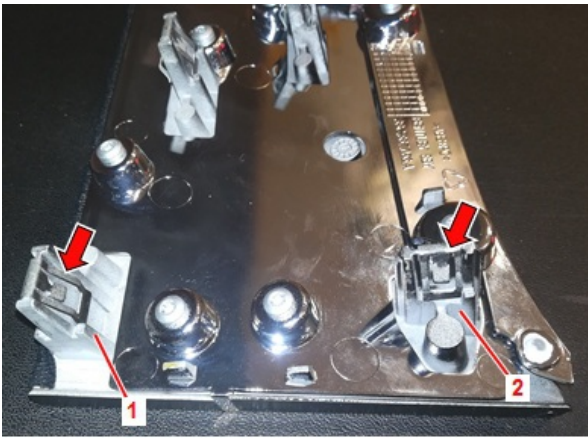
Figure 13

**i** Note. The locator pin (1) is for adjustment the top of the fascia panel and locator pin (2) is for adjusting the bottom of the fascia panel. All other locator pins are not affected.

With the fascia panel face down on a soft, clean and protective work surface, remove the appropriate spring clip(s) (arrow) as required. See Figure 13.

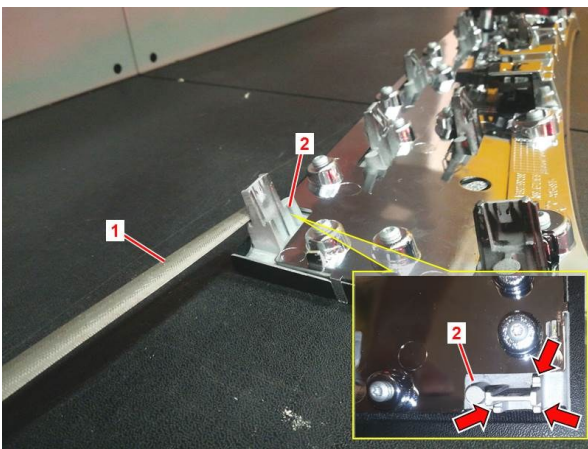
Figure 14

**i** Note. The upper locator pin (2) has three "RPS" points (arrows) whereas the lower locator pin only has two "RPS" points.

Carefully file the "RPS" points (arrows) by the required amount that the fascia panel needs to move in.

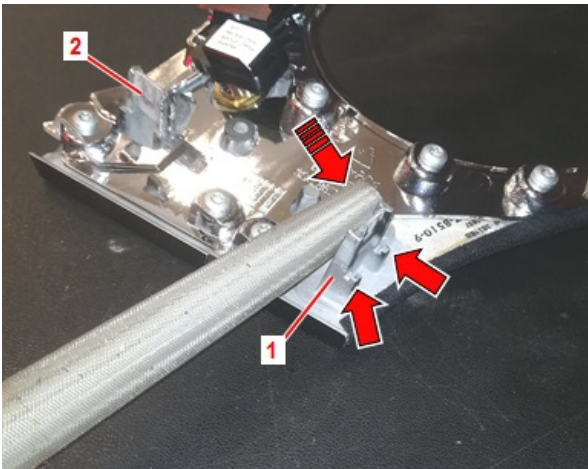
**Figure 17**

*Note. The upper locator pin (1) has three "RPS" points (arrows) whereas the lower locator pin (2) only has two "RPS" points.*

Carefully file the "RPS" points (arrows) by the required amount that the fascia panel needs to move in. See Figure 17
