## Technical Service Bulletin

| <b>Topic</b> | New Continental GT - Ski hatch difficult to latch/unlatch |
| <b>Transaction No.</b> | 2052208/4 |

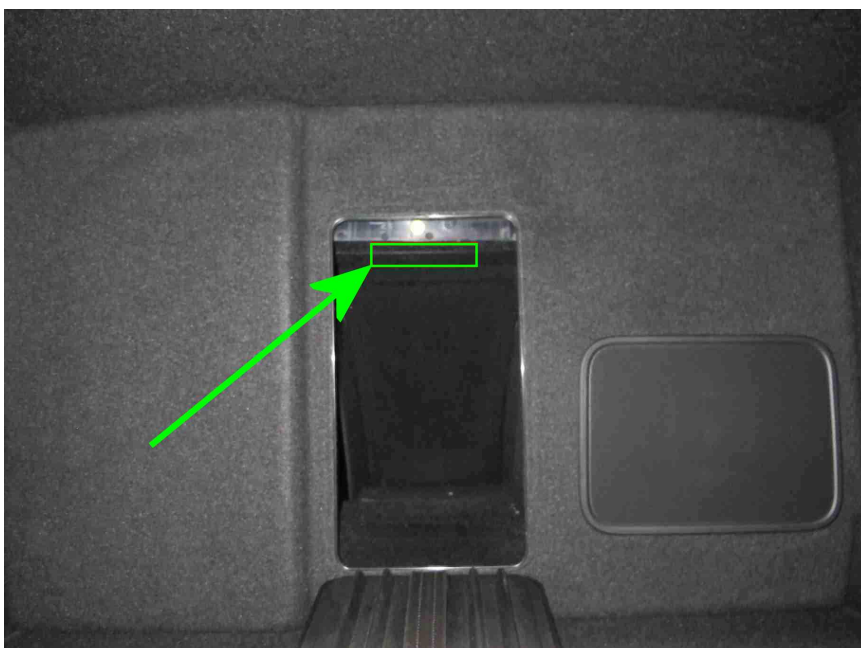
Figure 1

- Refer to Figure 1, looking into the boot locate the ski hatch lock aperture which is in the area shown

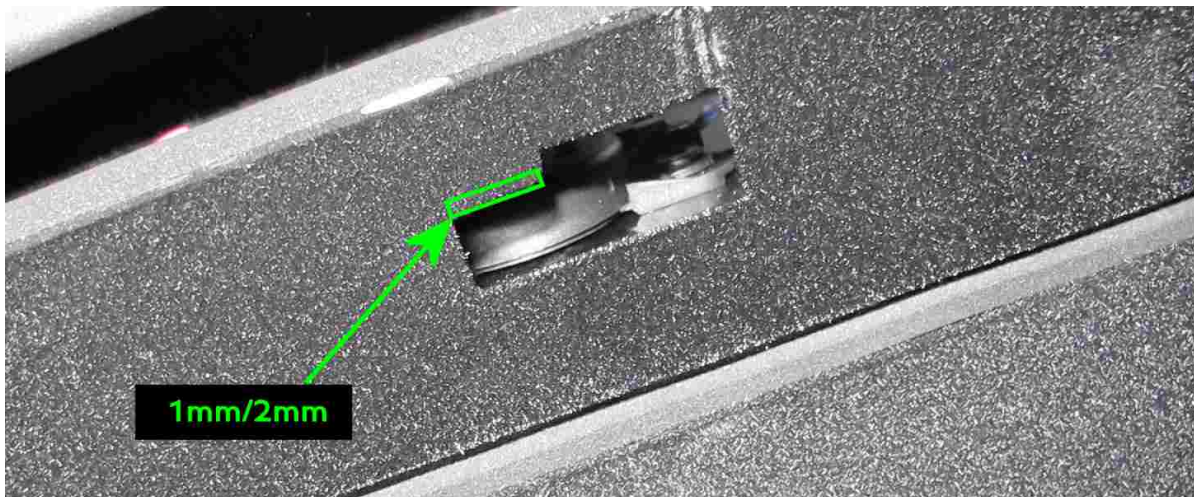
Figure 2

Due to tight tolerances the ski hatch mechanism fouls the upper ski hatch trim when closed/locked.

The close proximity of the mechanism in relation to the hatch trim when closed/locked can create difficulty in opening/unlocking the hatch

- Referring to Figure 2, Using a suitable tool initially remove up to 1mm from the trim and retest
- In the event the hatch does not close remove a further 1mm from the lock trim and retest
