## Technical Service Bulletin

| <b>Topic</b> | Reverse camera image - Blurred |
| <b>Brand</b> | Bentley |

### New Continental GT and New Continental GTC

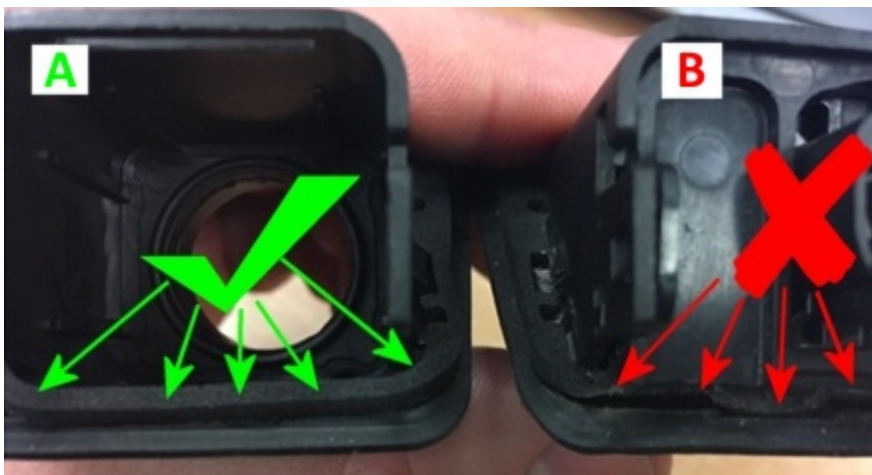
Water ingress into the holder of the reverse camera can cause temporary fogging of the camera lens which may result in a blurred reverse camera image within the Infotainment screen

The ingress is due to a displaced foam seal around the edge of the camera holder

3) Referring to Figure 1 - Carry out an inspection of the reverse camera holder foam seal

- Should the seal be as shown (Point A) this is to correct specification, should the seal be at the correct specification and the reverse camera has evidence of moisture on OR within the lens - Allow the camera to fully dry out ensuring that no moisture is evident then carry out the modification instructions as detailed in step 5 - **Reverse camera holder modification instructions**
- Once the modification has been completed - Refit the reverse camera holder/reverse camera ensuring the seal is fitted/located correctly - Refer to Repair manual Rep.Gr 94 **IMPORTANT:** Ensure the instructions within the Repair manual are strictly adhered to including all camera calibration instructions

4) Should the seal be as shown in Figure 1 (Point B) this is not to correct specification, a new replacement holder should be sourced/ordered

□  
**An improved reverse camera holder is under development which will include a drain hole, until this part is available the modification detailed in step 5 must be followed on all replacement holders in which the drain hole is not evident**

- Allow the camera to fully dry out ensuring that no moisture is evident
- Once the modification has been completed - Refit the reverse camera holder/reverse camera ensuring the seal is fitted/located correctly - Refer to Repair manual Rep.Gr 94 **IMPORTANT:** Ensure the instructions within the Repair manual are strictly followed including all camera calibration instructions

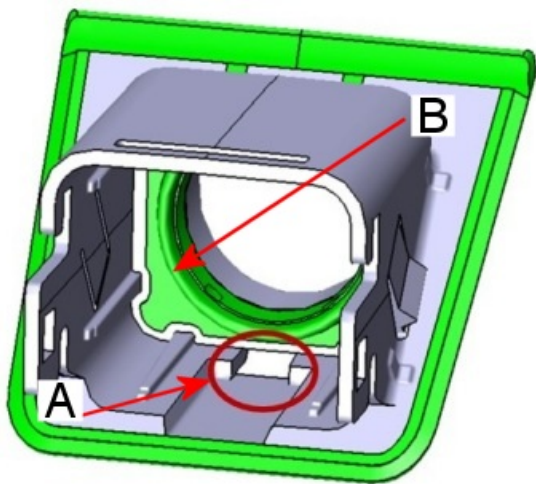
Figure 2

**IMPORTANT: REFERRING TO FIGURE 2 - PRIOR TO ADDING THE HOLE (Point A) THE OPERATIVE SHOULD FAMILIARIZE THEMSELVES WITH THE LOCATION OF THE SEAL (Point B)**

**The seal should remain intact to ensure the seal does not split or dislodge away from the housing as the fitting position of the camera may be compromised should the seal be damaged**

- Add a drain hole to the reverse camera holder as follows:
