Technical Service Bulletin

| Topic | Headlamp operation issues |
| Transaction No. | 2054599/3 |

New Continental GT and New Continental GTC

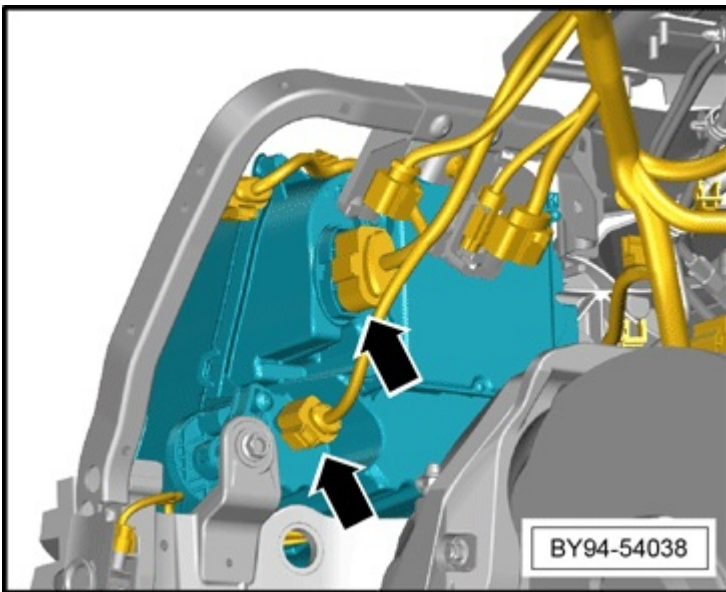
- 1) Remove the applicable front wheel arch liner – Refer to Repair manual Rep.Gr 66
- 2) Referring to Figure 1 - Disconnect the applicable headlamp plugs (right and/or left hand side) - During disconnection look out for any abnormalities for example a plug which is loose/broken or can easily be disconnected

- 3) Check the condition of the headlamp plug and terminals
- 4) Check the condition of the headlamp assembly connection pins
- 5) Using the applicable Elsa pro wiring diagrams – Check the electrical integrity of the complete headlamp circuit

- Should NO concerns be identified – Carry out the remaining instructions
- 6) Reconnect the headlamp plugs NOTE: An audible click will be heard once the plug is refitted/connected correctly

- 7) Carry out a pull check to confirm correct fitment
- 8) Erase any related DTC's using offboard Diagnostic Information System (ODIS)
 - Carry out a road test (maximum of 50 time units) to confirm the headlamps are fully functional
