Technical Service Bulletin

Topic	Abnormal sound issues from front shaker speaker/s
Market area	Bentley: worldwide (2WBE),Hongkong-Macau (5HK)
Brand	Bentley
Transaction No.	2055644/1
Level	EH
Status	Released for publishing
Release date	Aug 21, 2019

New Continental GT

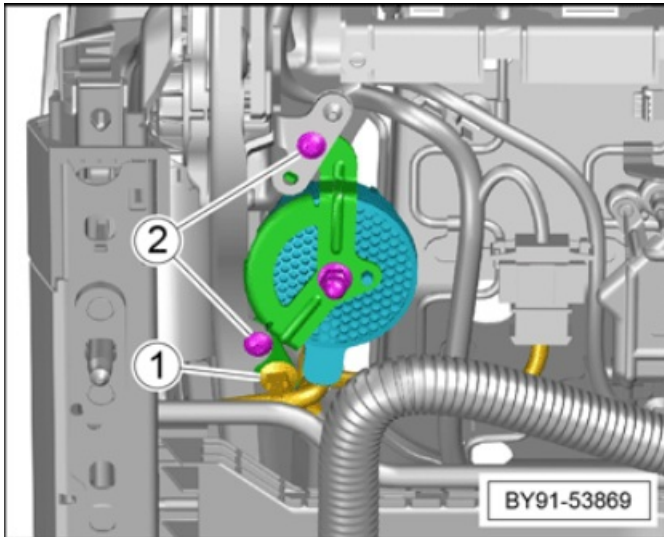
Abnormal sounds transmitted from front shaker speaker/s (PR code 9VL only).

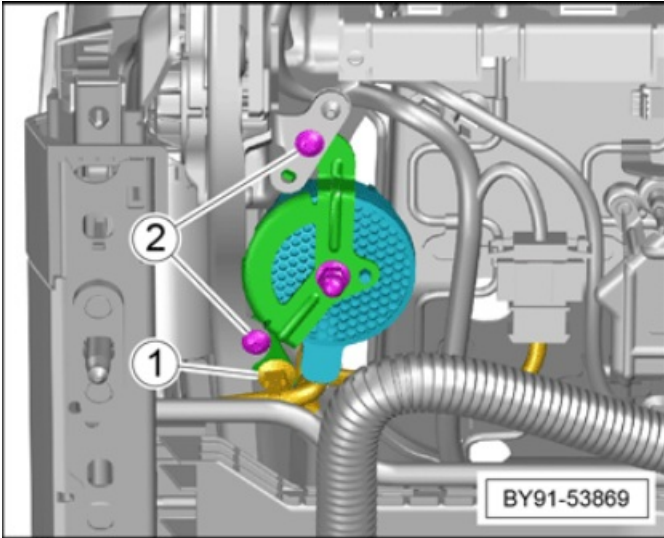
Figure 7

5. If there is insufficient clearance around the shaker speaker or the locating pins are not seated correctly then follow the below steps:

- Loosen the fixings -2- (Figure 7) and adjust the speaker bracket to increase clearance
- Locate correctly then retighten the fixings -2- (4 Nm)
- Recheck steps 2 to 5.
