Technical product information

Topic	Unable to run basic settings within the Adaptive suspension control unit (J775)
Market area	Bentley: worldwide (2WBE),Hongkong-Macau (5HK)
Brand	Bentley
Transaction No.	2055693/1
Level	EH
Status	Approval
Release date

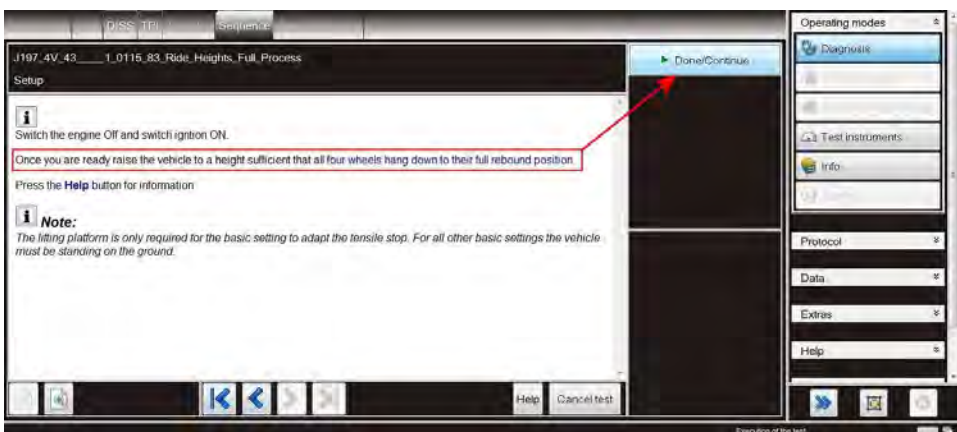
Figure 2

Referring to Figure 1, During the Basic setting (full process + rebound end stops) the routine can stop during the initial part of the procedure, in particular at the stage shown in Figure 2, which is when the vehicle is raised to allow all four wheels to hang down to their full rebound position

Should this issue be evident and the Basic settings routine does not continue - Refer to the Measure section of this TPI

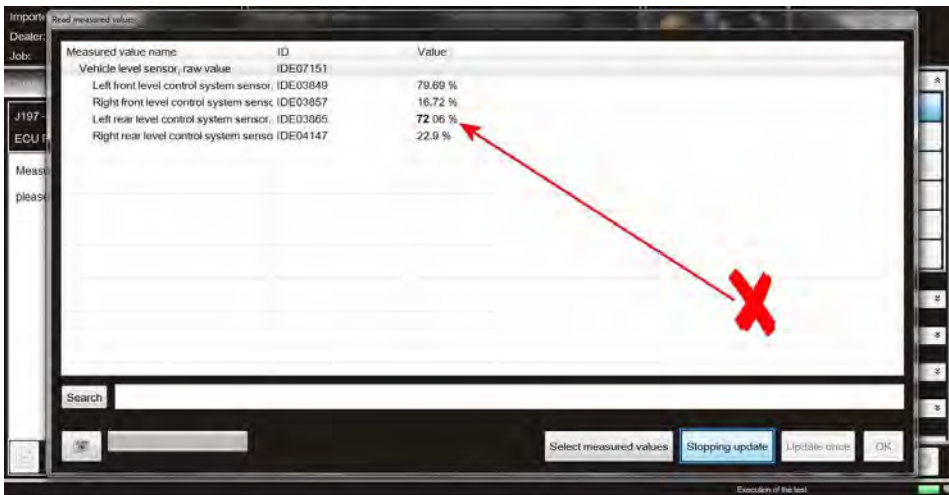
- Compare the sensor measured results in Figure 4 against the correct tolerance bands shown in Figure 5
- Within the example shown, the left hand rear level control sensor is not in tolerance as the value is 72.06%

- 2) When prompted search for IDE 07151 –
- When IDE 07151 is located - Select - Starting update
- Monitor the measured value results for each level control sensor (Figure 4)

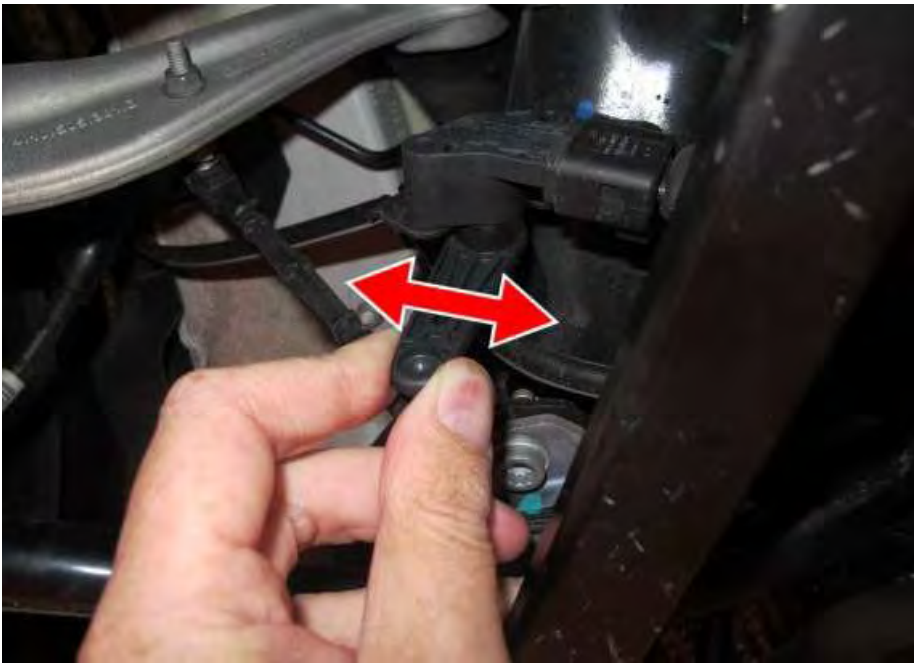
NOTE: For photographic purposes only the left hand rear sensor is shown in Figure 6

Referring to Figure 6, The correct tolerance should be achieved by moving the sensor arm (by hand within the parts natural limits of movement) in the required direction until the tolerance band is within specification NOTE: The tolerance can be achieved by using the recommended method

DO NOT ATTEMPT TO ADJUST THE TOLERANCE BAND OF THE LEVEL SENSORS BY PRYING, BENDING OR MANIPULATING THE SENSOR RODS BY THE USE OF FORCE

- Once the required tolerance band criteria is met carry out the Basic setting (full process + rebound end stops) until completion
