Technical Service Bulletin

Subject: A/C BLOWS WARM AIR DUE TO REFRIGERANT LEAK FROM CONDENSER	Bulletin No.: 07-001/19
	Last Issued: 09/10/2019

2016-2017 CX-3 vehicles with VINs lower than JM1 DK ***** 158284 (produced before October 21, 2016)
2016-2017 CX-3 Canada vehicles with VINs lower than JM1 DK ***** 158210 (produced before October 21, 2016)

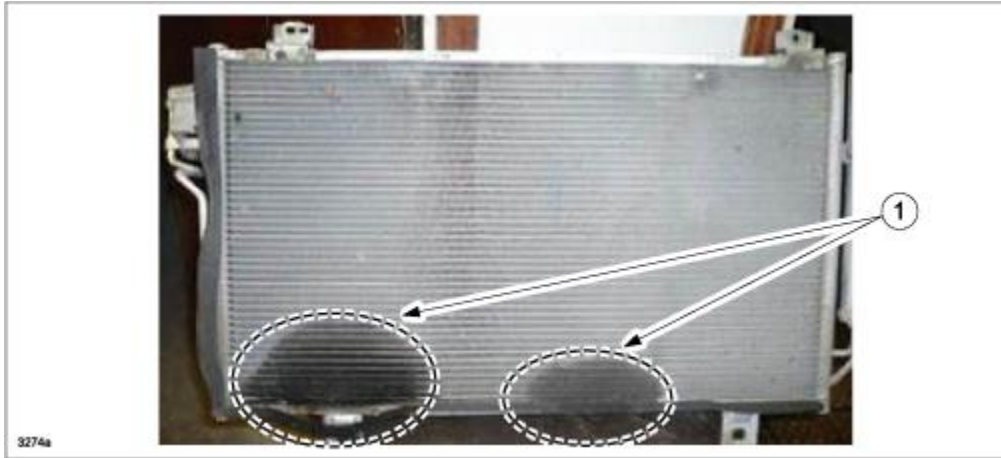
Some customers may complain about warm air from the climate control vents when the air conditioner is ON. This may be caused by condenser corrosion, causing a refrigerant leak.

1. Verify the customer concern.
2. Visually inspect the condenser for A/C refrigerant leak.
 - Is there a visible trace of A/C refrigerant leaking at location (1)?

- Yes - Go to step 4.
 - No - This Service Information is not applicable. Refer to MGSS online Workshop Manual (NO COOL AIR [FULL-AUTO AIR CONDITIONER]).
4. Replace the condenser according to the instructions on MGSS online (CONDENSER REMOVAL/INSTALLATION [SKYACTIV-G 2.0]).
 5. Verify the repair.
