CUSTOMER SATISFACTION CAMPAIGN 2A91 GSX-R1000RA/RZAL7-L8 Inertial Sensor Replacement

Affected Models: 2017 - 2018 GSX-R1000R/RZ

Suzuki Motor of America, Inc. (Suzuki) is initiating a customer satisfaction campaign to replace the inertial sensor on certain 2017 - 2018 GSX-R1000R/RZ motorcycles.

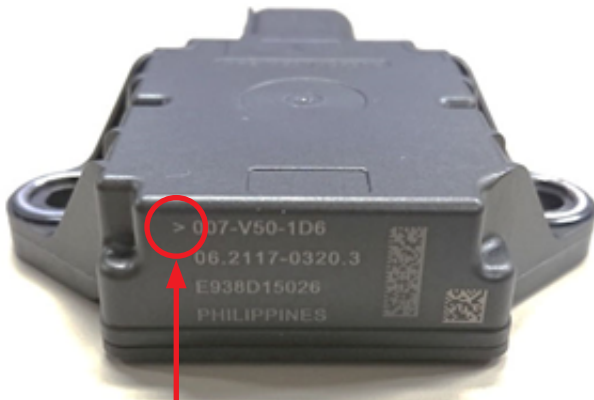
Old Part

The old part is marked with the **Greater Than** symbol...

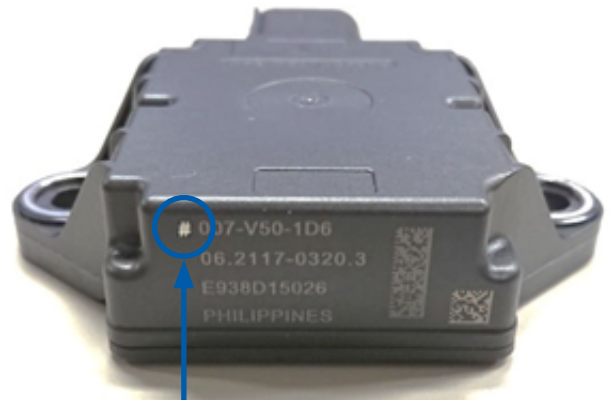
Countermeasure Part

The countermeasure part is marked with the **Number** or **Pound** symbol.

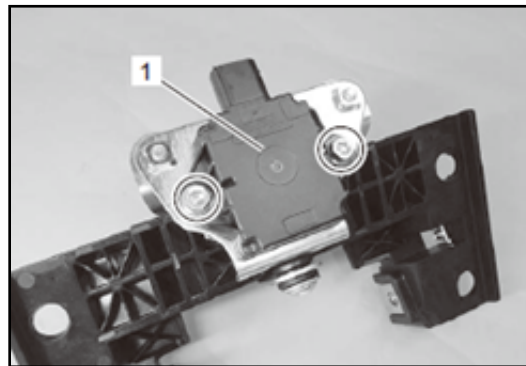
Excessive vibration can damage the IMU.

Be careful not to use excessive vibration when removing the IMU and do not use an impact wrench to remove the IMU.
