Service Alert

Subject: LACK OF POWER UNDER HEAVY LOAD WITH NO WARNING LIGHTS OR DTCS	Service Alert No.: SA-040/19
	Last Issued: 09/06/2019

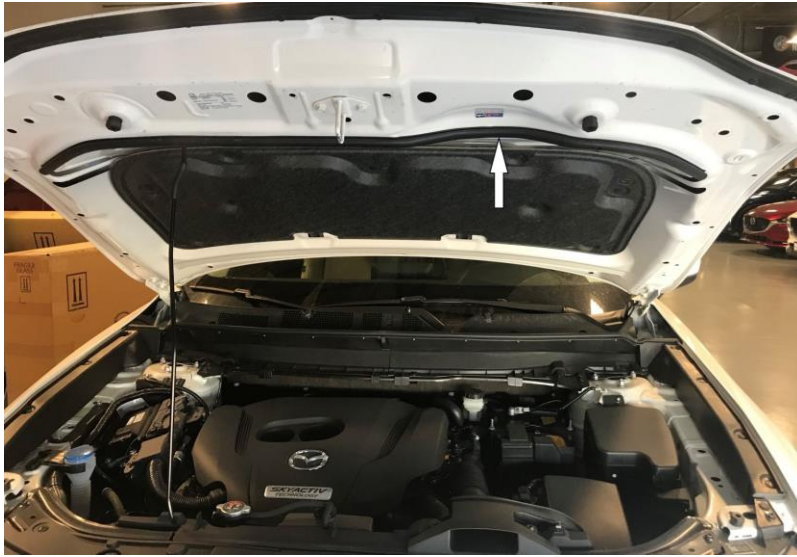
(Hood Weatherstrip Location Shown Below, Correctly installed)

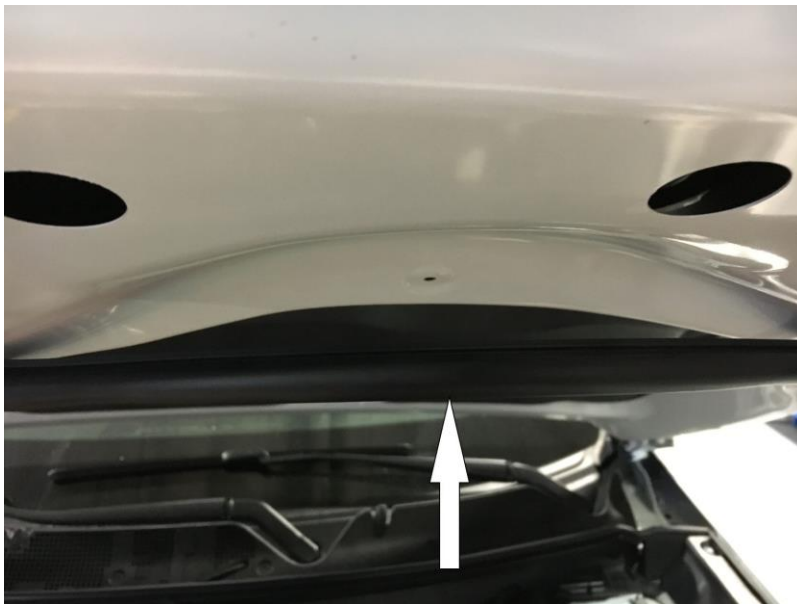
Some customers may complain of a lack of power under heavy load without any warning lights or DTCs. This concern may be due to a loose or detached hood weatherstrip, which can cause a blockage or restriction in the air intake system.

(Hood Weatherstrip Shown Below, Loose / Detached From Hood)

To correct this concern, reattach the weatherstrip or replace it with a new one if it is damaged.
