Service Alert

2019-2020 MAZDA3 SERVICE CAUTIONS FOR NEW AND REVISED FEATURES

Service Alert No.: SA-010/19

Last Issued: 09/16/2019

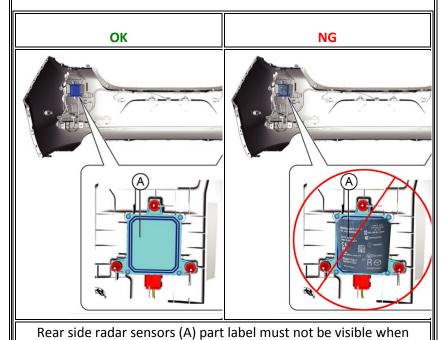
- 1. BSM system indicates vehicle on the opposite side.
- 2. i-ACTIVSENSE indicator ring will not turn green
- 3. Rear Cross Traffic Alert (RCTA) does not work
- 4. Rear side radar sensor aiming may fail
- 5. TPMS DTC(s) stored

This may be caused by BSM rear side radar sensor(s) installed facing the wrong direction.

installed.

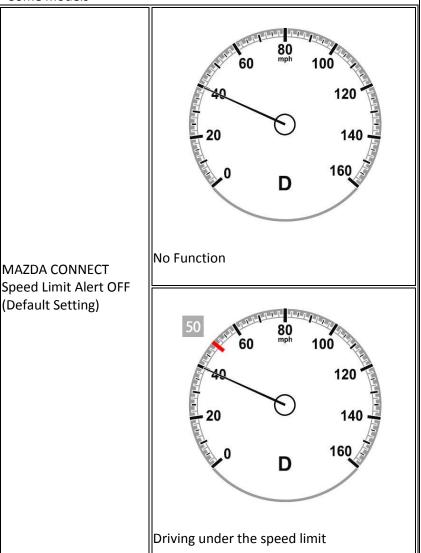
- 1. TSR function is only available with a dealer installed in-vehicle navigation system accessory.
- 2. TSR function requires Forward Sensing Camera (FSC) recognition or navigation SD card map data when the vehicle is driven.**
- 3. TSR function is not displayed in the Active Driving Display.
- TSR function is disabled when Apple CarPlay[™] or Android Auto[™] is connected.
- * Some models

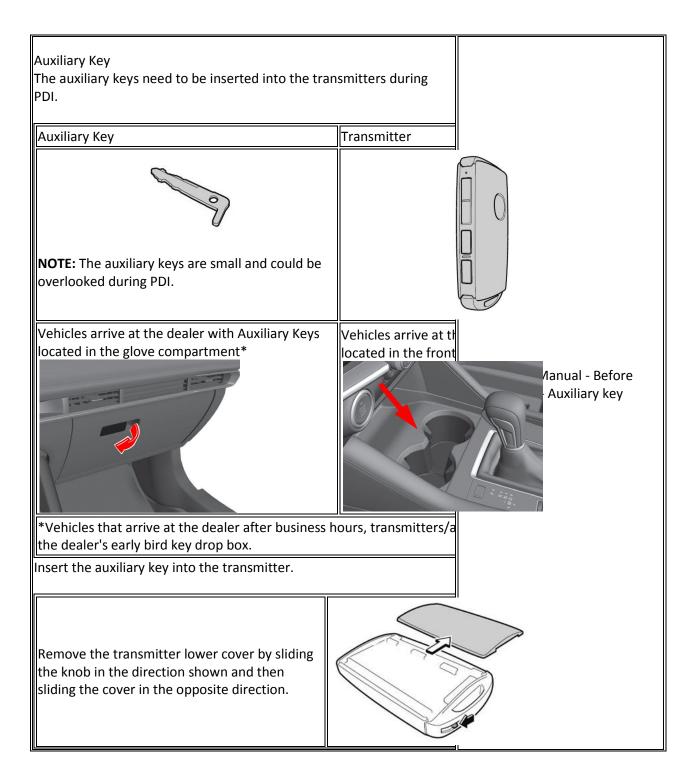
- 1. If one auxiliary key is lost, some key machines can trace cut a new replacement key.
- If both auxiliary keys are lost, key cutting machines do not recognize vehicle key code and will not cut new replacement keys. Replace the front door key cylinder set.

NOTE: If the front door key cylinder set is replaced, eMDCS system key code information will need to be changed. Contact Helpdesk by phone (949 727-6434) or email (HelpDesk@mazdausa.com) and provide:
