Technical Service Bulletin

39 Transfer case leaks

39 19 25 2016880/8 September 5, 2019. Supersedes Technical Service Bulletin Group 39 number 19-24 dated August 29, 2019 for reasons listed below.

Model(s)	Year	VIN Range	Vehicle-Specific Equipment
Q7	2007	000001 – 055095	Not Applicable
	2008	000001 – 011586	Not Applicable

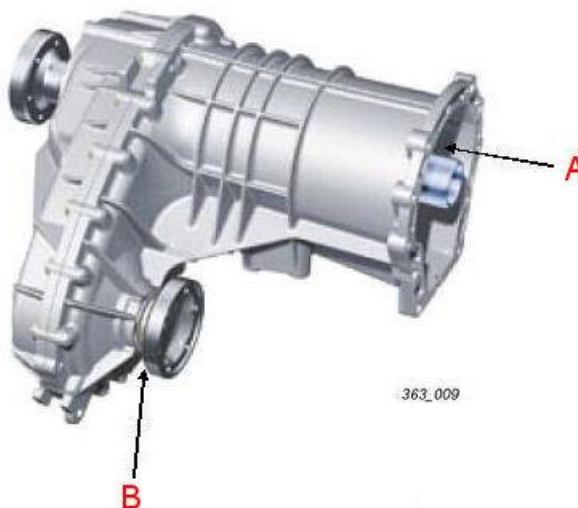
- Oil leak between automatic transmission and transfer case (Figure 1, A).
- Oil leak at front driveshaft output flange on transfer case (Figure 1, B).

Figure 1. The input shaft seal (A), and the front driveshaft output flange seal (B).

- Transfer case input shaft seal is damaged during installation.
- The internal circlip of the output flange shaft has come loose, allowing the output flange to move out slightly, causing seal to leak.

1. Replace the transfer case input shaft seal (Figure 1, A). Refer to Elsa for seal installation instructions.
2. Replace the complete transfer case assembly if the front driveshaft output flange seal is leaking (Figure 1, B). Refer to Elsa for transfer case removal and installation instructions.
