Technical Service Bulletin

69 Seat belts twitch

69 19 42 2056007/1 September 12, 2019.

Model(s)	Year	VIN Range	Vehicle-Specific Equipment
A6, A7, and Q8	2019 – 2020	All	Not Applicable

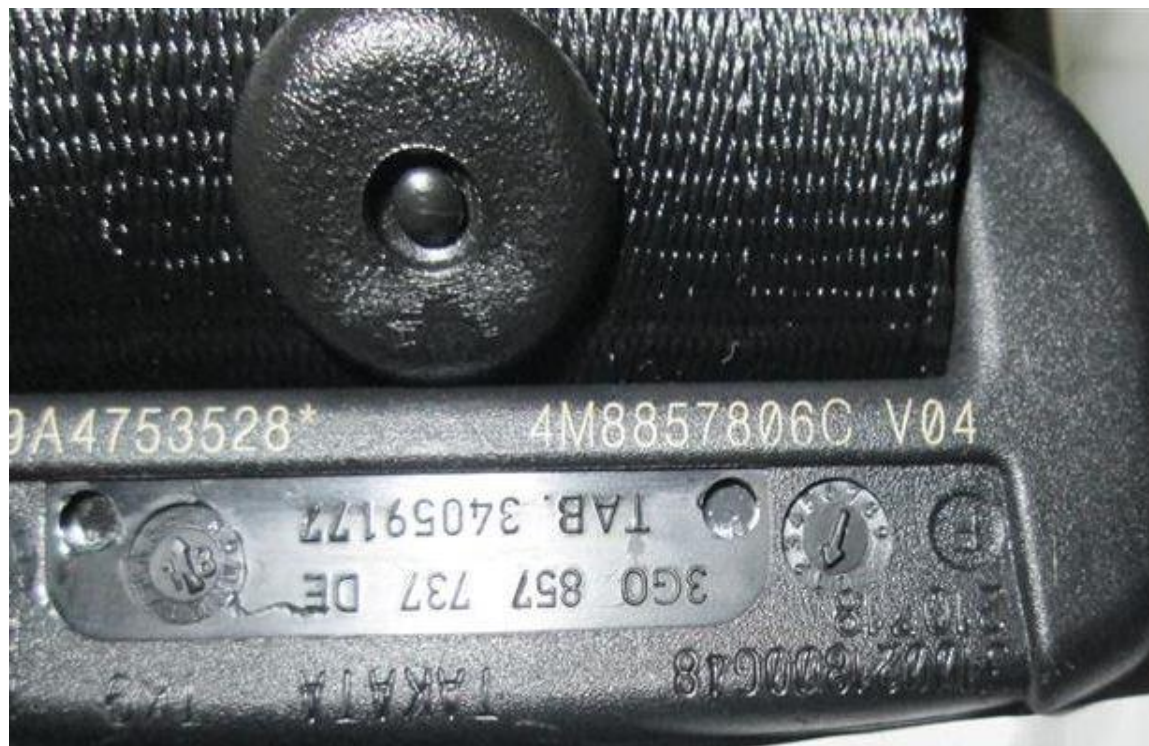
During vehicle production the front and/or rear seat belts were installed on the wrong side of the vehicle.

1. Compare the seat belt part numbers located on the seat belt latch plates (Figure 1) with ETKA to determine if the seat belts are installed on the correct side of the vehicle.

Figure 1. Sample part number of right rear Q8 seat belt shown.

3. Remove and reinstall the affected seat belts on the correct side of the vehicle according to the Repair Manual.
4. After swapping the seat belts side to side, it is not necessary to adapt them.

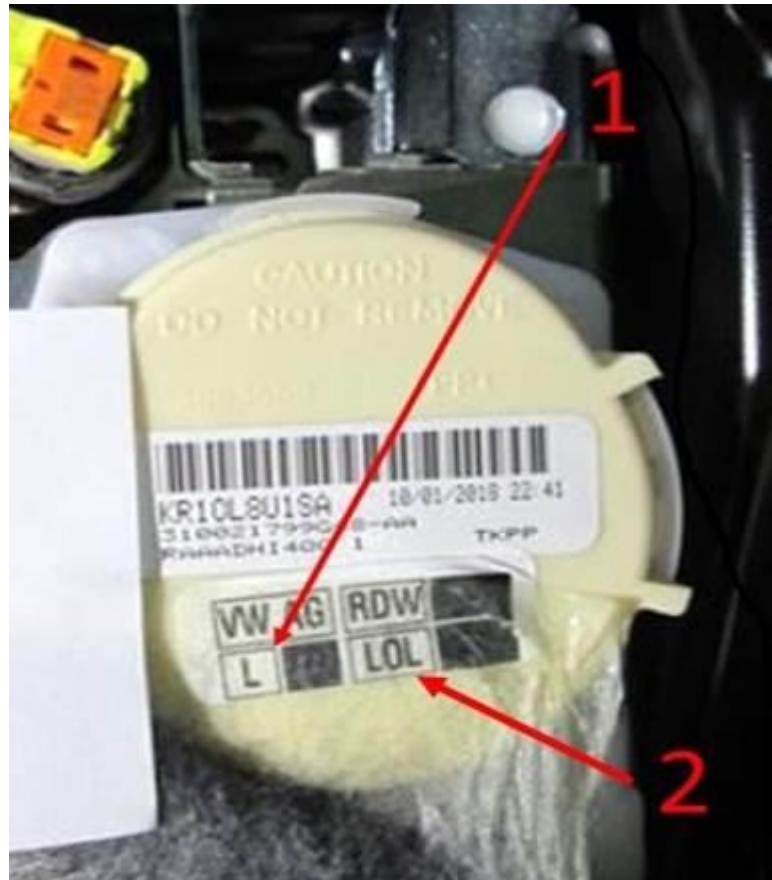
2. If seat belt part numbers differ from ETKA, perform a diagnostic output test in ODIS Service. If during the diagnostic output test the wrong side seat belt is activated, the seat belts were swapped side to side during assembly.

Figure 2. Example of left Q8 seat belt (-L- pos. -1-) for left hand drive (LHD) car (-LOL- pos. -2-).
