Technical Service Bulletin

87 A/C does not cool - A/C compressor is seized

87 19 96 2056100/1 September 5, 2019.

Model(s)	Year	VIN Range	Vehicle-Specific Equipment
A6 and A7	2019 – 2020	All	Not Applicable

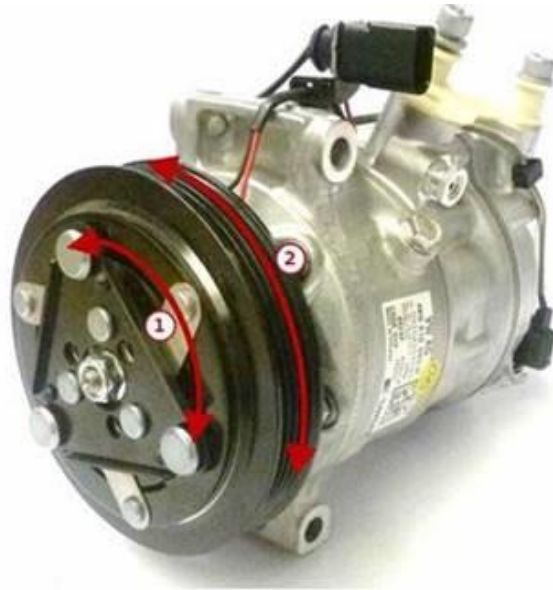
Figure 1. A/C compressor.

Diagnosis finds that the air conditioning compressor and/or the air conditioning compressor pulley is extremely difficult to rotate or is seized.

1. Specifically identify the failure as either a seized A/C compressor, a seized pulley/clutch or both by attempting to turn either by hand. Note the type of failure.

2. When the refrigerant circuit is evacuated please document the amount of refrigerant evacuated from the circuit as well as the amount of oil extracted from the circuit from the service machine. Note these amounts.

3. For the compressor replacement procedure please immediately cap off the original compressor using the caps supplied with the replacement. Allow no oil or debris to escape the original compressor. It will be requested for return.

4. The refrigerant circuit will need to be completely flushed. An additional amount of oil will be flushed and contained in the procedure. Note this additional amount of oil extracted.
