# Technical Service Bulletin

## 91 SOS Warning displayed in the instrument cluster, no communication to the telematics control module

91 19 85 2056076/1 September 5, 2019.

Model(s)	Year	VIN Range	Vehicle-Specific Equipment
A4, A6, A7, A8, Q5, Q7, and Q8	2019	All	With ConBox

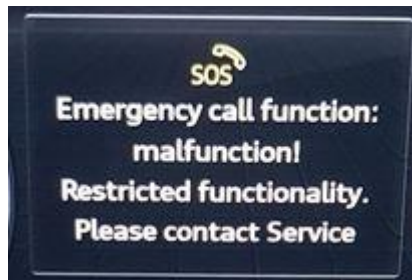
- An SOS Warning is displayed in the instrument cluster (Figure 1).

Figure 1. Emergency call malfunction warning.

- No diagnostics communication can be established with the control module for emergency call module and communication unit (telematics control module or ConBox), J949 (address word 0075).

A software bug can cause the control module to freeze during cold start.

- Remove the telematics control module, J949 (address word 0075) according to the repair manual in Elsa.

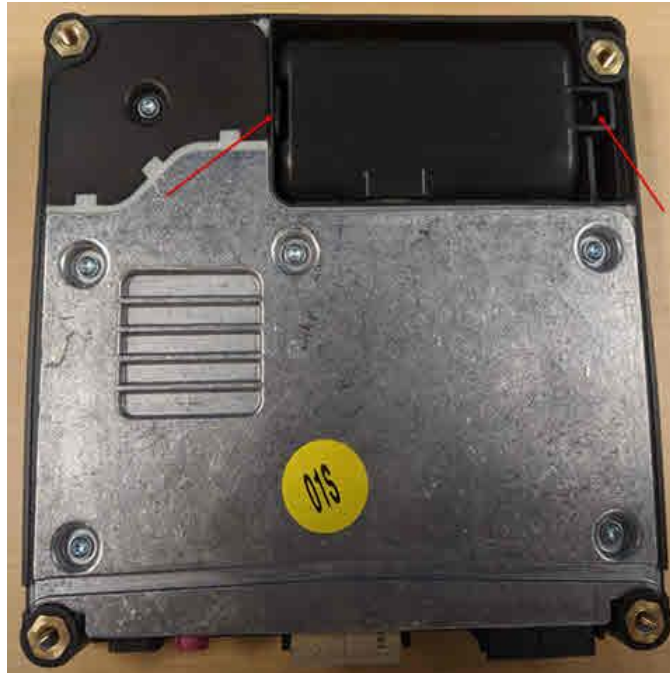
**Figure 1.** Backup battery compartment location.

2. Open the battery compartment of the telematics control module, J949 (address word 0075) and disconnect the backup battery.

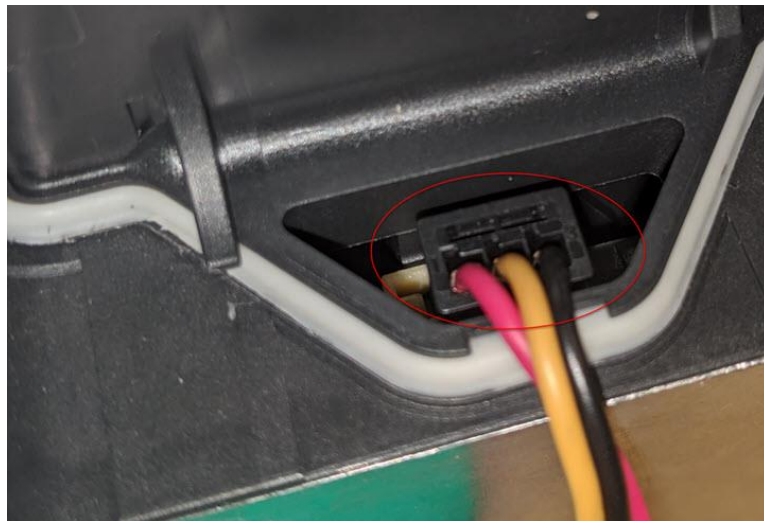
**Figure 2.** Backup Battery connector (no release mechanism).

3. Leave the battery disconnected for approximately 60 seconds.
4. Reinstall the backup battery back into the telematics control module, J949 (address word 0075).
5. Reinstall the telematics control module, J949 (address word 0075) back into the vehicle.
