Technical Service Bulletin

91 Top view camera setting changes to graphic view intermittently after startup

91 19 89 2053028/3 September 13, 2019. Supersedes Technical Service Bulletin Group 91 number 19-69 dated July 3, 2019 for reasons listed below.

Model(s)	Year	VIN Range	Vehicle-Specific Equipment
A4 and Q7	2017 - 2018	All	With front and rear view camera system and two side cameras
A5 and Q5	2018	All	With front and rear view camera system and two side cameras

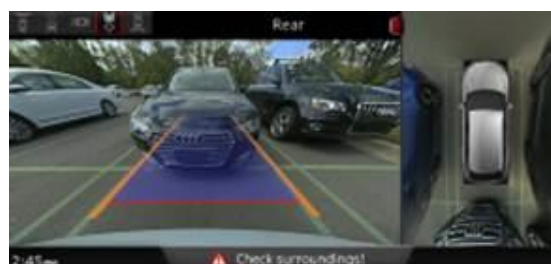
- When the reversing camera is active showing the Top view camera to the right, the display changes intermittently at startup from camera view to graphics view. Compare the images to the right (Figure 1 and 2).

Figure 1. Correct camera view.

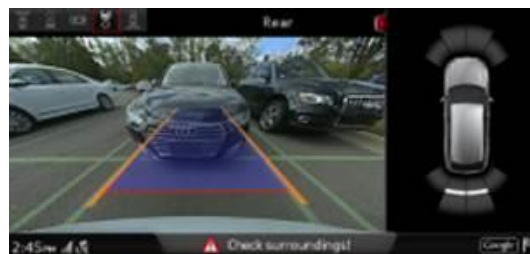
Figure 2. Incorrect graphics view.

The software needs to be updated. The optimized software will correct the view switch.

1. Follow all instructions in TSB 2011732: *00 Software Version Management (SVM), operating instructions* and TSB 2047812: *00 SD Creator: How to setup and use the SD Creator for obtaining vehicle software updates via the MirrorServer*.
2. Update the information electronics control module 1, J794 (address word 005F) using the SVM action code MH12QUS5087 (SD-Card 4M0906961BN).
