# Hendrickson HaulMaax Rear Suspension Transverse Torque Rod Tower Bracket Replacement

# 32-054

Century Class Conventional  
Argosy COE  
Cargo

Freightliner  
Service Bulletin

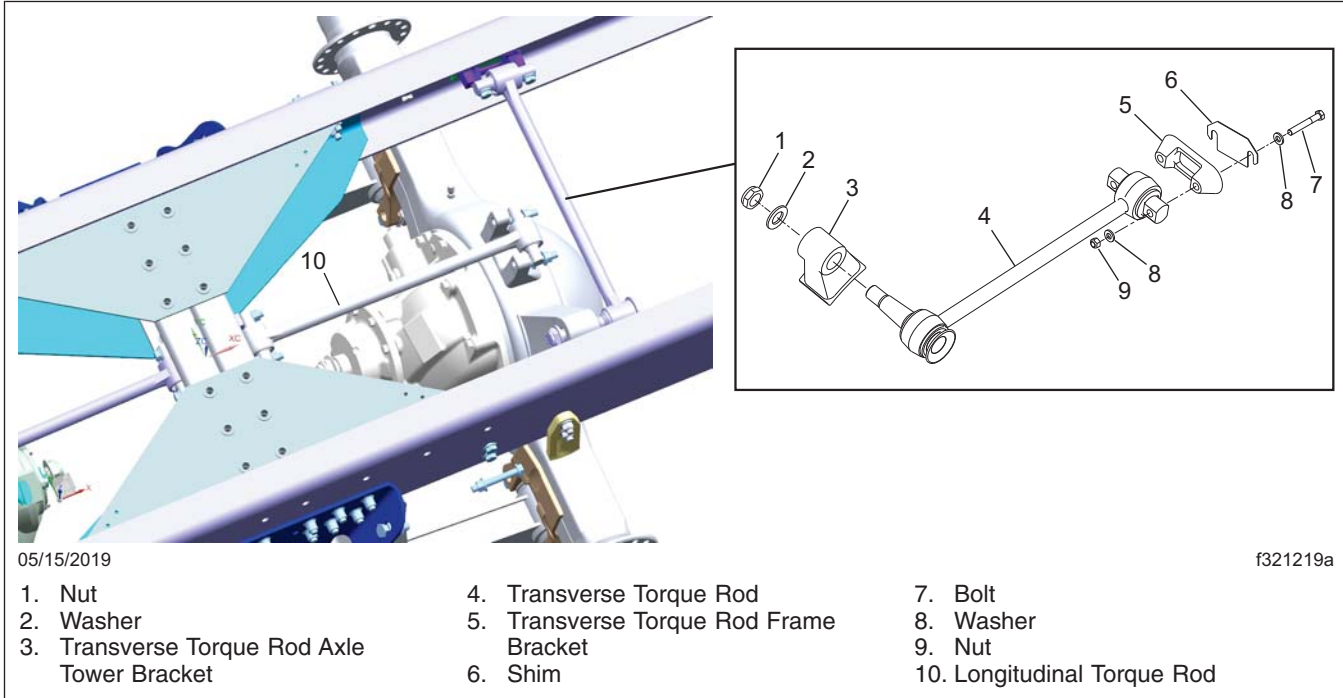
**Fig. 1, Rearmost Axle Assembly**

Some vocational vehicles built with a Hendrickson HaulMaax 46,000 lb (20,865 kg) rear suspension and a 40,000 lb (18,143 kg) rear axle combination may have an incorrect transverse torque rod tower bracket installed on the rear drive axles at the factory. This can result in cracking at the transverse rod tower where it is welded to the axle housing, premature wearing of the transverse torque rod tapered pin and bushings, and damage to the transverse torque rod frame bracket.

3. Remove the three mounting fasteners from the transverse torque rod and discard the rod and fasteners. Save the shims. See Fig. 1.
