GLOBAL SAFETY FIELD INVESTIGATIONS
DCS5111
URGENT - DISTRIBUTE IMMEDIATELY

Subject: N192210570 - Special Coverage
Center High Mount Stop Lamp Water Leak

Models: 2016 – 2017 Chevrolet Malibu

N192210570 Center High Mount Stop Lamp Water Leak

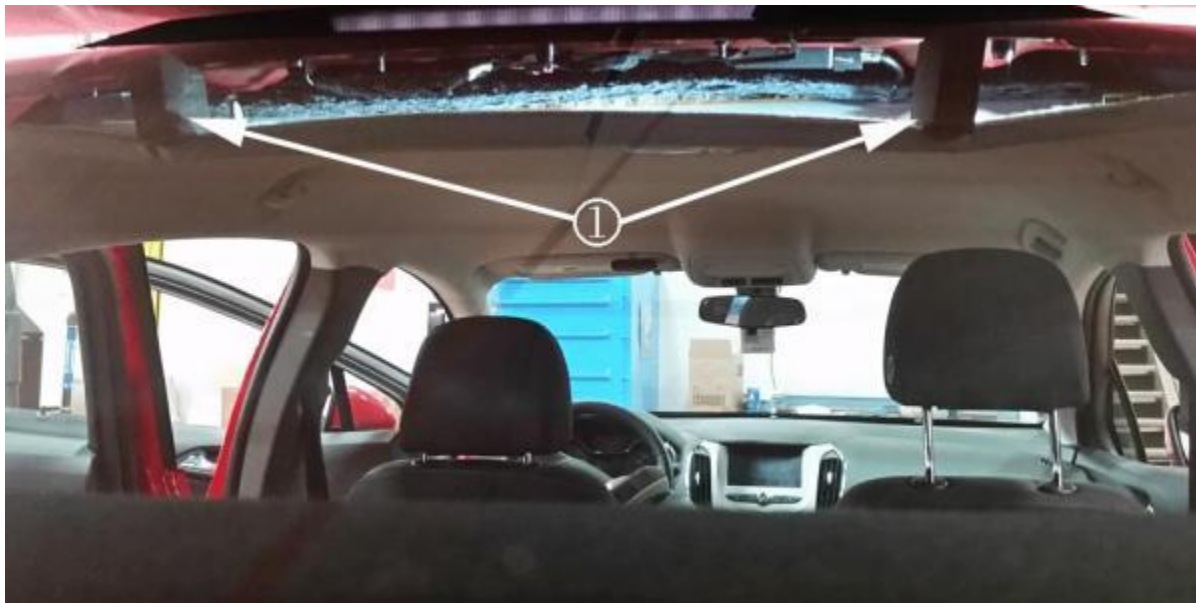
4641372

TIP: Install two foam blocks (1) between the roof of the vehicle and the headlining trim panel to gain access to the high mount stop lamp nuts.

1. Remove the high mounted stop lamp. Refer to *High Mounted Stop Lamp Replacement* in SI.

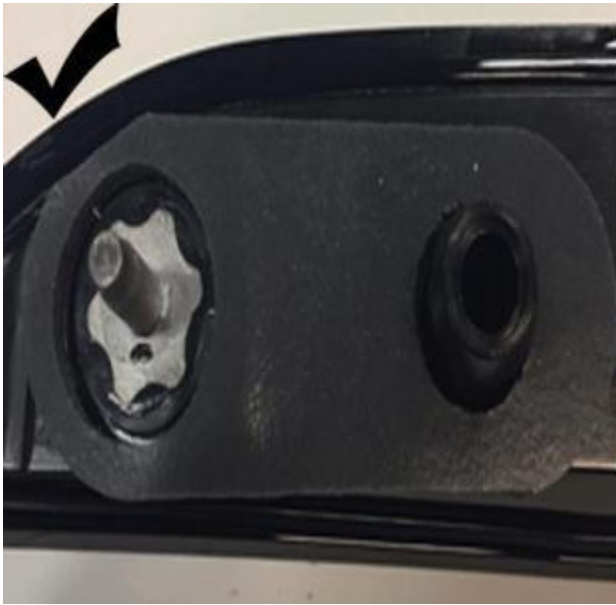
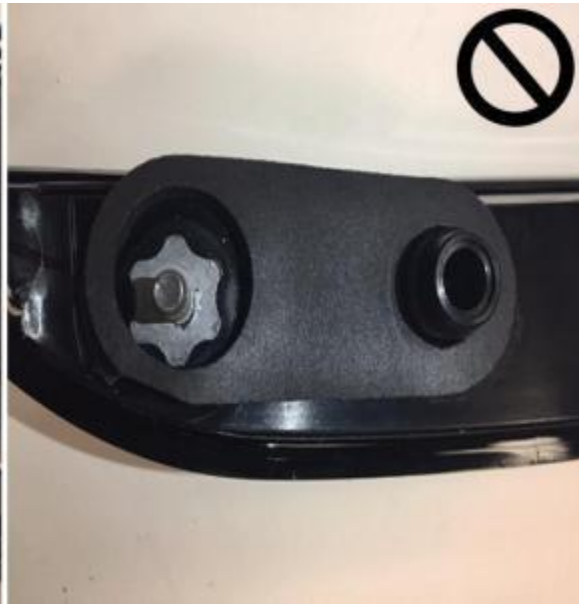
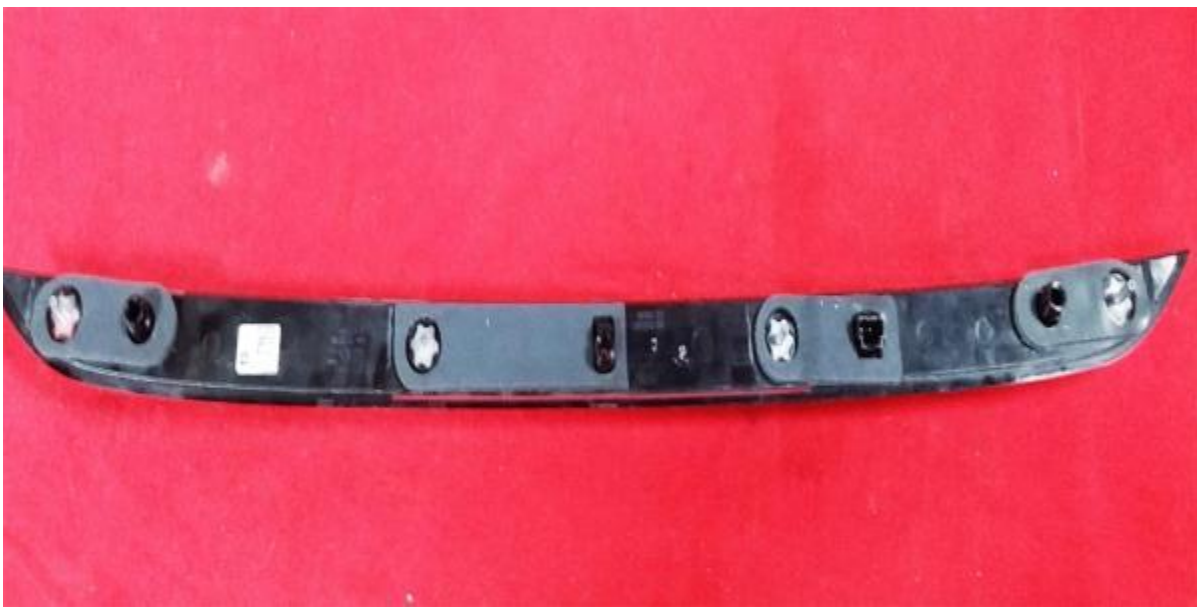
Caution: Make sure the gasket is centered and does NOT ride up the fastener joint. A water leak may occur if the gasket is not installed properly. Refer to the pictures above.

4. Install the NEW gaskets on the high mount stop lamp.
5. Install the high mount stop lamp in the vehicle.

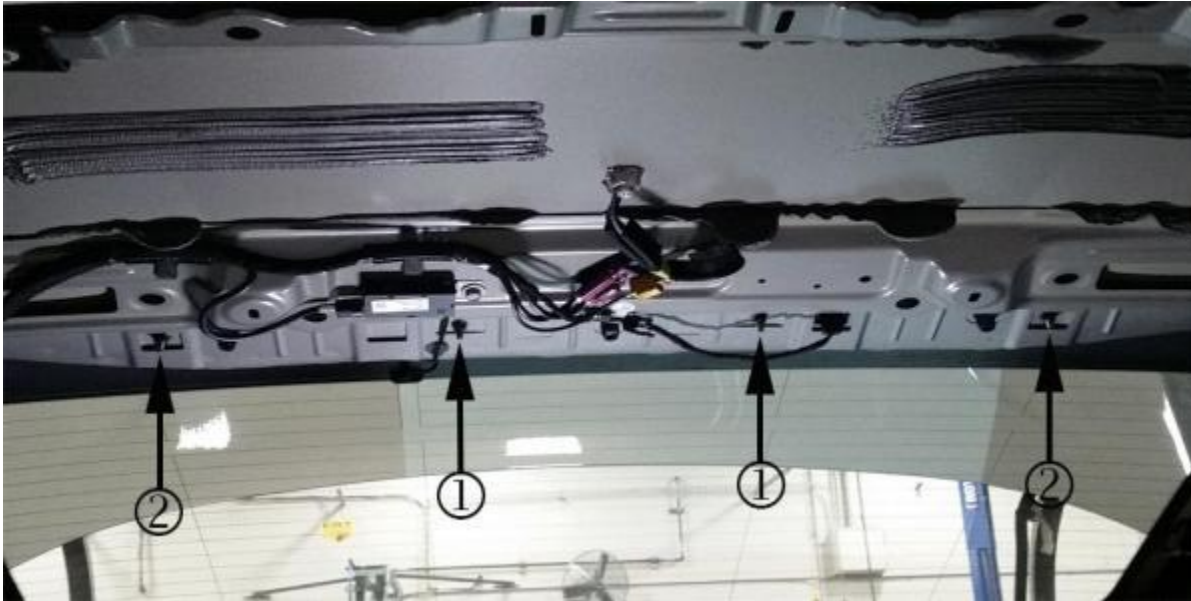
4641397

Note: The two middle high mount stop lamp nuts (1) **MUST** be torqued first.

8. Tighten the two middle high mounted stop lamp nuts (1) to 4.7 Nm (41.52 lb in).
9. Tighten the two outside high mounted stop lamp nuts (2) to 4.7 Nm (41.52 lb in).
10. Remove the foam blocks and reinstall the removed components. Refer to *High Mounted Stop Lamp Replacement* in SI.
11. Repair or replace any water damaged trim, as necessary. Refer to *Floor Carpet Drying* in SI.
