Subject: N182206730 - Customer Satisfaction Program
Hard Pedal at Low Speed Stops

Models: 2015 – 2018 Chevrolet Silverado
Equipped with Special Service Package (RPO 5W4)
2015 – 2019 Chevrolet Tahoe
Equipped with Police Package (RPO 9C1) or Special Service Package
(RPO 5W4)

Customer Satisfaction Program

N182206730 Hard Pedal at Low Speed Stops

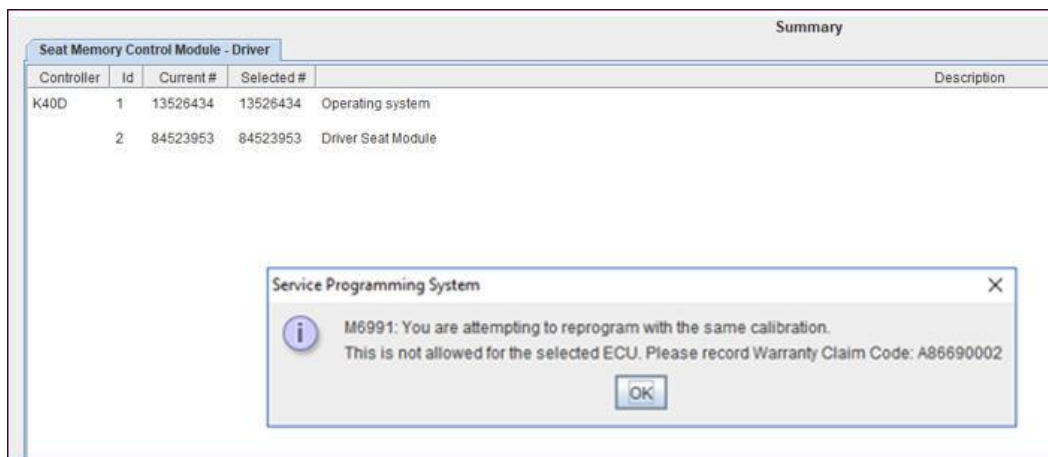
5164840

Note: If the Same Calibration/Software Warning is noted on the SPS Summary screen, record the warranty claim code (WCC) and select OK and follow screen instructions. After a successful programming event, the WCC is located in the Service Programming System dialogue box of the SPS Summary screen. No further action is required. Refer to the Warranty section of the bulletin.
