GLOBAL SAFETY FIELD INVESTIGATIONS
DCS5124
URGENT - DISTRIBUTE IMMEDIATELY

Subject: N192267090 - Customer Satisfaction Program
Water Leak Due to Incorrect Sealer Path

Models: 2020 Chevrolet Traverse

N192267090 Water Leak Due to Incorrect Sealer Path

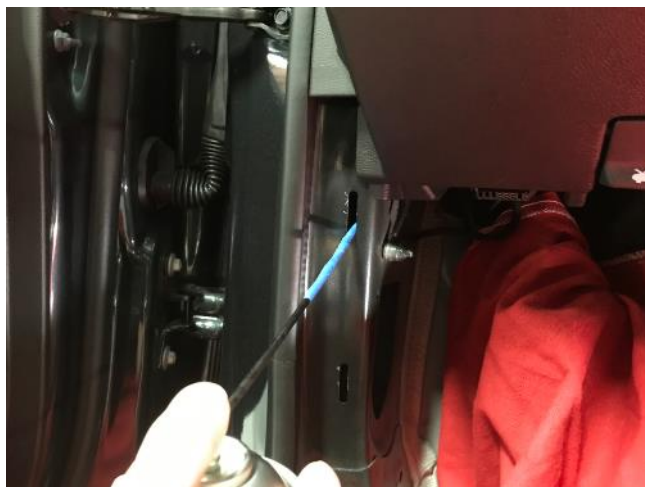
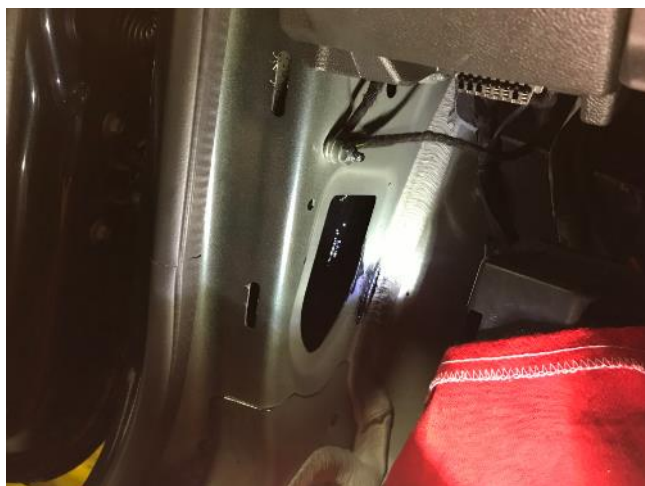
| Condition | Certain 2020 model year Chevrolet Traverse vehicles, may have a condition in which sealer was incorrectly applied at the driver side body hinge pillar. |

6. Spray sealer through the trim panel clip opening covering the complete inside area from top to bottom. This process will be done 3 times with a 15-minute drying time in between the first 2 applications. After the third application, let the sealer dry 1 hour before continuing to step 7.
7. Install the X200 connector pocket and connector.
8. Install the foot rest energy absorber and nut.
9. Fold the carpet back in place.
10. Install the front side door sill garnish molding. Refer to *Front Side Door Sill Garnish Molding Replacement* in SI.
11. Place vehicle outside with windows open (weather permitting) to dissipate chemical smell.
