# Technical Service Bulletin

GROUP <b>AUTOMATIC TRANSMISSION</b>	NUMBER <b>19-AT-019H</b>
DATE <b>AUGUST 2019</b>	MODEL <b>SONATA (LFA) SANTA FE (TMA) PALISADE (LX2)</b>

**SUBJECT:** AUTOMATIC TRANSAXLE  
OIL TEMPERATURE SENSOR DTC P071200, P071300

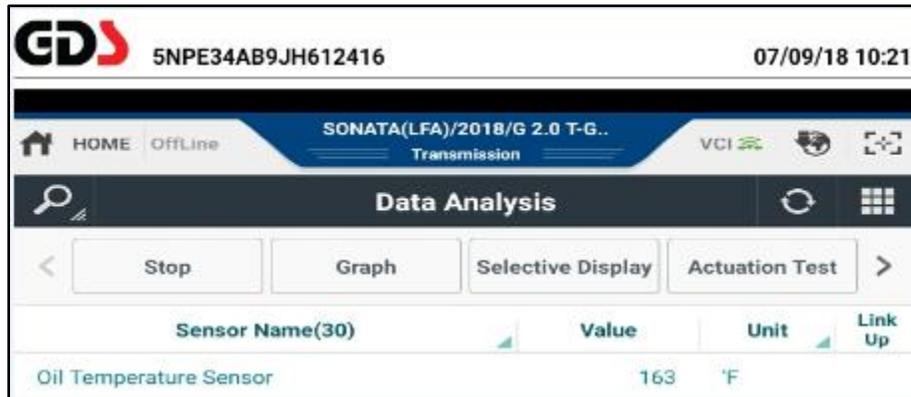
1. Attach a GDS and select **DTC Analysis** and **A/T** menu. Record the DTC and description. Delete the DTC.
2. From the GDS home screen, select **Data Analysis** and **A/T** menu and **Oil Temperature Sensor**. If the sensor shows:
  - Continuous and changing output while driving, the wiring **currently** has no open/short circuits. Go to Step 4.
  - No continuous and changing output, go to Step 3.
