**RP170 Power connector incorrect gender on Terrapro**

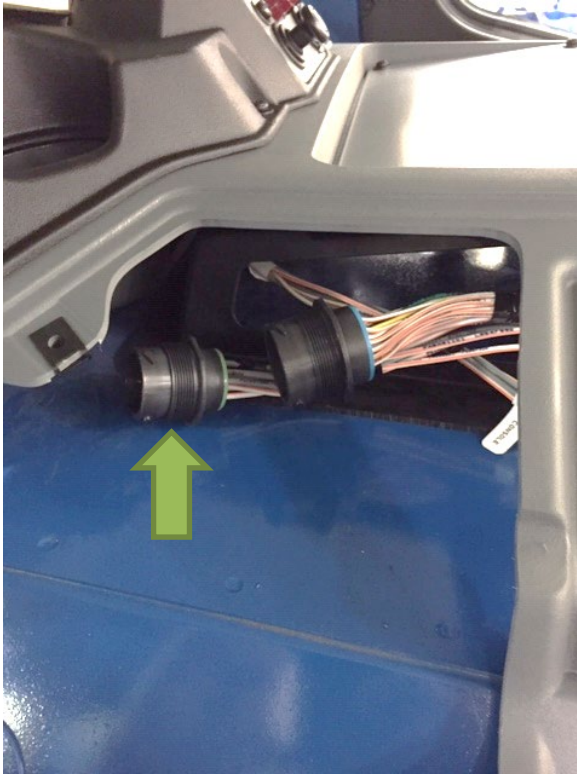
Some Mack Terrapro trucks were built with an incorrect connector for the Bodylink RP170 power connection. A jumper is available to change the connection to the correct gender.

1. Locate clean power connector

Add jumper PN 23630007, fold back extra length and secure to harness.

2. Add jumper PN 23630007
