# Product Upgrade Bulletin 190528REV

Fleetwood Brand:  
2014-2020 Discovery  
(mfd. 5/31/2013 and later)  
2017-2020 Discovery LX  
2014-2015 Providence  
(mfd. 6/5/2013 and later)

**SUBJECT:**  
Inspection/  
Installation of  
Secondary  
Generator Slide-  
Out Latch/Catch

**ISSUE DATE:**  
August 2019

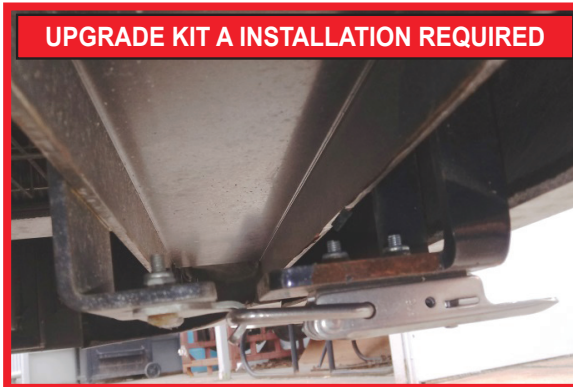
**Figure 2**

Secondary Latch Catch with Pin and Lanyard **Missing**  
Upgrade Repair Kit A Installation Required  
Follow Steps 6-13

5. If repairs are required, refer to the following information and photos to obtain the repair kit that applies to the product description and model year of coach on which you are working. Follow Steps 6-13 for Repair Kit A; follow Steps 14-23 for Repair Kit B.

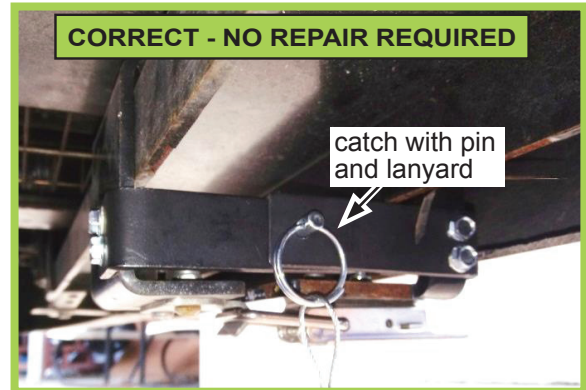
**Figure 3**

Secondary Latch Catch with Pin and Lanyard Installed  
No Further Action Needed

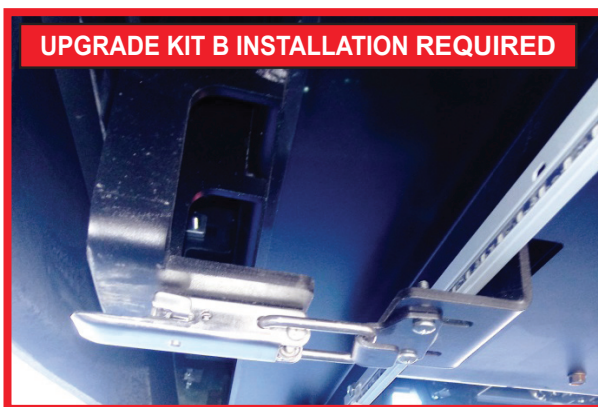
**Figure 4**

Secondary Latch Catch with Pin and Lanyard **Missing**  
Upgrade Repair Kit B Installation Required  
Follow Steps 14-23

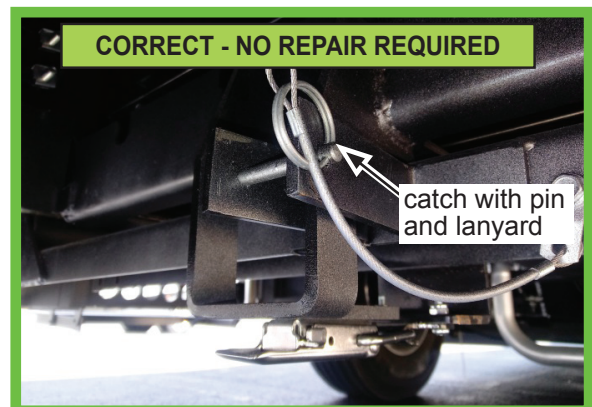
**Figure 5**

Secondary Latch Catch Installed  
No Further Action Needed
