SERVICE BULLETIN

APPLICABILITY: 2013-19MY BRZ

NUMBER: 02-136-12R

SUBJECT: Oil Seepage Diagnosis and Repair Procedures

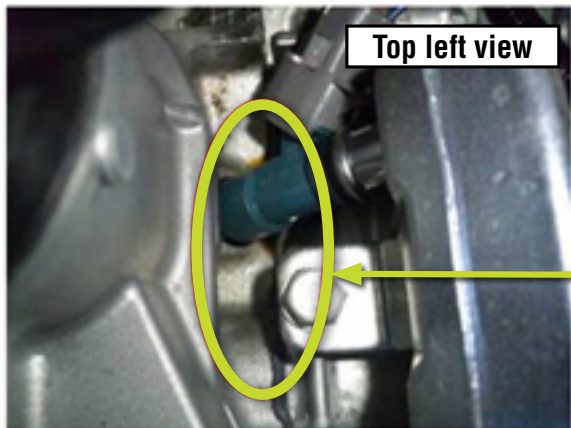
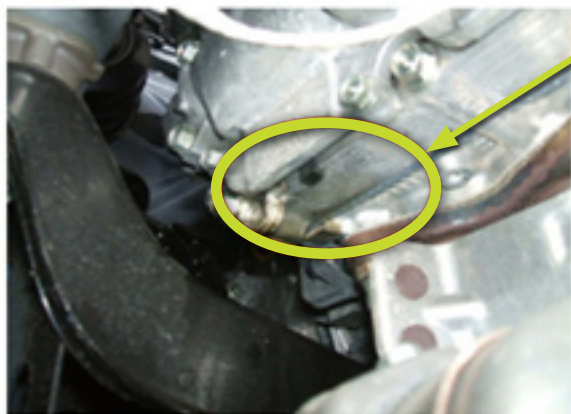
Cam carrier seepage seen from top left and lower right side of engine

If oil seepage is verified coming from between the cam carrier and the cylinder head as shown in the photos below, remove the cam carrier. Clean the machined sealing surfaces thoroughly and then re-seal using Liquid Gasket ThreeBond 1280B (Part No. SOA5499100) or equivalent*. As shown in the photos below, the o-rings between the cam carrier and the cylinder head will need to be replaced as they are not re-usable. This would also be a good time to clean the Active Valve Control System (AVCS) filter screens which are contained in the cam carriers and shown in the photos below. **NOTE:** The filter screens are one-time use and must be replaced if they need to be removed. The replacement filter part # is 14451 AA 050.

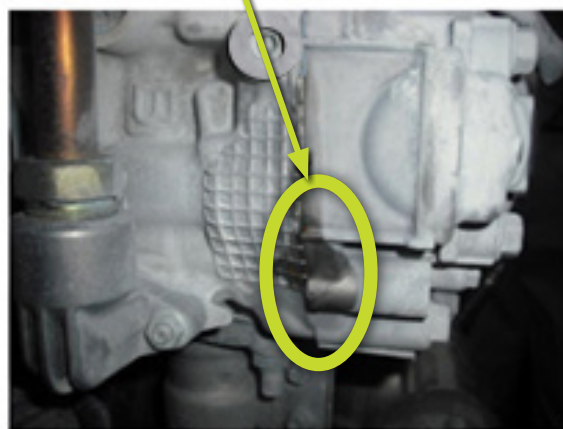
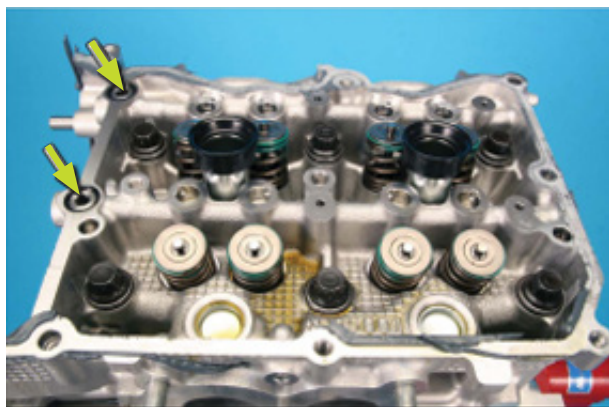
One-time use cam carrier o-rings which must be replaced.

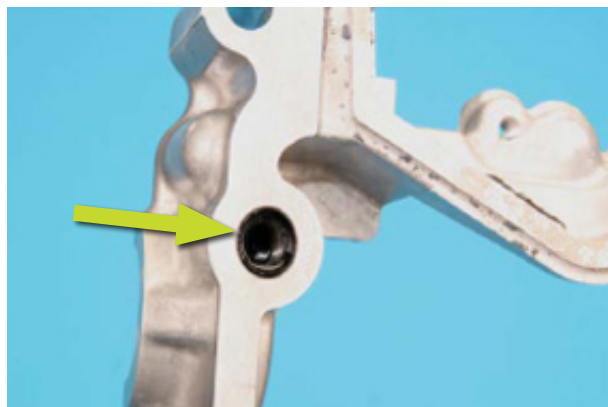
AVCS filter screens must be replaced if removed.

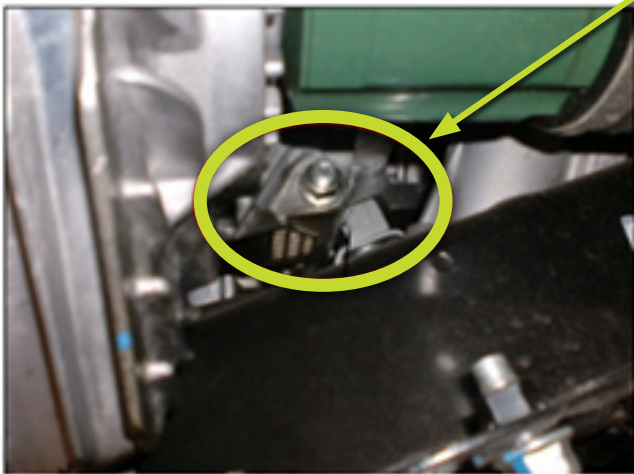
These photos show areas of seepage coming from the upper oil pan to engine block sealing surfaces.

If you find oil seepage between the cylinder block and upper oil pan, remove the upper oil pan, clean the machined sealing surfaces thoroughly and then re-seal using Liquid Gasket ThreeBond 1280B (Part No. SOA5499100) or equivalent*. In addition, the o-rings between the upper oil pan and the cylinder block along with those between the upper and lower oil pan will need to be replaced as they are also one-time use items.

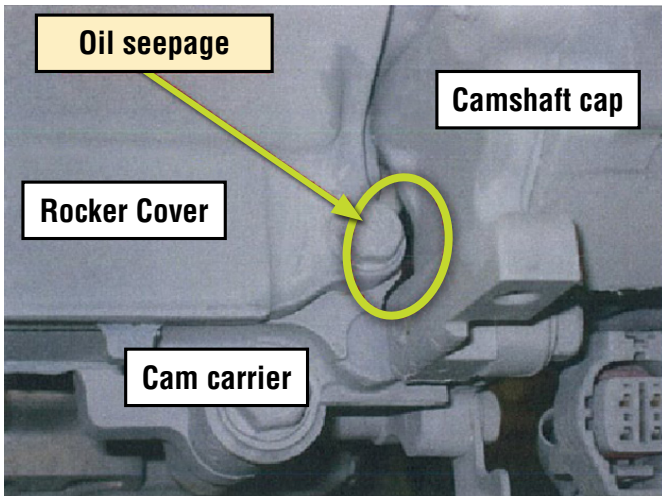
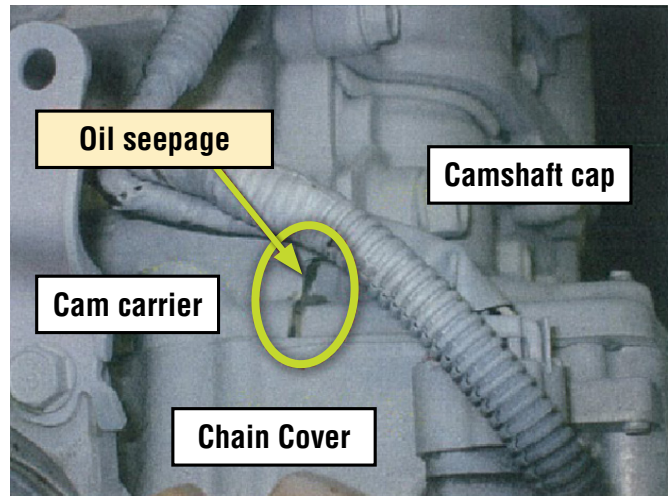
If oil seepage is verified coming from the front camshaft cap and/or camshaft carrier as shown in the photos below, remove the cam cap and clean both surfaces thoroughly before applying sealer. **Note:** The 2 o-rings between the camshaft cap and the cam carrier will need to be replaced as they are not re-usable.

Apply Liquid Gasket, ThreeBond 1280B, (Part No. SOA5499100) or equivalent* as shown below:

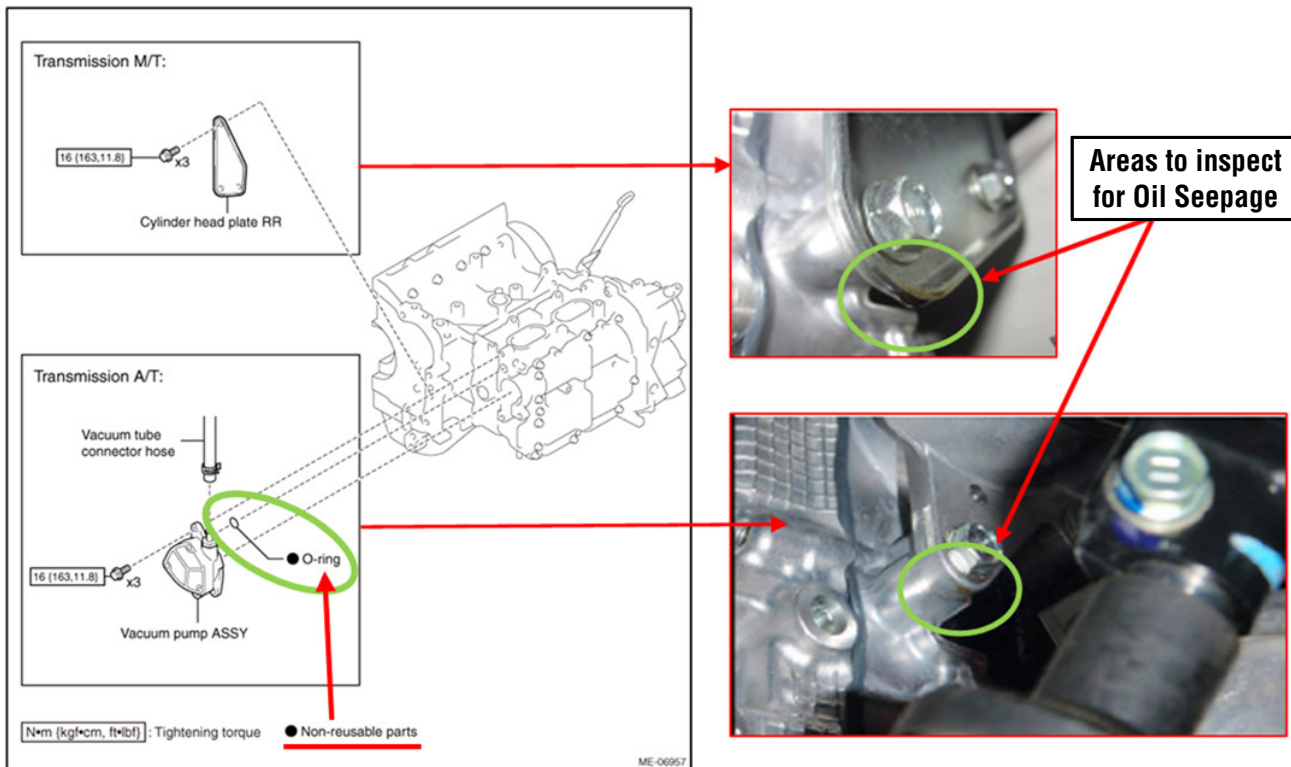
If oil seepage is verified at the bottom of the cylinder head block-off plate (on M/T models) or bottom of the vacuum pump assembly (on A/T models), the source may be the area between the cam carrier and the intake cam cap. The seeped oil then collects at the bottom of the block-off plate or vacuum pump as shown in the photo and illustration below.

IMPORTANT: ALWAYS replace the small vacuum pump o-ring as it is a **one-time use item**.

Remove the cylinder head block-off plate (or vacuum pump) following the procedure outlined in the applicable Service Manual and thoroughly clean all the machined sealing surfaces. Be sure to trim away any sealant which may have squeezed out during installation of the intake cam cap onto the cam carrier. Apply ThreeBond 1280B sealant as shown in the reference illustrations below.
