## SERVICE BULLETIN

**APPLICABILITY:** 2012-19MY Forester  
 2012-19MY Impreza  
 2015-19MY WRX

**NUMBER:** 02-131-12R

**SUBJECT:** Oil Seepage Diagnosis and Repair Procedures

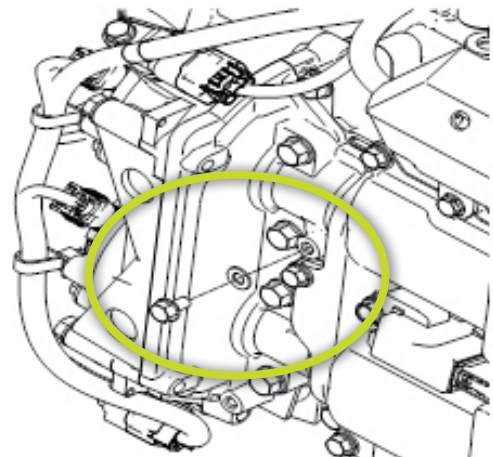
If oil seepage is verified coming from the 6mm threaded hole in the left-hand camshaft cap, install the specified bolt and flat washer.

**Bolt:** Part# 800206180

**Washer:** Part# 031106000

**Tightening Torque:** 6.4 +/- 0.5 Nm  
 (57 +/- 4 inch-pounds)

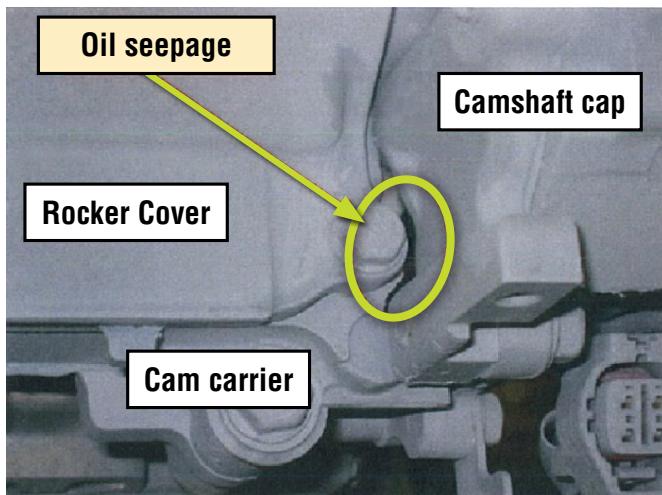
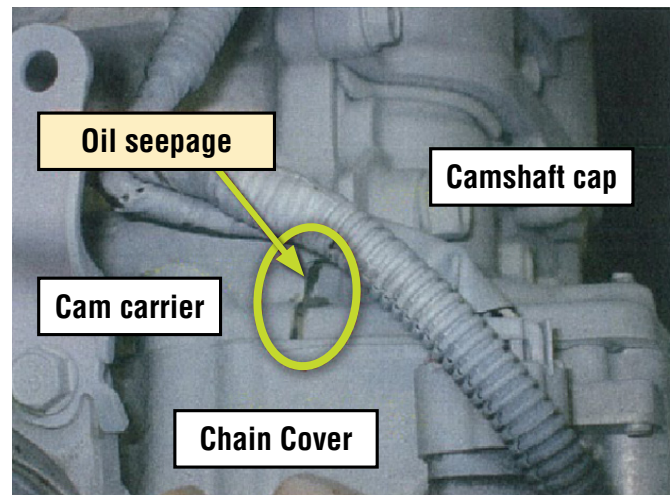
If oil seepage is verified coming from the front camshaft cap or cam carrier as shown in the photos below, remove the cam cap and clean both surfaces thoroughly before applying sealer. **Note:** The 2 o-rings between the camshaft cap and the cam carrier will need to be replaced as they are not re-usable.

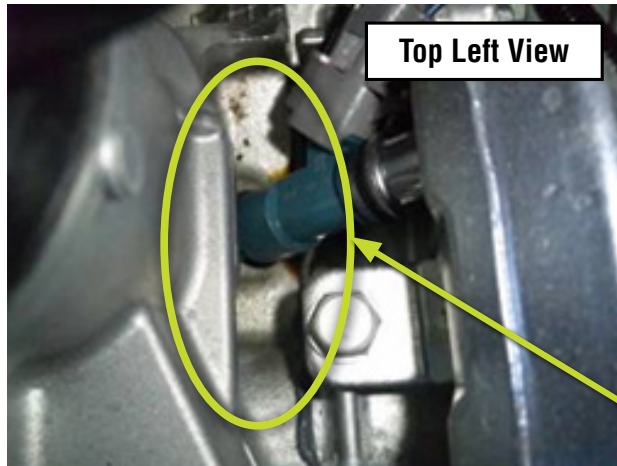
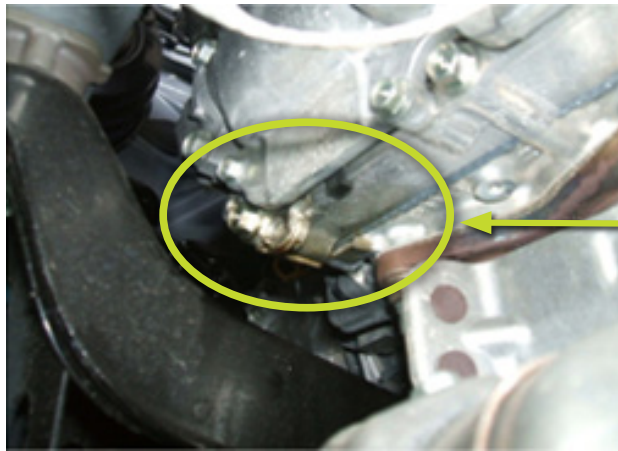
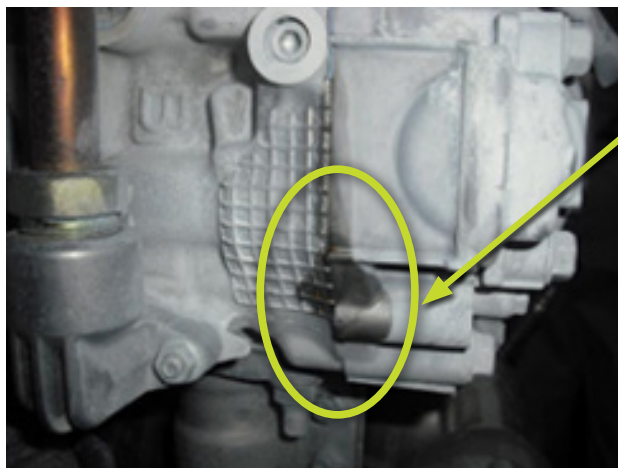
Top Left View

If oil seepage is verified coming from between the cam carrier and the cylinder head as shown in the photos below, remove the cam carrier. Clean the machined sealing surfaces thoroughly and then re-seal using Liquid Gasket ThreeBond 1280B, (Part No. SOA5499100) or equivalent\*. As shown in the photos below, the o-rings between the cam carrier and the cylinder head will need to be replaced as they are not re-usable. This would also be a good time to clean the Active Valve Control System (AVCS) filter screens which are contained in the cam carriers. **NOTE:** The filter screens are one-time use and must be replaced if they need to be removed. The replacement filter part# is 14451AA050.

Cam carrier seepage seen from top left and lower right side of engine

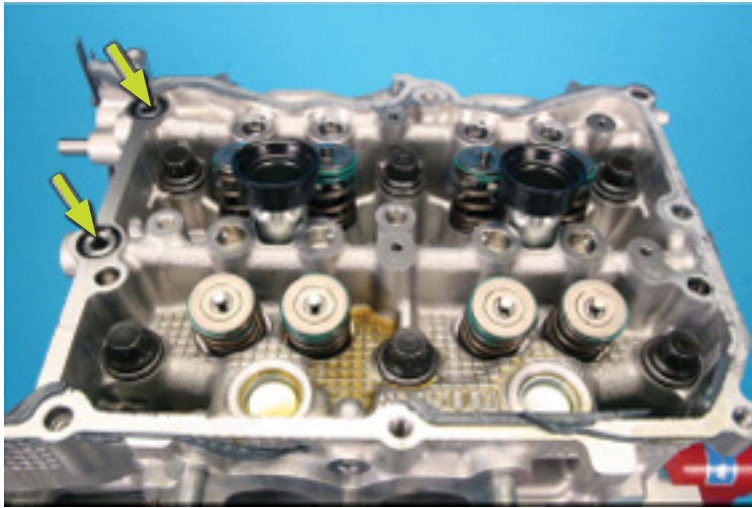
**Cam carrier o-rings requiring replacement**

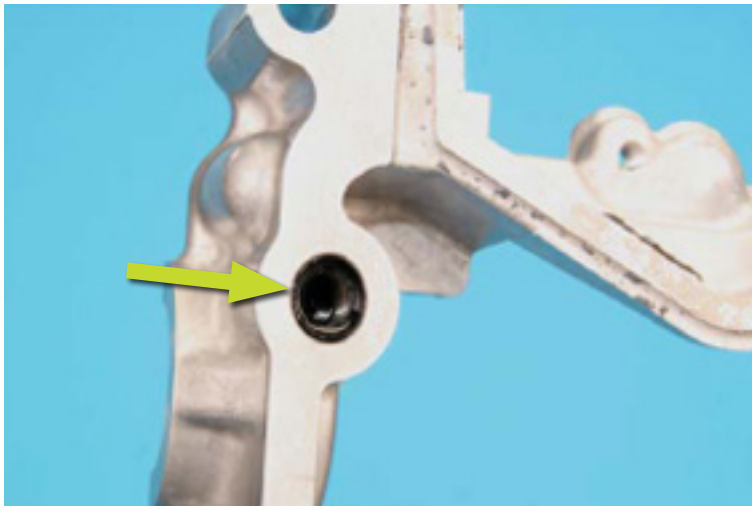
**AVCS filter screen in cam carrier**

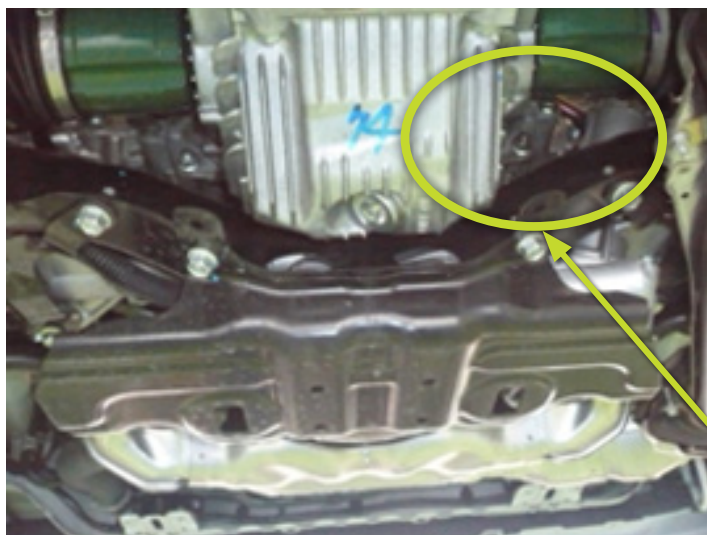
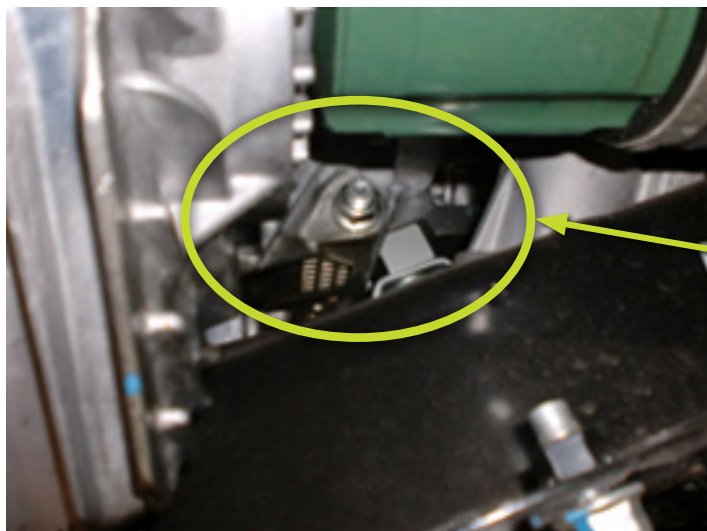
**As viewed from the rear, oil seepage from the upper pan to engine block sealing area may be present in these areas.**

If you find engine oil seepage between the cylinder block and upper oil pan, remove the upper oil pan, clean the machined sealing surfaces thoroughly and then re-seal using Liquid Gasket ThreeBond 1280B, (Part No. SOA5499100) or equivalent\*. **Note:** The o-rings between the upper oil pan and the cylinder block along with those between the upper and lower oil pan will need to be replaced as they are not re-usable.

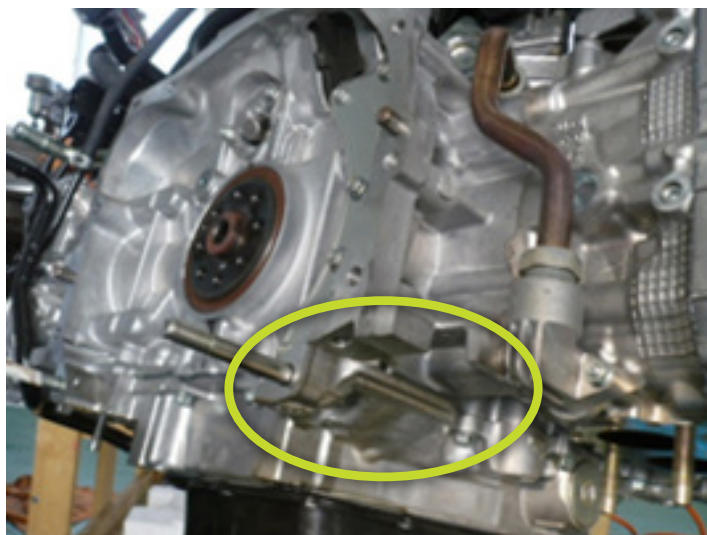
Photo shows seepage from upper oil pan to engine block sealing surfaces.

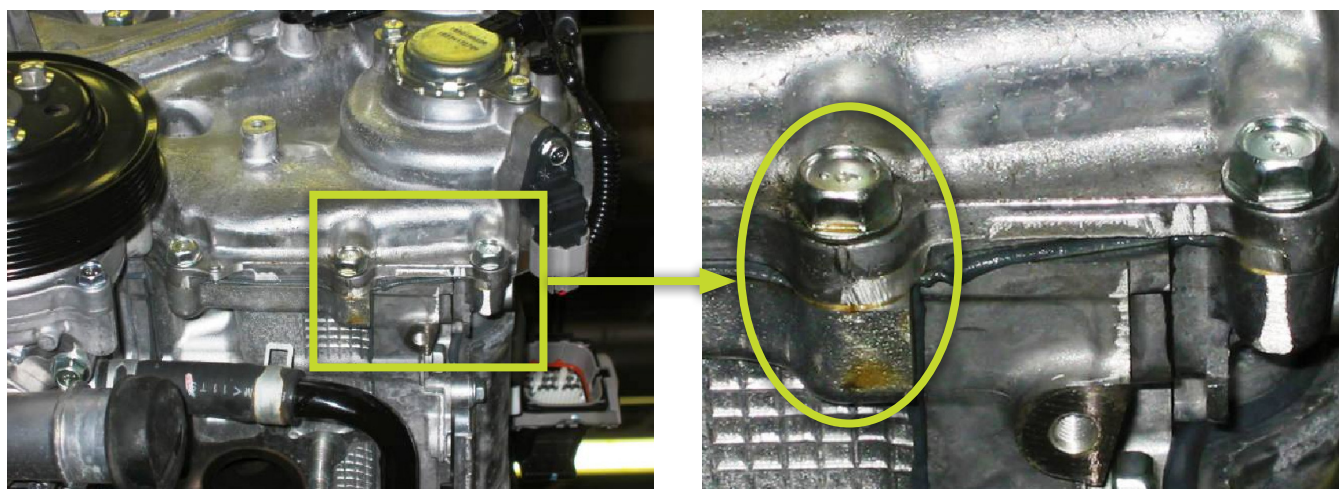
**Note:** Only reseal the front chain cover AFTER confirming there is no oil seepage coming from the cam retainer cap (area 1) as previously described.

1. If there are no oil droplets found on the engine under-cover or the lower radiator hose, thoroughly clean the chain cover sealing area along with the surrounding cylinder head and crankcase areas. Re-check for oil seepage again at the next service interval.
2. If the front chain cover is leaking and needs to be resealed, follow the repair procedure in the applicable Service Manual. Thoroughly clean and inspect the sealing surfaces then re-seal using Liquid Gasket ThreeBond 1280B, (Part No. SOA5499100) or equivalent\*.
