21-15-06 - Engine Lacks Performance, DTCs P2562, P2563, P2564, P2565, P2566, P0299, P20D8 or P00AF

Release date: 9/30/2019

Applicable Vehicles					
Model(s)	Year	Eng. Code	Trans. Code	VIN Range From	VIN Range To
Jetta, Jetta Wagon	2009	2.0L TDI (CBEA)	All	All	All
Jetta Sedan, Golf, Golf Wagon, Jetta SportWagen	2010	2.0L TDI (CJAA)	All	All	All
Jetta Sedan, Golf, Golf Wagon, Jetta SportWagen	2011-2014	2.0L TDI (CJAA)	All	All	All

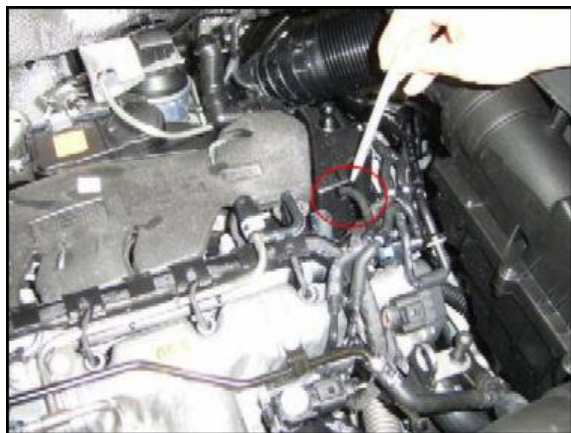
Figure 1

Hose not inserted into the Vacuum Container.

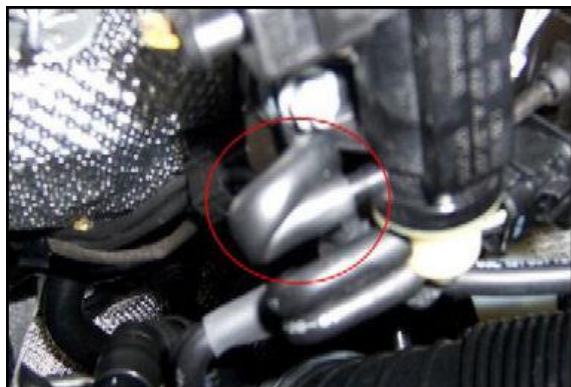
Figure 2

Vacuum Hose at the Solenoid Valve, or in the pipe system, is kinked.

- Re-position Hoses to avoid pinching. It is not necessary to replace the Hoses.

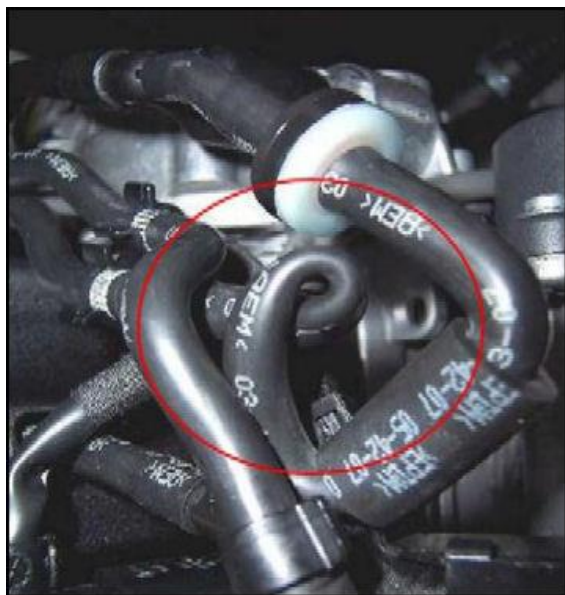
Figure 3

Vacuum Hose at the Solenoid Valve, or in the pipe system, is twisted.

- Re-position Hoses to avoid pinching. It is not necessary to replace the Hoses.

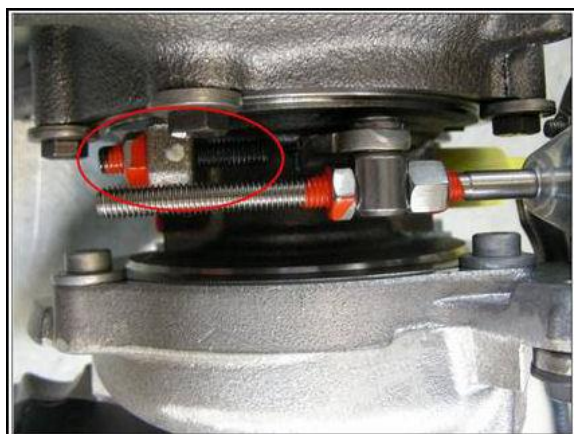
Figure 4

- Inspect the Turbocharger stud with clamp nut (min. flow adjustment screw) (Figure 4).

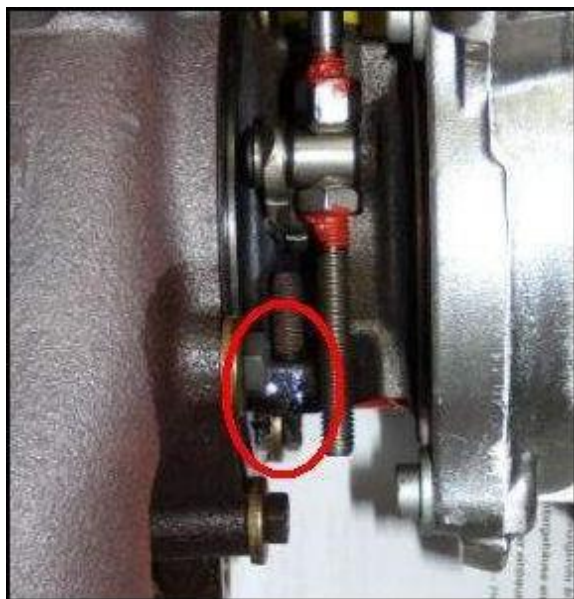
Figure 5

- Inspect the Turbocharger to see whether the stud with clamp nut is broken (Figure 5).

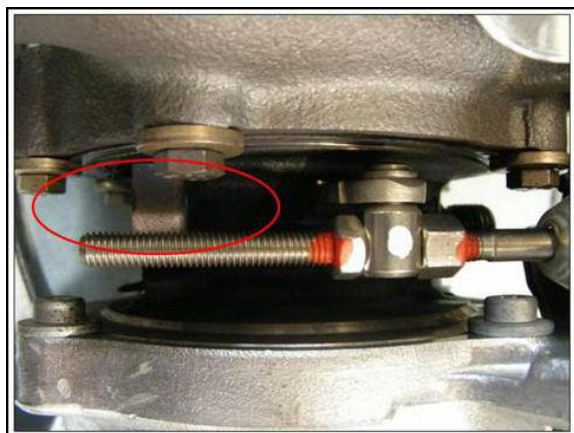
Figure 6

- Inspect the Turbocharger to see whether the stud with clamp nut is missing (Figure 6).
- If the stud or clamp nut are missing, replace Turbocharger.

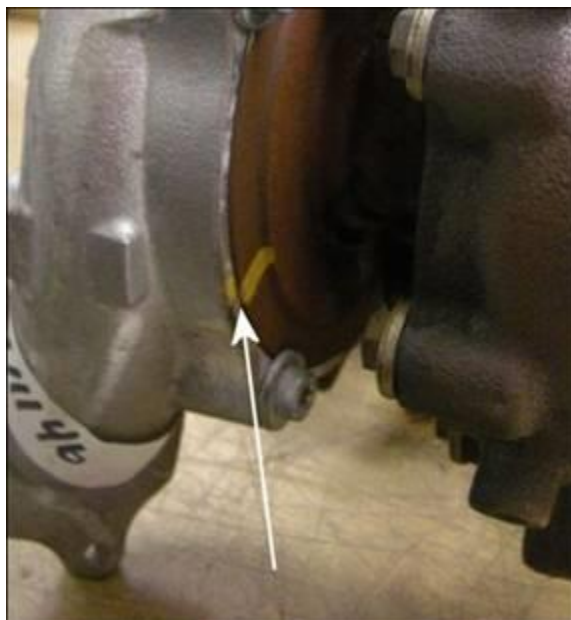
Figure 7

- Carefully inspect the Turbocharger Housing around the entire housing assembly for an alignment mark (Figure 7). If the alignment mark is misaligned, this indicates that the housing has rotated.
- If misaligned, replace Turbocharger.

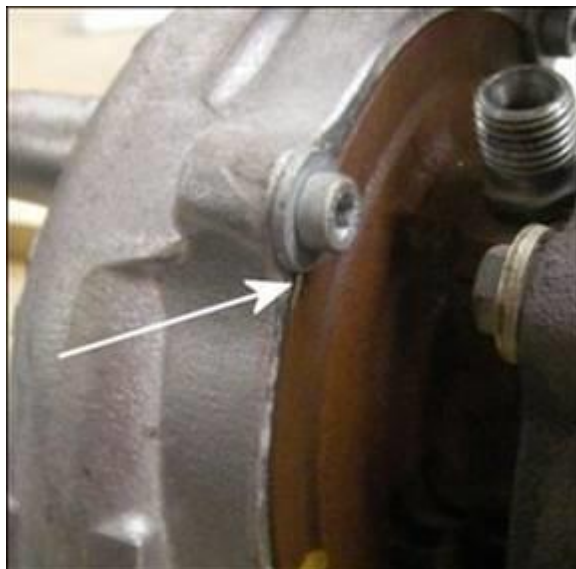
Figure 8

- Carefully inspect the Turbocharger Housing around the retaining bolts for witness marks (Figure 8), indicating that the housing has rotated.
- If witness marks are present from washers, replace Turbocharger.

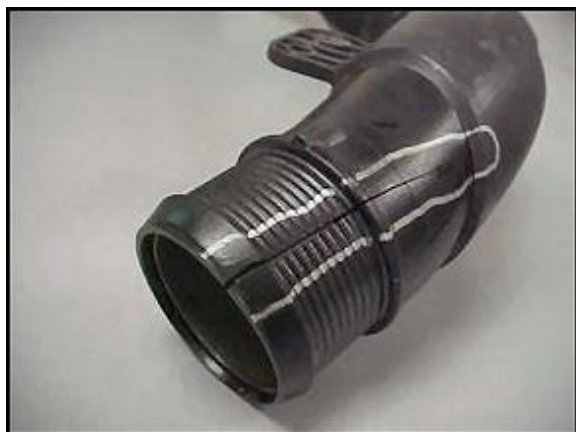
Figure 9

- Inspect the Plastic Boost Pipe that runs from the intake side of the Turbocharger to the Intercooler for cracks or leaks (Figures 9 and 10).

These cracks can be difficult to see. It may be necessary to pressure test the Charge Air System according to Repair Manual Group 21.

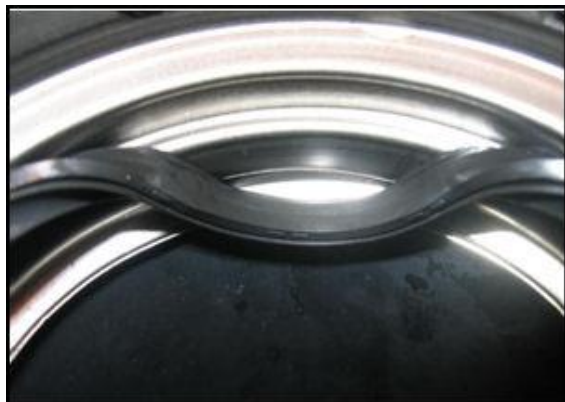
Figure 11

- Inspect the Boost Pressure Hose connections to the Intercooler for leaks.
- Ensure that the Seals are in the proper position and not damaged (Figure 11).
- Damaged or missing Seals should be replaced. The Seals are available separately, it is not necessary to replace the entire hose.

Pay close attention to this area if DTC P20D8 is recorded in ECM faults.
