ARTICLES CONTAINED IN THIS ISSUE

01 SUBARU SELECT MONITOR (SM4) UNRESPONSIVE WHEN CONNECTING TO SOME 2020MY VEHICLES

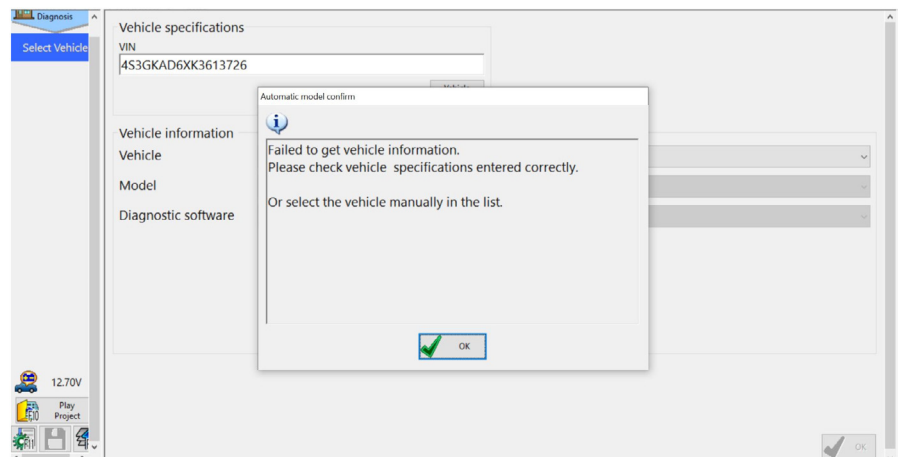
When connecting the SSM to some 2020MY vehicles, the system appears unresponsive (does not automatically “identify” the vehicle / VIN) and displays the screen as shown below. The Vehicle information must be selected manually to initialize SSM communication. This condition will be addressed in the January 2020 SSM Software Update release.

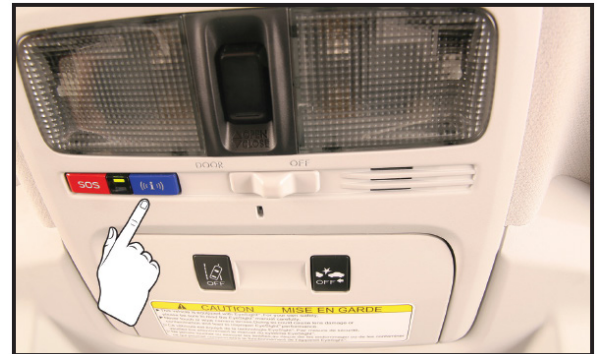
During ongoing review of Techline cases, there have been several inquiries regarding the PDI comm check, Error Code 202, and Error Code 204.

- Error Code 202 essentially means the comm check signal failed to send from the DCM. It could be a network issue or hardware problem but, the most common root cause is the comm check has never been completed.
- Error Code 204 occurs when the provisioning message which is returned to the DCM and writes the VIN has not been returned. This could be a network issue or hardware problem but most often, it is a technical issue with one of the databases which can only be resolved by opening a TechLine case.

Comm Check Procedure:

Press and hold the blue i-Call (i-button) switch for 2 seconds or more.

This will identify both the VIN (via the ECM) and the DCM ID then transmit them to the SOA network via the AT&T 4G LTE network. When received, subscription information will be associated with the VIN and verified on the Subaru of America, Inc. (SOA) servers.

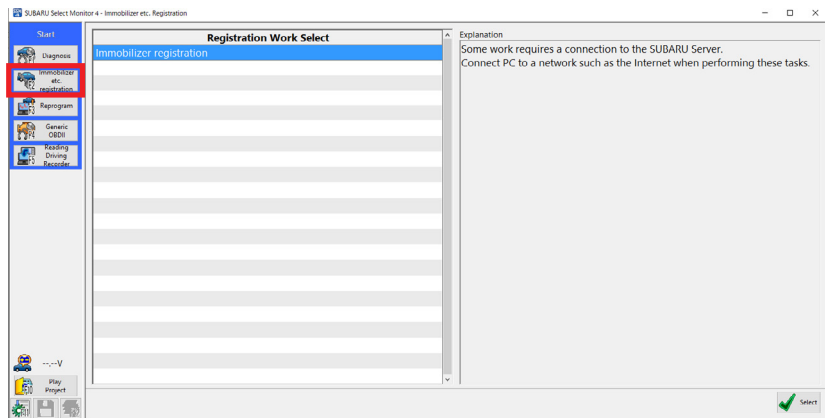
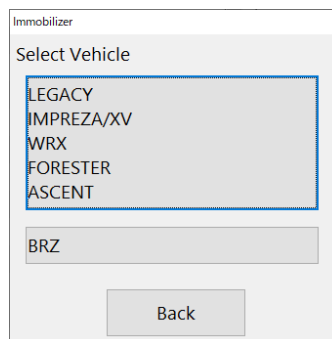
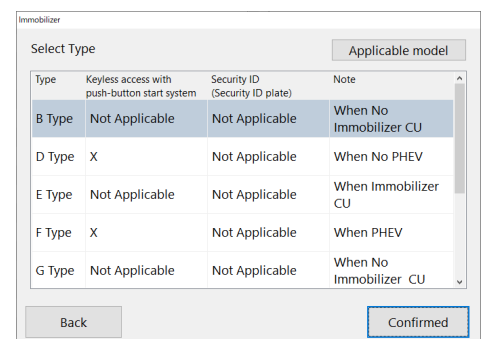
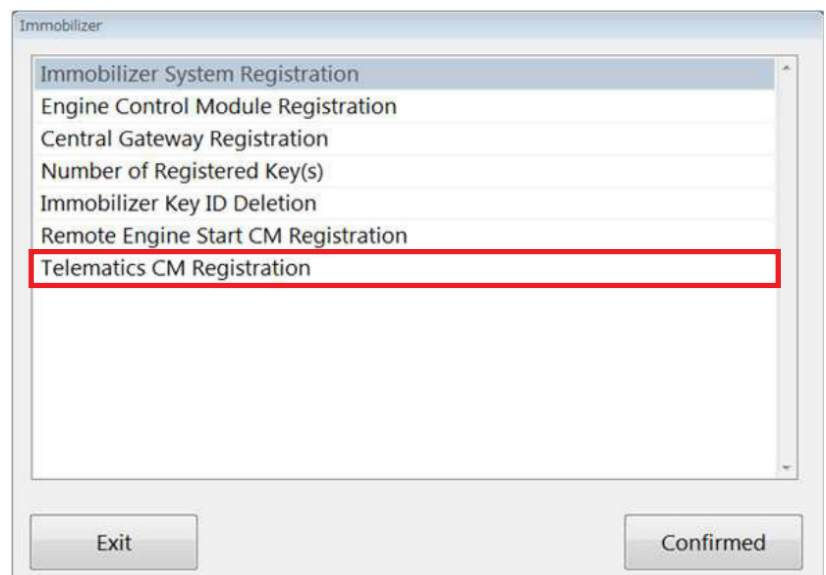
The Techline has received some reports recently about DTC B2A16 on STARLINK Gen2 Telematics equipped vehicles (2019-20 Ascent, 2019-20 Impreza, 2019-20 Crosstrek / Crosstrek Hybrid, 2019-20 Forester, and 2020 Legacy/ Outback).

- When attempting to use the Remote Engine Start (RES) feature via Telematics (STARLINK / My Subaru), the request is unsuccessful and the red Telematics lamp illuminates. All other Telematics remote functions work normally.
- Customer brings their car to the Retailer and the Technician finds DTC B2A16 to be the only code stored in the DCM.
- When the Technician attempts to repair the DTC according to the Service Manual Trouble Tree for B2A16, the DCM ends up being replaced.

Actually, nearly all of these cases can be fixed without DCM replacement. SBR is working now to revise the troubleshooting tree information to reflect this.

If DTC B2A16 code is found in the DCM, start by registering the DCM with the vehicle Immobilizer to avoid unnecessary DCM replacement. Follow the instructions found in the applicable Immobilizer manual. See basic SSM screenshots for reference.

Once registered, confirm the RES function of the Telematics system operates. The customer will need to help with this as it requires them to enter their PIN through either the MySubaru web page or the mobile MySubaru App.

If this resolves the condition and the STARLINK Telematics RES feature now works, clear the DTC and release the vehicle.
