SERVICE BULLETIN

APPLICABILITY: 2019 - 20MY Ascent

NUMBER: 12-273-19

SUBJECT: Leather Front Seat Covers- Design Change

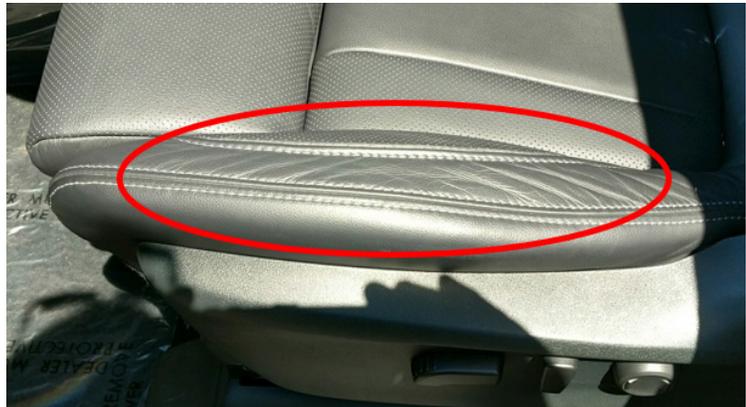
This bulletin announces availability of redesigned leather seat cushion trim covers to address isolated customer concerns of wrinkles appearing during early stages of vehicle use as shown in the example photo below. The new covers utilize materials with higher durability and resistance to wrinkling.

The new seat cushion trim covers were incorporated into production starting with VIN L3400954.
