Technical Service Bulletin

91 SOS Warning displayed in the instrument cluster, no communication to the telematics control module

91 19 95 2056076/3 September 30, 2019. Supersedes Technical Service Bulletin Group 91 number 19-90 dated September 18, 2019 for reasons listed below.

Model(s)	Year	VIN Range	Vehicle-Specific Equipment
A4, A5, A6, A7, A8, Q5, Q7, Q8, and Audi e-tron quattro	2019 - 2020	All	With ConBox

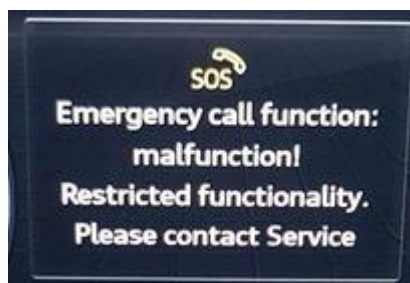
- An SOS Warning is displayed in the instrument cluster (Figure 1).

Figure 1. Emergency call malfunction warning.

- No diagnostics communication can be established with the control module for emergency call module and communication unit (telematics control module or ConBox), J949 (address word 0075).

A software bug can cause the control module to freeze during cold start.

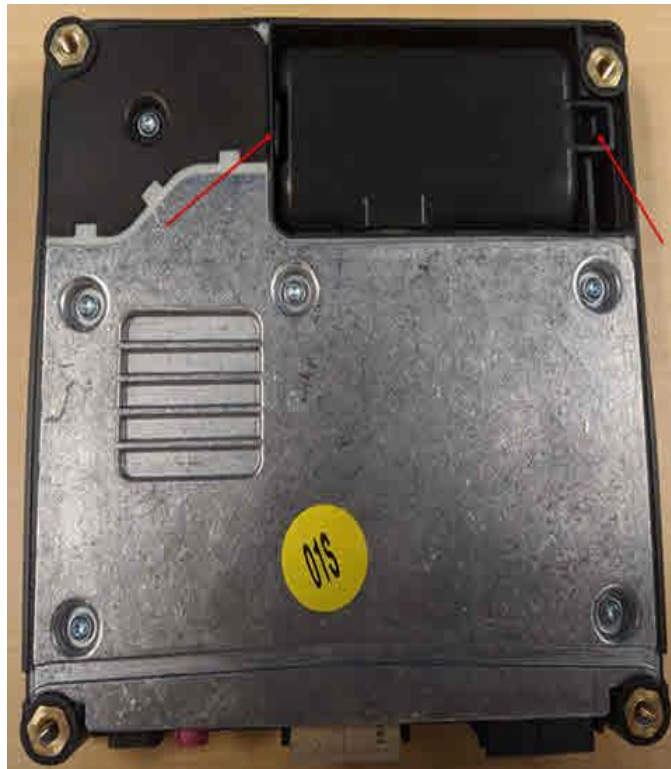
Figure 1. Backup battery compartment location.

1. Remove the telematics control module, J949 (address word 0075) according to the repair manual in Elsa.
2. Open the battery compartment of the telematics control module, J949 (address word 0075) and disconnect the backup battery.
