Technical Service Bulletin

94 Adaptive light malfunction or running gear malfunction shown in instrument cluster with various DTCs

94 19 14 2056219/1 September 27, 2019.

Model(s)	Year	VIN Range	Vehicle-Specific Equipment
A6 and A7	2019	All	Not Applicable

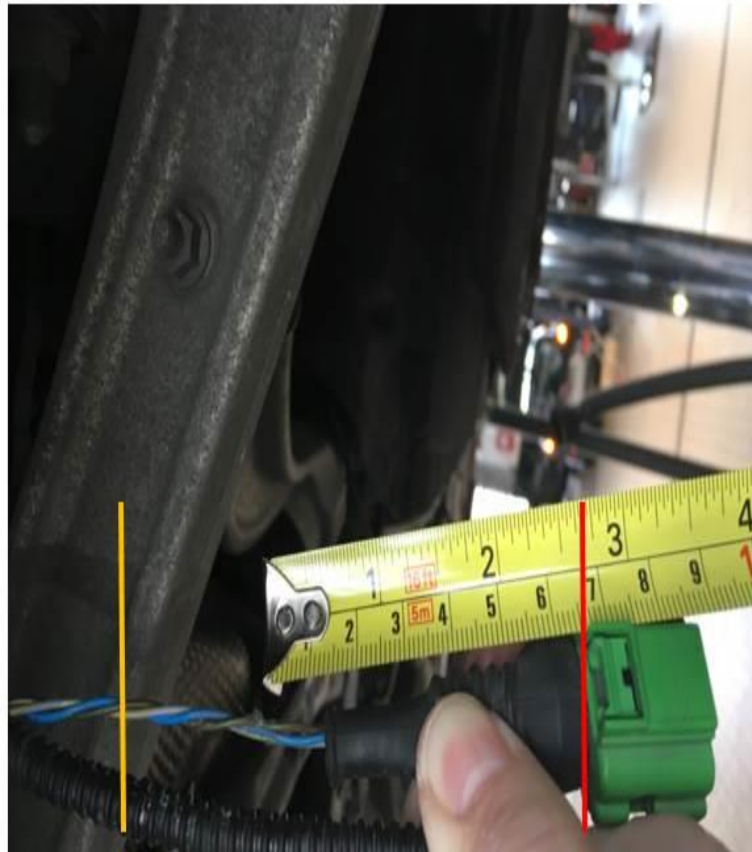
Damage to the left front level sensor (G78) wire harness may have occurred during production. This can result in the harness becoming oxidized underneath the protective corrugated tube.

Figure 1. The affected area located under the corrugated tube between the red and yellow mark.

1. Peel back the corrugated tube and inspect the wiring of the front left level sensor (G78) about 5 to 10 cm after the connector (Figure 1).

2. If there is damage in this area, repair the wires with the VAS1978B.

Tip: If multiple wires are affected the repairs will need to be staggered to fit within the corrugated tube.

3. Once the repair is complete, wrap the harness from the rubber sleeve to the first mounting clip with tape **N 106 497 02** then refit the corrugated tube over the harness.

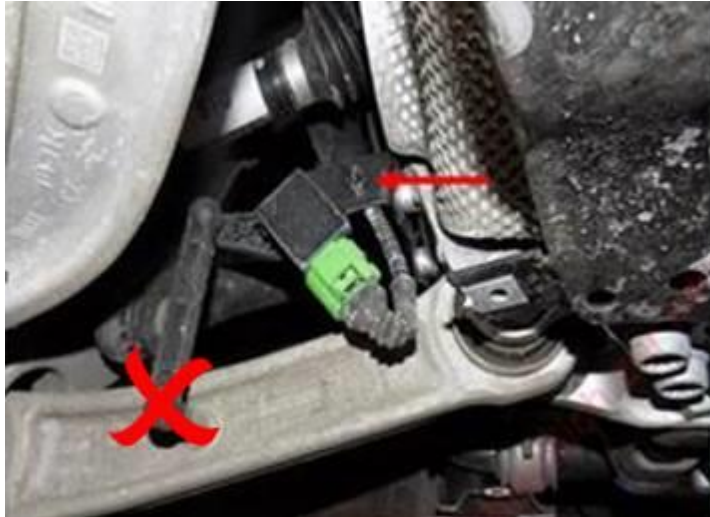
Figure 2. Incorrect position of the harness clip. The clip is mounted on the opposite side of the sensor bracket.

4. Check from which side of the sensor bracket the first mounting clip for the corrugated tube is attached. The first clip of the corrugated tube must be attached on the sensor side of the bracket. If the clip is incorrectly attached (Figure 2), refit the clip (Figure 3).

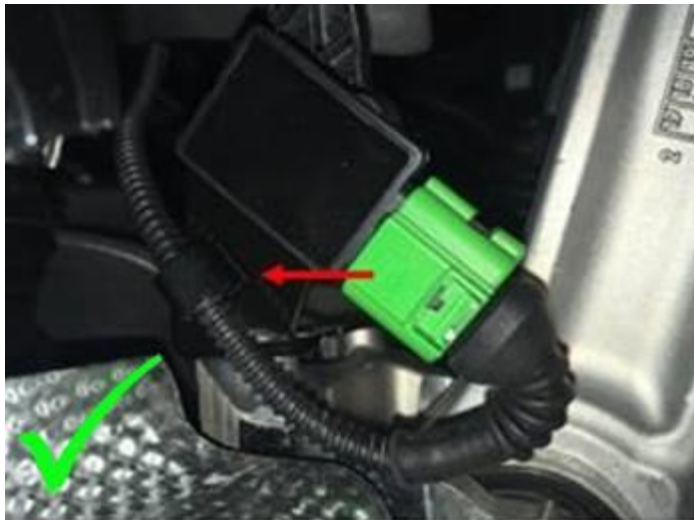
Figure 3. Correct positioning of the harness clip. The clip is mounted on the sensor side of the bracket.
