Technical Service Bulletin

97 Fuel gauge does not work

97 19 65 2056234/1 September 23, 2019.

Model(s)	Year	VIN Range	Vehicle-Specific Equipment
A8	2018 - 2020	All	Not Applicable

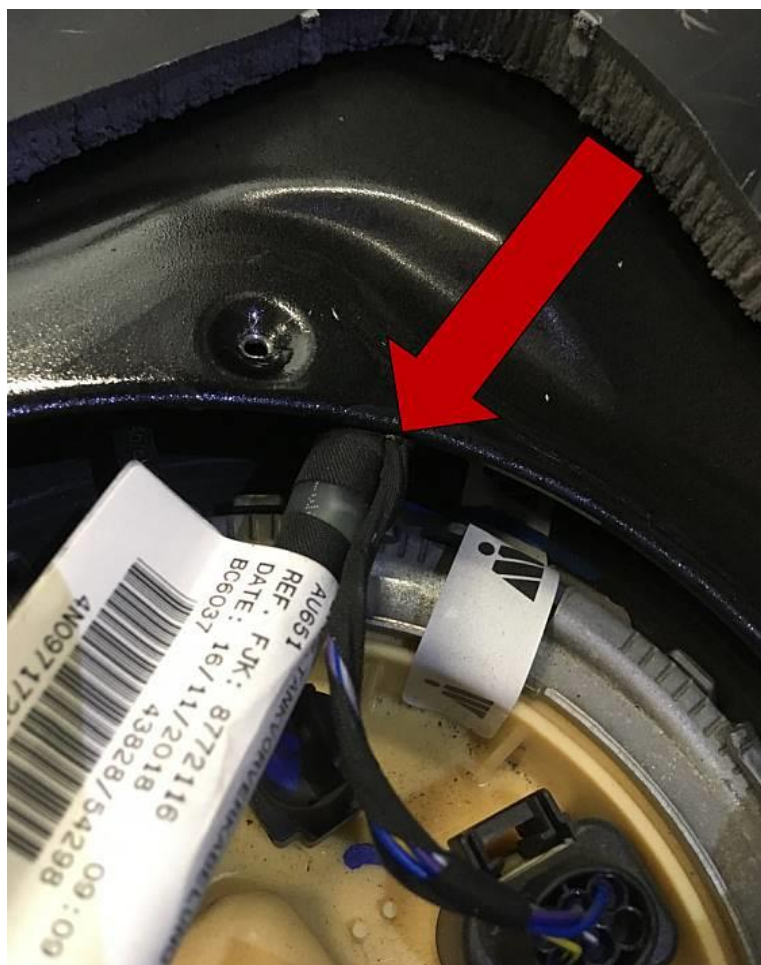
The wiring of the fuel tank senders can rub through on the service opening for the fuel tank.

If one or more of the above DTCs are stored, open the service cover under the rear seat bench. Inspect the fuel tank wiring harness near the body flange (Figure 1). If the insulation is damaged, repair using the steps below.

Figure 1. Location to inspect for rub through.

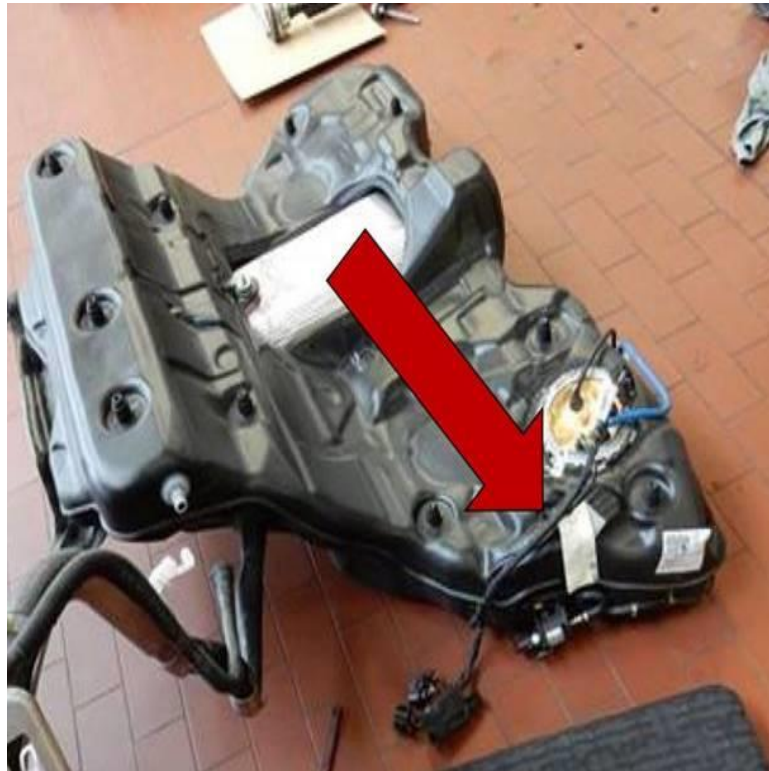
Figure 2. The arrow points towards the harness clip to be removed.

1. Remove the trim of the fuel pump control unit from the underbody of the vehicle.
2. Disconnect all connectors from the tank wiring harness.
3. Loosen the harness clip from the retaining strap of the tank so that the wiring harness can be pulled upwards through the service opening (Figure 2).

Tip: The harness clip (Figure 2) has to be removed from the tank to gain enough clearance for the repair. This harness clip does not need to be replaced for the repair however it will need to be refit after the repairs are made.

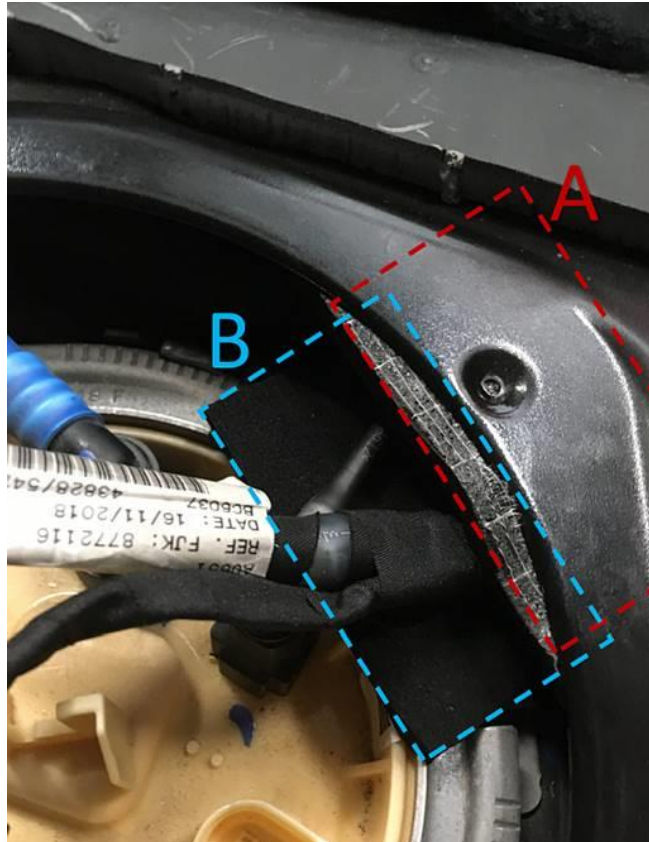
Figure 3, A and 3, B. Section A and B are attached to the topside of the tank and the bottom side of the body to prevent further rubbing of the harness.

8. Attach self-adhesive foam pad (443201365B, 100x100x6mm). Cut the pad into two equal sections measuring 50x100mm. Attach one section to the underside of the body flange (Figure 3, A).

9. Attach the other half to the top side of the fuel tank so that the wiring harness will not rub through on any components (Figure 3, B).
10. Refit the wiring harness and plug in the connections for the fuel pump and tank sensor.
11. Reconnect the cables to the fuel pump control module.
12. Secure the wiring harness to the welding stud of the tank strap with the harness clip. Ensure that the wiring harness is at least 1cm away from the tank strap.
13. Reassemble the vehicle, however, before closing the service cover check the wiring harness again for correct routing.
