Service Bulletin

19-096

Product Update: Display Audio Clock Off by 1 Hour

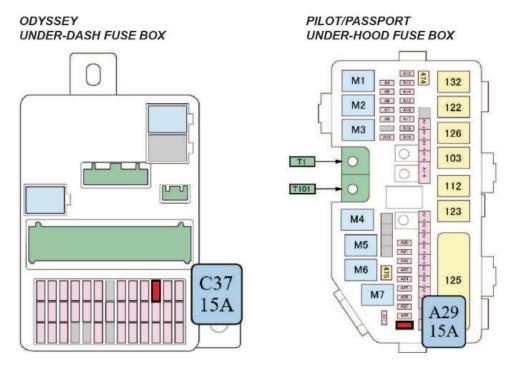
If this step is skipped or not correctly done, the customer will still experience the issue.

- If B.1.0.26 or higher is displayed, go to step 6.
- If B.1.0.26 or higher is not displayed, contact Tech Line.
- 6. Turn the vehicle OFF and pull the 15 amp B+ radio fuse for 10 minutes to clear the data from the audio unit.
