GROUP <b>Electrical</b>	MODEL <b>2018-2019MY Niro (PHEV/EV)</b>
	NUMBER <b>PS626</b>	DATE <b>September 2019</b>

**SUBJECT:** CHARGE PORT STICKING AND/OR INTERMITTENT FAILURE TO CHARGE (PHEV/EV)

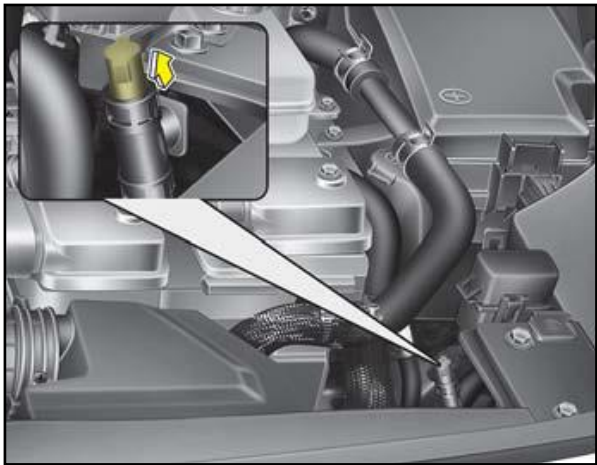
**Niro (PHEV)**

In some cases, the inlet cable lock may not function properly when foreign materials such as debris enter the cable or when the cable is encrusted with ice. If this occurs, the charging cable may not be disconnected from the vehicle, the charging cable may not lock, or the vehicle may not charge.

If any of the above symptoms occur pull the emergency cable lightly 2 to 3 times prior to charging.
