MODEL
**2020MY
Telluride (ON)**

NUMBER
PS627

SUBJECT: INOPERATIVE LICENSE PLATE LAMP AND/OR
LIFTGATE HANDLE SWITCH

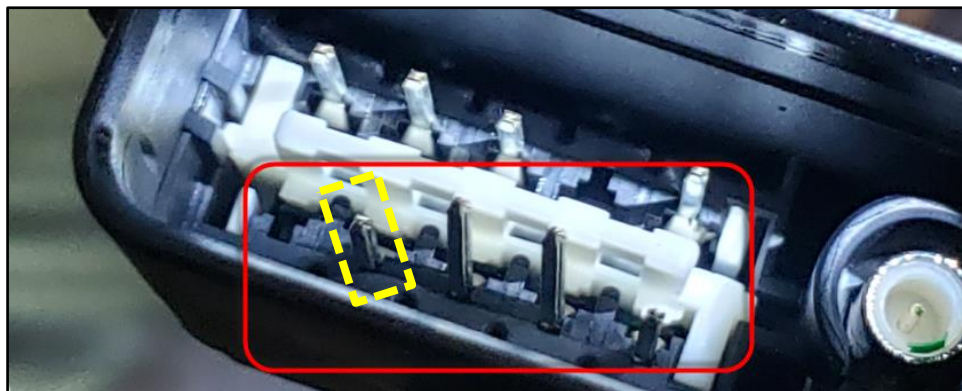
The sample image above shows a bent and backed out pin outlined in yellow.

Inspect the connector R28 for bent or backed out pin(s). If the connector pin(s) are found to be damaged, repair as needed. Once repaired, check for correct operation of the license plate tail lamps and liftgate handle switch. If no damage is found on the connector, proceed with normal diagnosis.
