GROUP BOD	MODEL 2018MY Niro (DE, DE PHEV)
	NUMBER 195	DATE September 2019
TECHNICAL SERVICE BULLETIN		
SUBJECT: SERVICE ACTION: TAILGATE STRIKER AND OVER-SLAM ENHANCEMENT (SA399)

SERVICE ACTION: TAILGATE STRIKER AND OVER-SLAM ENHANCEMENT (SA399)

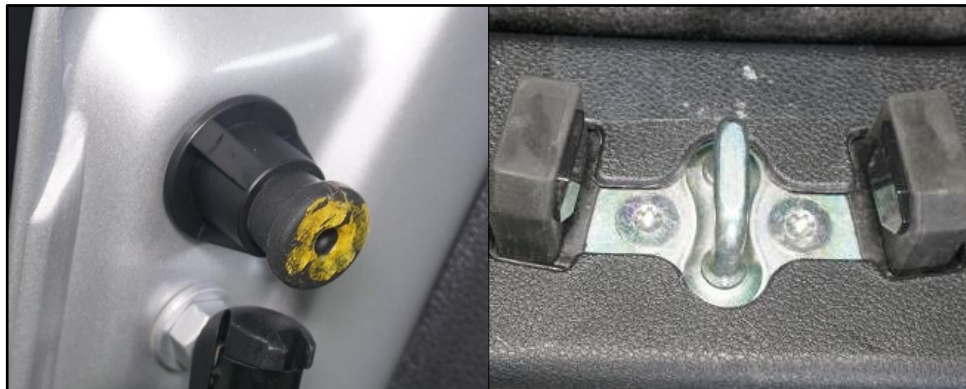
This bulletin provides the procedure to adjust the tailgate striker and over-slam bumpers to improve the closing of the tailgate on some 2018MY Niro (DE, DE PHEV) vehicles produced between July 24, 2017 through January 16, 2018. Before conducting the procedure, verify that the vehicle is included in the list of affected VINs.

Over-Slam Bumper

Tailgate Striker

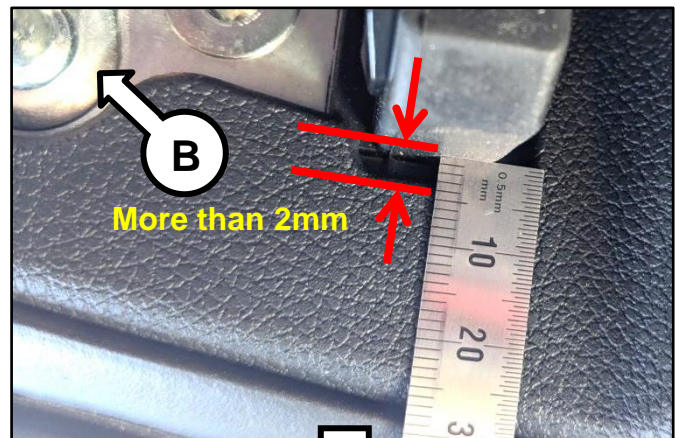
3. Locate the tailgate striker (B). Using a ruler, measure the gap between the rubber stopper and transverse cover as shown. The measurement should not exceed 2mm (0.079 inches).

If the measurement is not 2mm, proceed to the next step.

If the measurement is 2mm, proceed to step 5 to adjust the over-slam bumpers.
