MODEL
2018-2019MY
Niro (DE PHEV)

NUMBER
161 (Rev 1, 09/16/2019)

TECHNICAL SERVICE BULLETIN

SUBJECT: COMBINATION TSB / SERVICE ACTION: COOLANT
LEAK – OBC INLET HOSE DETACHING (SA365)

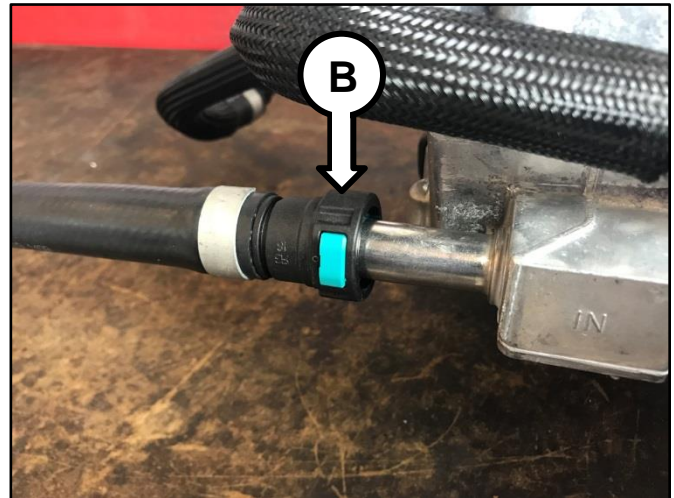
OBC assembly and inlet hose removed from vehicle for demonstration purposes only.

2. Ensure the OBC inlet hose (B) is fully installed.
