Technical Service Bulletin

Topic	HVAC operation issues/HVAC Motor defect DTC's logged
Market area	Bentley: worldwide (2WBE),Hongkong-Macau (5HK)
Brand	Bentley
Transaction No.	2051519/4
Level	EH
Status	Released for publishing
Release date	Sep 5, 2019

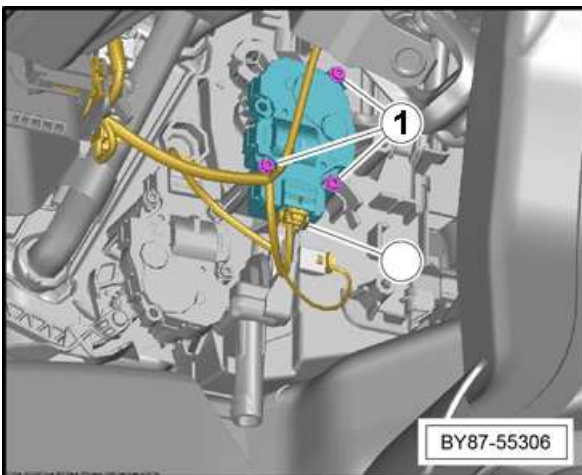
The servomotor can become jammed causing HVAC operation issues.

Figure 1 - Right foot well temperature flap motor (V581) is shown as an example only

1. Lightly tap the casing of the motor with, for example, a handle from a screwdriver then erase the DTC.
2. If the DTC erases, carry out basic settings of the HVAC control module then recheck for DTC's. If the DTC does not erase or returns then continue to point 3
3. Remove fixings which secure the motor to the HVAC unit

4. With care attempt to manoeuvre/reposition the motor (without completely removing it from the HVAC assembly)
5. Secure the fixings -1- then erase the DTC
6. If the DTC erases, carry out basic settings of the HVAC control module. If the DTC does not erase the motor should be replaced.
7. If applicable to your vehicle please ensure Service Campaign EB28 (Bentayga) or EB29 (New Continental GT/GTC) has also been applied.
