Technical Service Bulletin

Topic	New Continental GT and New Continental GTC - Driver/Passenger door power latch creak on close
Market area	Bentley: worldwide (2WBE),Hongkong-Macau (5HK)
Brand	Bentley
Transaction No.	2052394/5
Level	EH
Status	Released for publishing
Release date	Sep 5, 2019

New Continental GT and New Continental GTC

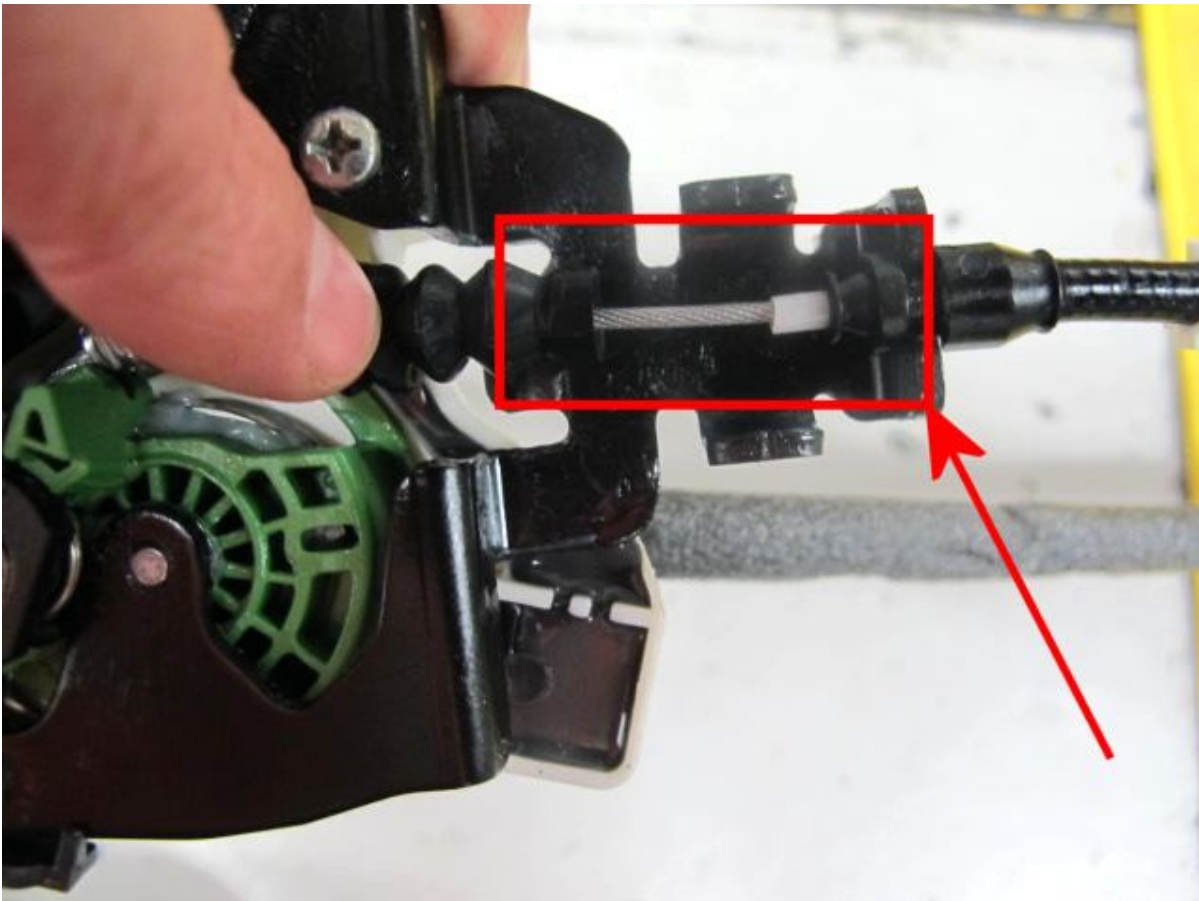
Figure 1

Driver or Passenger door creak during the power latch "Close" function

Application of grease to both ends of the power latch Bowden cable is required as per the instructions within the Measure section of this TPI

- 1) Obtain a clear video recording of the issue (save the video as it will be required later within this procedure)
- 2) Remove the applicable front door trim - Refer to Repair manual Rep.Gr 70
 - Remove the front door inner closing panel – Rep.57
 - Remove the door latch - Rep.Gr 57
- 3) Referring to Figure 1, Remove the rubber boot - Apply Dow Corning Molycote 33 extreme - Low temperature bearing grease to the inner cable
 - Refit the rubber boot
