Technical product information

Topic	Emergency call function test at PDI
Market area	United States E05 Bentley USA and rest America (6E05)
Brand	Bentley
Transaction No.	2056105/1
Level	EH
Status	Approval
Release date

New Continental GT and New Continental GTC

Emergency call function test required at PDI

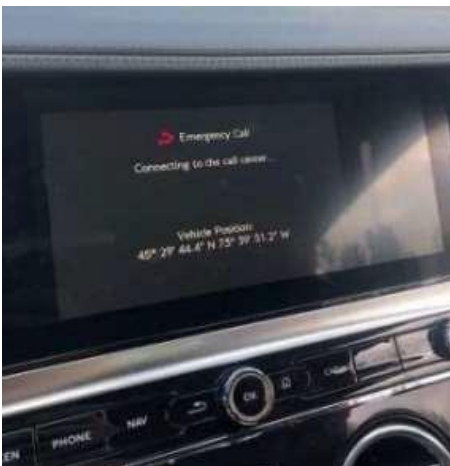
2) Carry out an Emergency call function test to check/confirm if the call is successful/answered, the operative must also check/confirm the Infotainment system is displaying the information as shown in Figure 1

NOTE: The coordinates within Figure 1 are shown as an example only

Should the emergency call system be operational after the first or second attempt (*call successful/answered*) and the Infotainment system is displaying as shown in Figure 1 - No further action is required

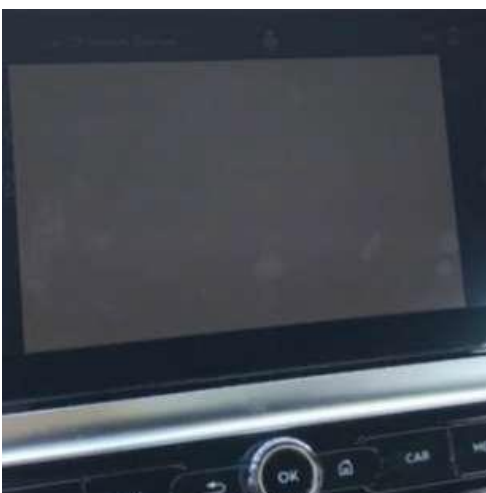
Figure 2

3) If the call is successful/answered but the Infotainment display is blank as (Figure 2) Re-test the Emergency call function a second time

IMPORTANT NOTE: If the Infotainment display remains blank after the second test

If the call is unanswered, raise a DISS query and await feedback from Product support before carrying out any further work
